VESSELS AND PIPING

This document contains loss prevention recommendations and supporting information for vessels, piping, and systems used in the storage, transfer, or processing of solids (powders, granules, etc.), liquids, and gases.

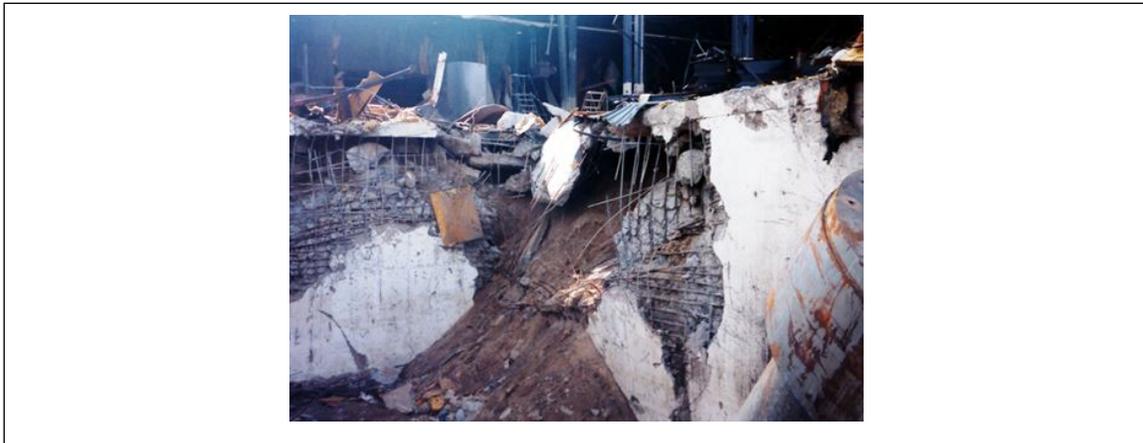
The photographs below show the potential collateral damage from the failure of a vessel at pressure (Figure 1) and under vacuum (Figure 2).

*Fig. 1. Collateral damage following catastrophic failure of a hot isostatic press*

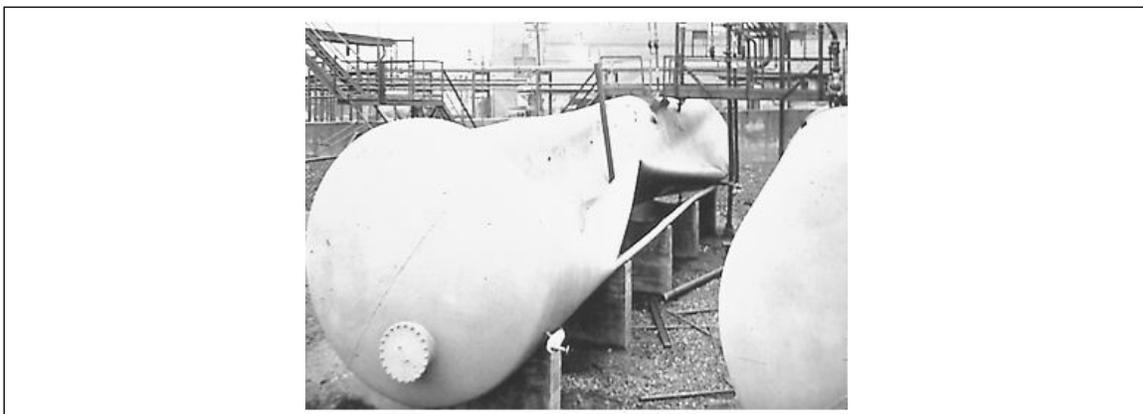
*Fig. 2. Imploded tank caused by inadequate design*

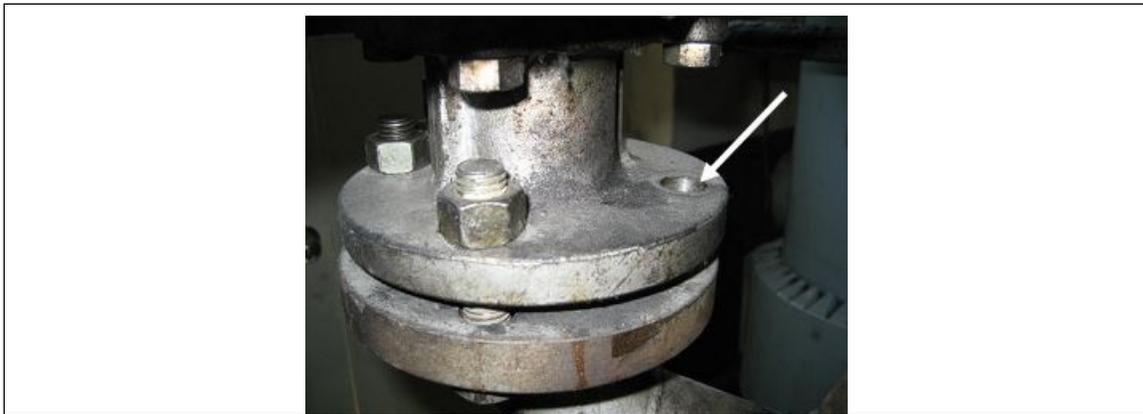
Common deficiencies in bolted flange joint assemblies include misalignment of the joint, not tightening the bolts in the proper sequence to evenly distribute the clamping force, using incorrect torque specifications leading to increased stress in the bolts or inadequate pressure retaining capability, and not providing full thread engagement of the nut-bolt assembly, otherwise known as short bolting. A photograph of a bolted flange with missing bolts is provided below in Figure 3.

*Fig. 3. Bolted connection on pressure vessel pressure boundary showing missing bolt*

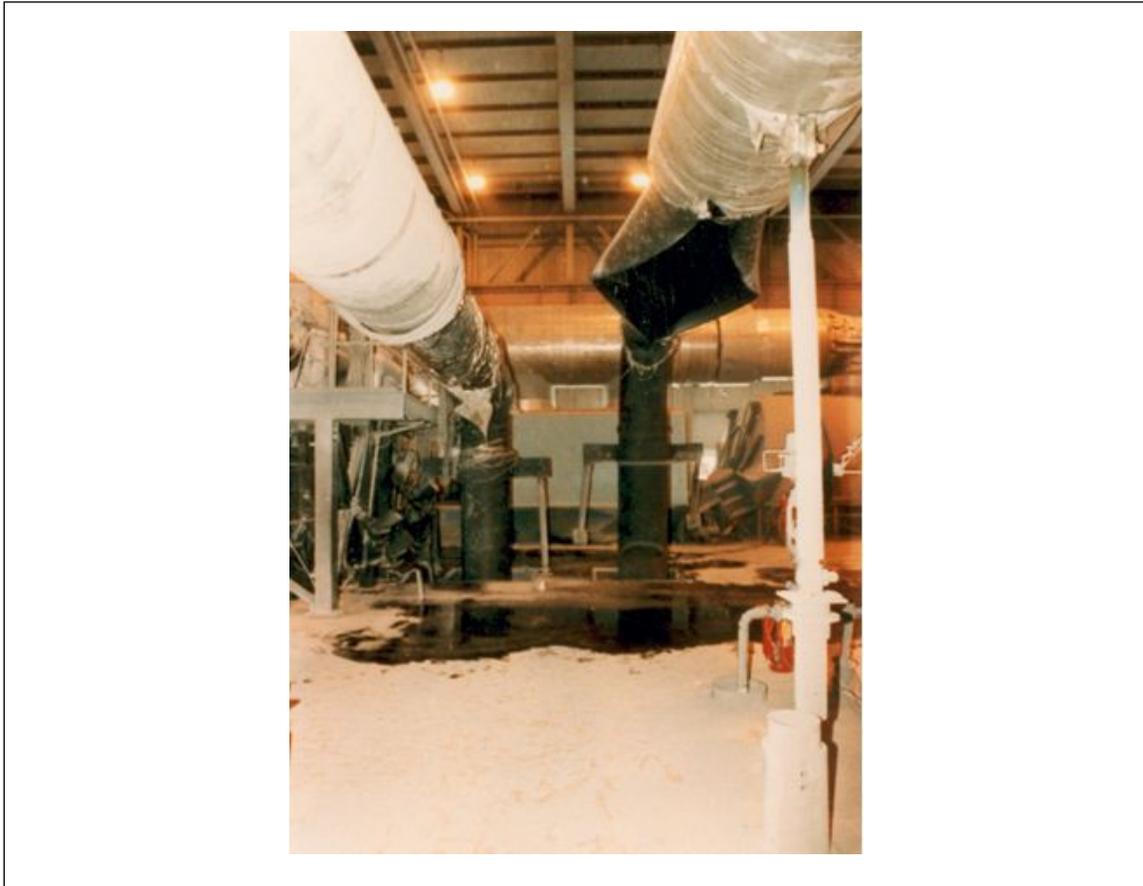
Inadvertent entry of water into a hot steam pipe is a common cause of steam hammer in power generating facilities that incorporate reheat cycles. This typically results from leakage through a block valve. Leak-tight block valve integrity can be extended by operating practice (i.e., terminating flow using a control valve, which

*Fig. 5. Utility reheat steam line failure along a pipe spool seam weld joint; timely inspection could have provided opportunity for corrective action*

Effective inspection of in-service systems, with appropriate repair or replacement of damaged components, can mitigate critical system failures. This is a lesson some electric generating companies learned the hard way, after suffering catastrophic failures of seam-welded hot reheat piping in 1985 and 1986. A photograph of a seam-welded pipe after failure is provided in Figure 5. Subsequent investigations revealed that in some plants, seam-welded pipe had been substituted for the specified seamless pipe, and experience demonstrated seam-welded pipe was likely to develop cracking conditions associated with the seam-weld. Inspection programs for seam-welded pipe were initiated and reliable examination techniques have been developed. Many electric generating companies have replaced extensive seam-welded piping systems to avoid disastrous failures due to creep. Additionally, some design codes (ASME B31.1, B31.3) have introduced factors to account for the reduction in long-term creep strength as a result of having a seam weld.

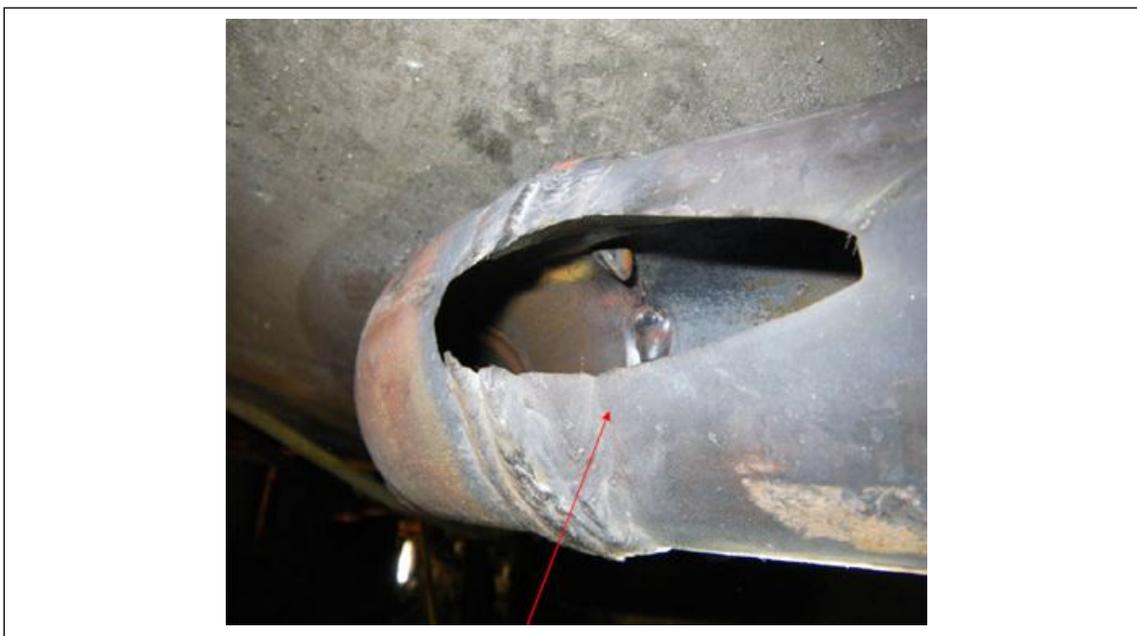
Erosion is a mechanical process. Typically, solid particles have an abrasive effect when they impact the metal surface. This abrasiveness can break the protective film on the material or scrape away material. The simultaneous combination of both the chemical corrosion process and the mechanical erosion process is known as erosion-corrosion and is often called flow-accelerated corrosion (FAC) in steels. A photograph showing the condition of a pipe after failure from solid particle erosion is provided as Figure 6.

*Fig. 6. Solid particle erosion at a change in direction led to the failure of this pipe at a power generating station*

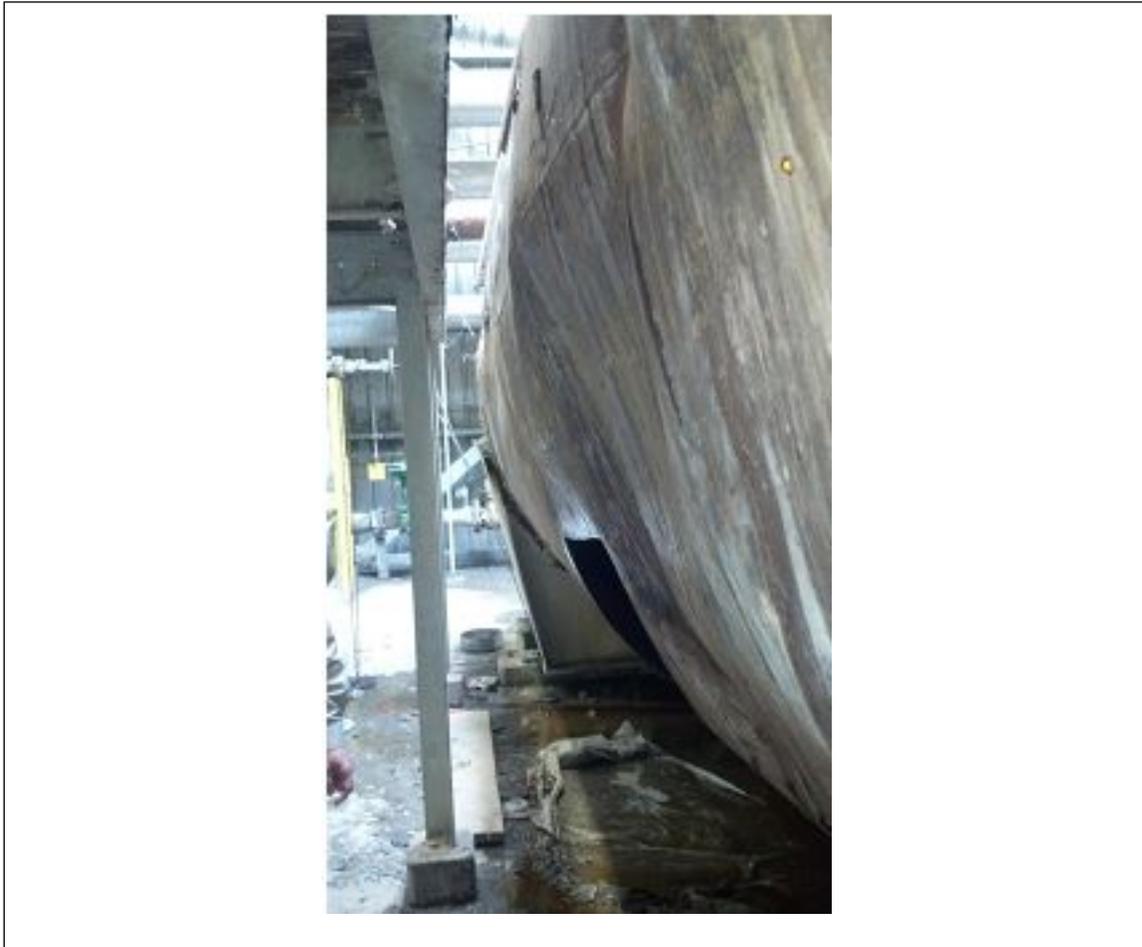
While operators worked to lower the deaerator storage tank level, a vacuum was produced. This vacuum imploded the lower half of the deaerator storage tank, which disabled the tank. The deaerator storage tank appeared distorted on its lower half and showed signs of vacuum collapse. There were six holes of various

sizes appearing to fish mouth inwardly. All adjacent piping and instrumentation were damaged. Photographs of the damage to the deaerator are provided in Figures 7 through 9.

Fig. 7. Photograph of failure location at center of tank

Improper operation of the deaerator unit (the bypass of the high-level dump valve and manual control of the water feed rate and water level allowing the deaerator storage tank water level to fill into the No. 1 Deaerator Head) led to the scenario that produced the vacuum on the vessel. The adequacy of the vacuum protection on the equipment will be considered.

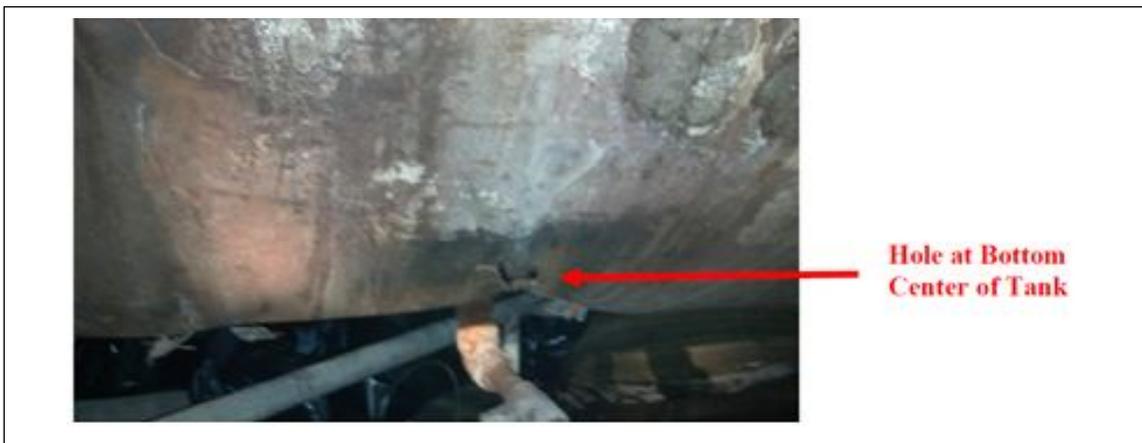
Fig. 8. Photograph of failure location at center of tank

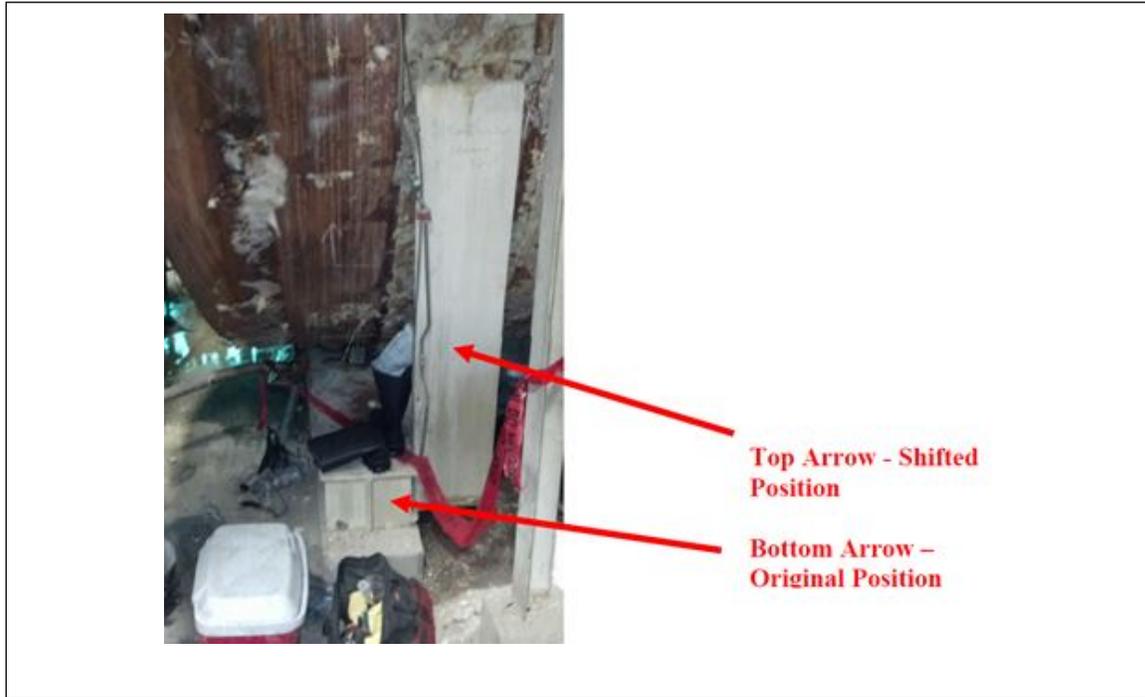
Fig. 9. Photograph of shifted support

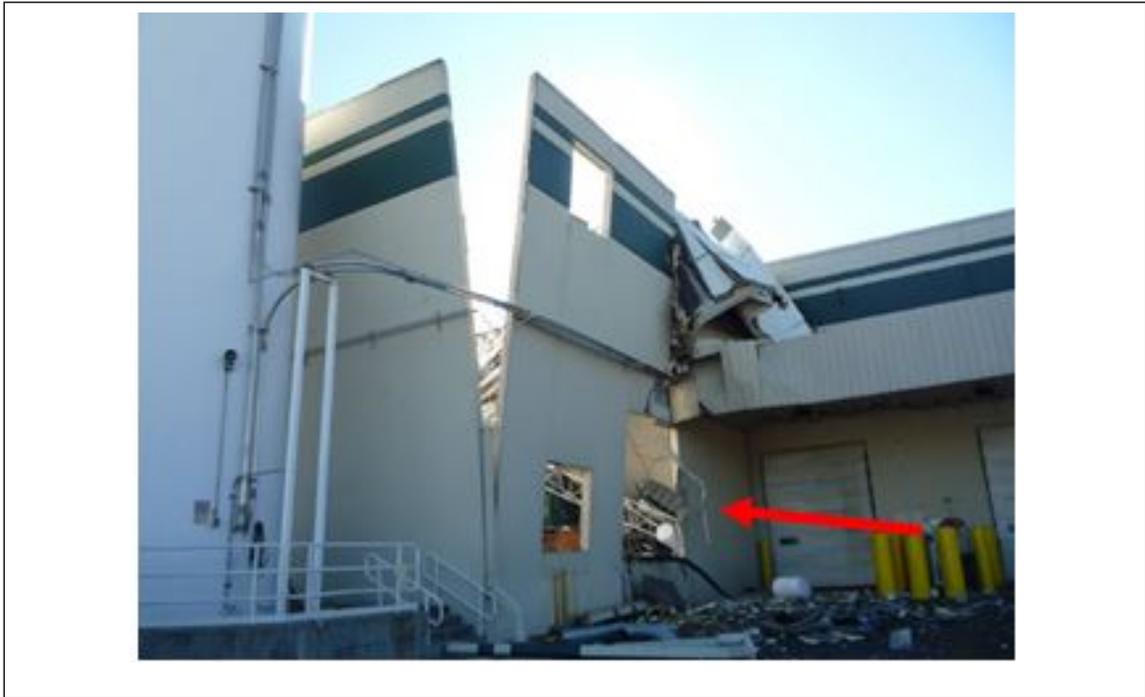
The deaerator had not been inspected and the weldments suffered from cracking and wall loss that routine inspection, testing, and maintenance would have been able to identify. Additionally, it was revealed that the original welding of the vessel did not achieve complete penetration of the weld joints. It was unsure if there was complete joint penetration in the location of the failure.

Fig. 10. The boiler building showing the rear walls; the red arrow shows the area where the deaerator exited the building

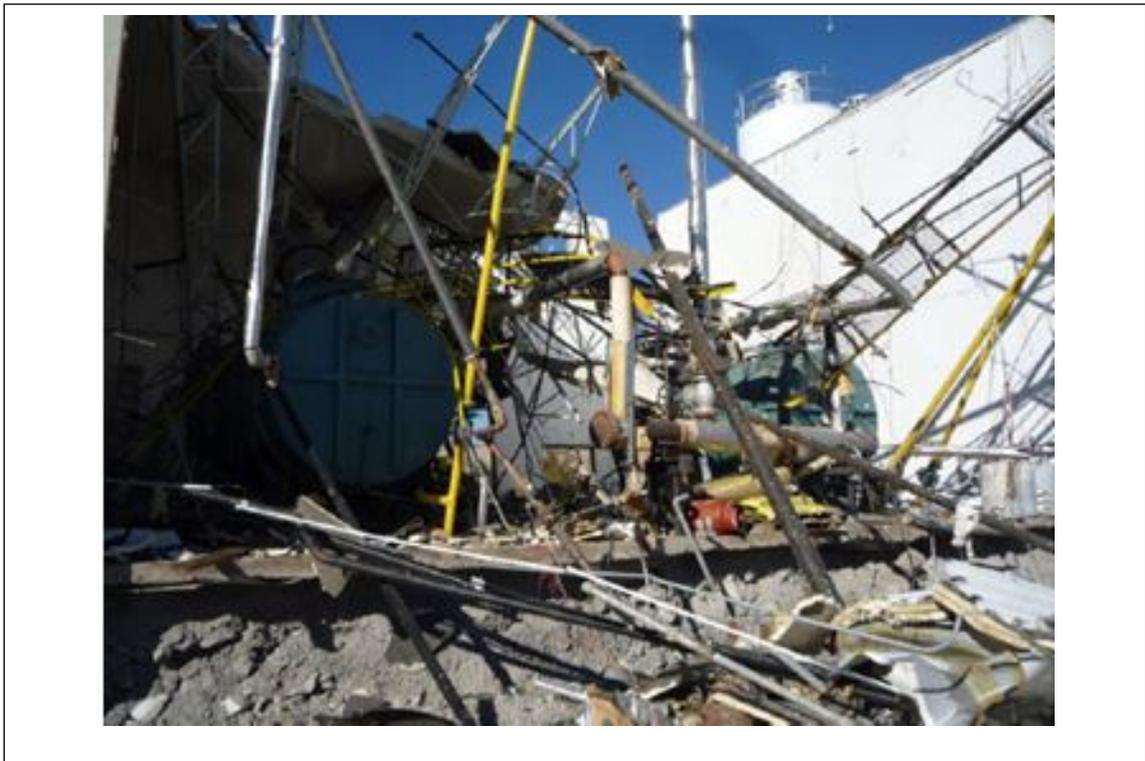
Fig. 11. The boiler room, showing the two front walls completely blown to the ground

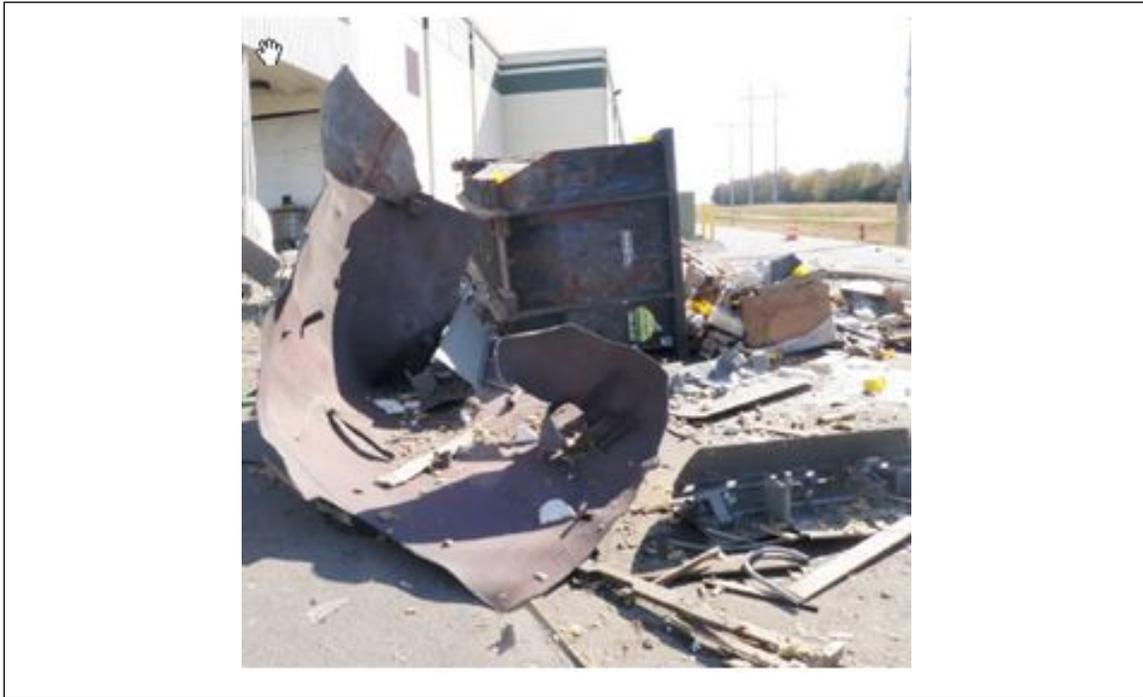
*Fig. 12. The deaerator after colliding with the dumpster; part of one head is attached to the shell (the other head went out the front of the boiler room)*

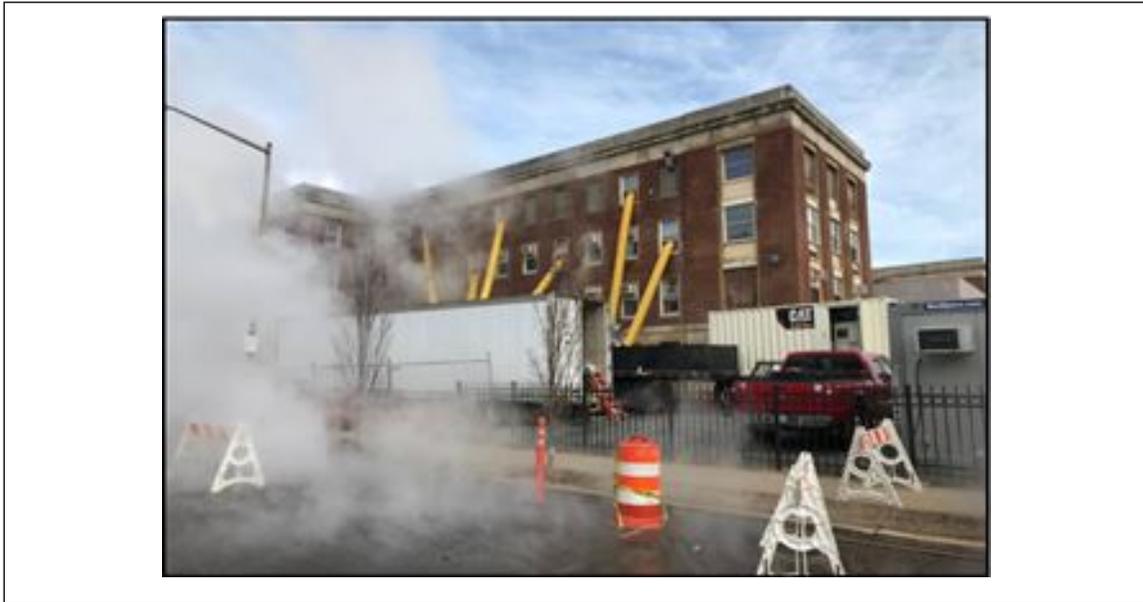
Insufficient maintenance and haphazard repairs of an already deteriorated steam and condensate system led to the severe failures. The poor quality of the steam only added to the ongoing corrosion and subsequent leaks within the piping installed in the underground tunnels. Several buildings sustained steam releases from corroded steam piping into the buildings from openings from the tunnels, resulting in extensive damage to interior finishes and contents. Some buildings lost adequate heat resulting in frozen sprinkler or domestic water piping and subsequent leaks. Photographs of the dehumidification process and interior damage to the buildings are provided in Figs. 13 and 14.

*Fig. 13 Dehumidification efforts*

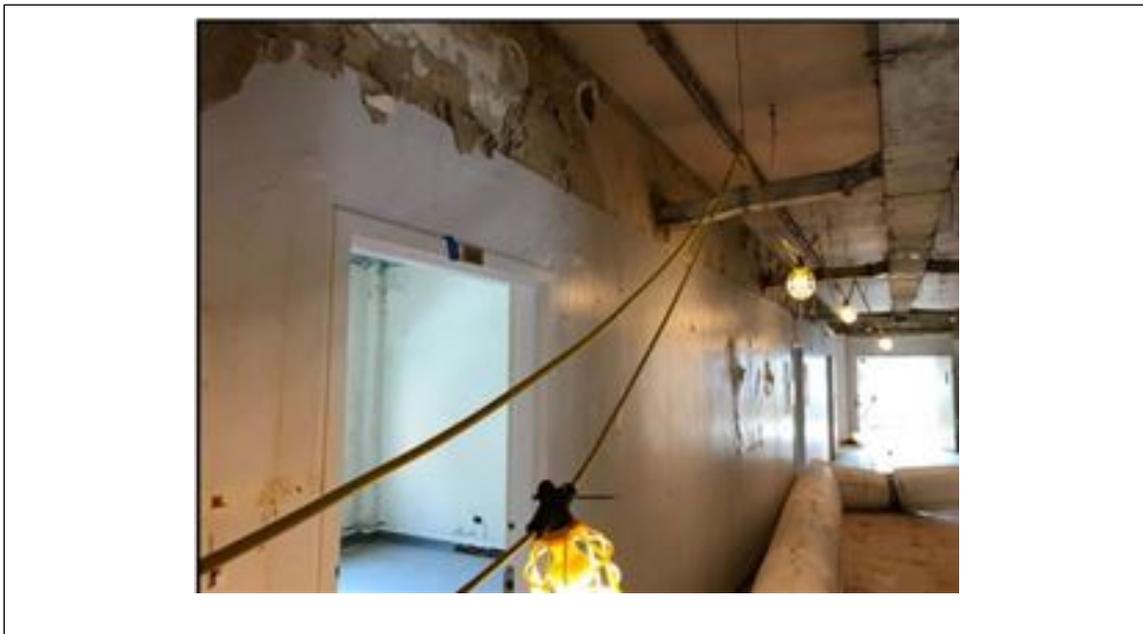
*Fig. 14. Interior building damage*

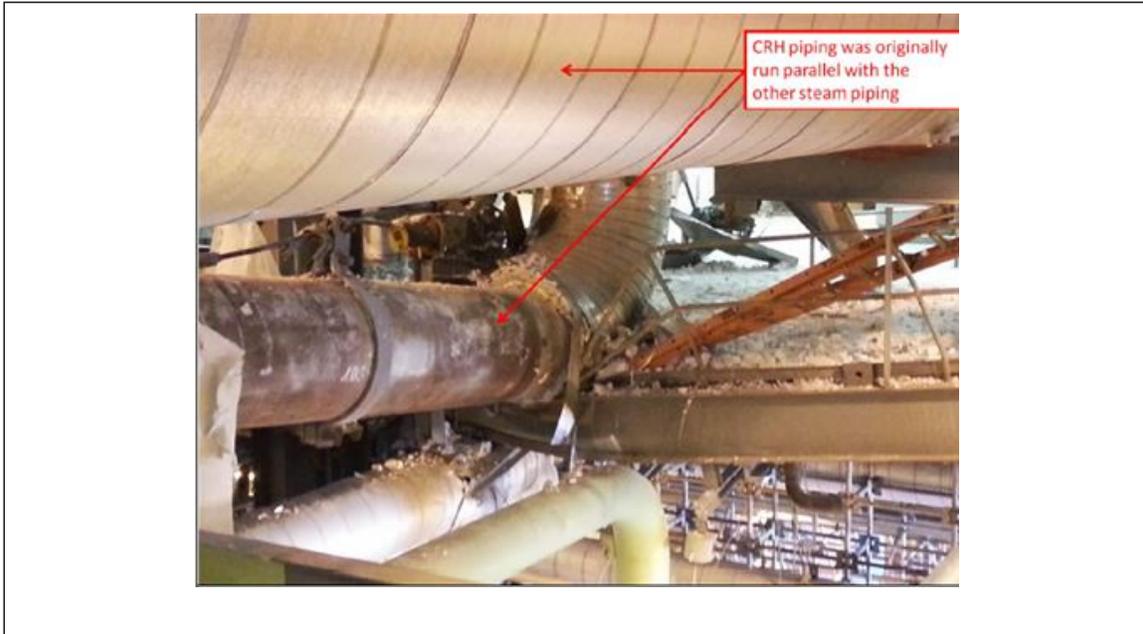
Approximately 280 ft (85 m) of CRH piping moved in this incident. Based upon the deformation of the structural steel, the vertical section of the CRH pipe moved significantly vertically, resulting in all of the pipe hangers and supports for the CRH piping being bent or broken. No piping ruptured due to overpressure.

The addition of the check valve in the CRH line allowed water that had leaked past the attemperator spray valves to collect on top of the valve. When the RSV was opened, steam was introduced into the system causing a "hammer" event.

Fig. 15. Unsupported CRH pipe

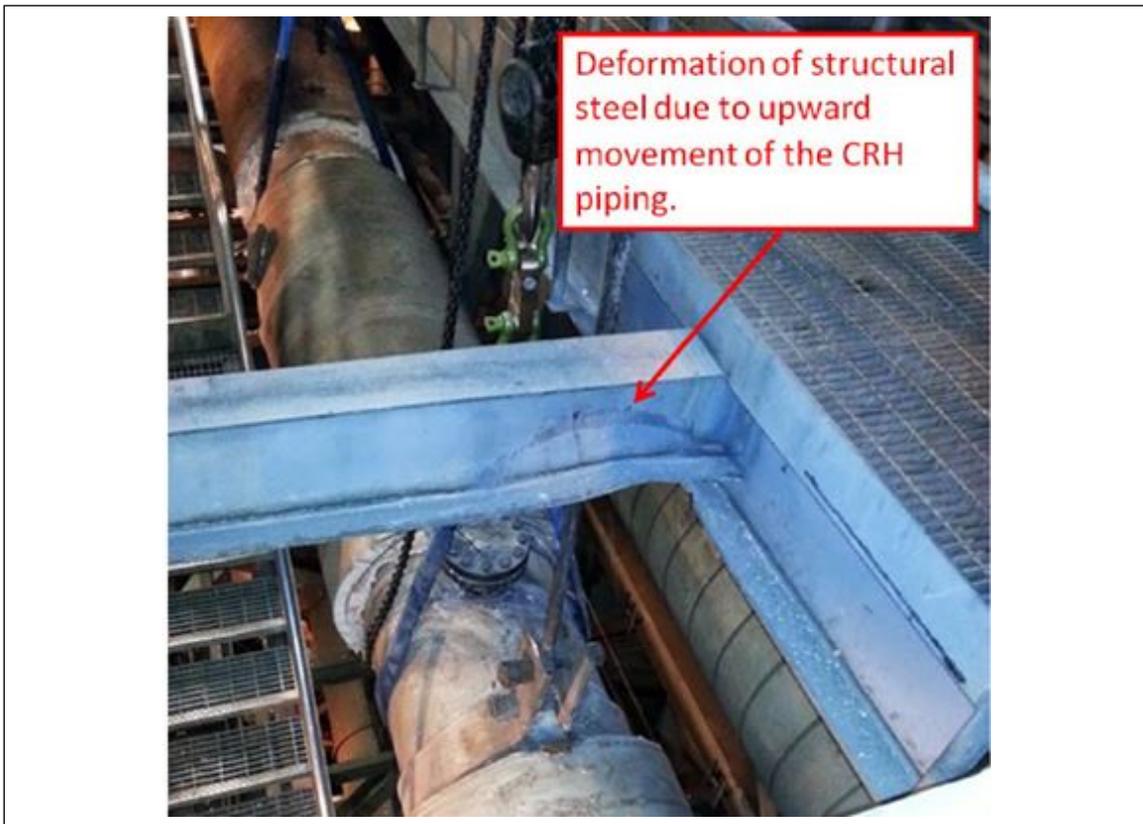
Fig. 16. Damage to the structural steel due to pipe movement

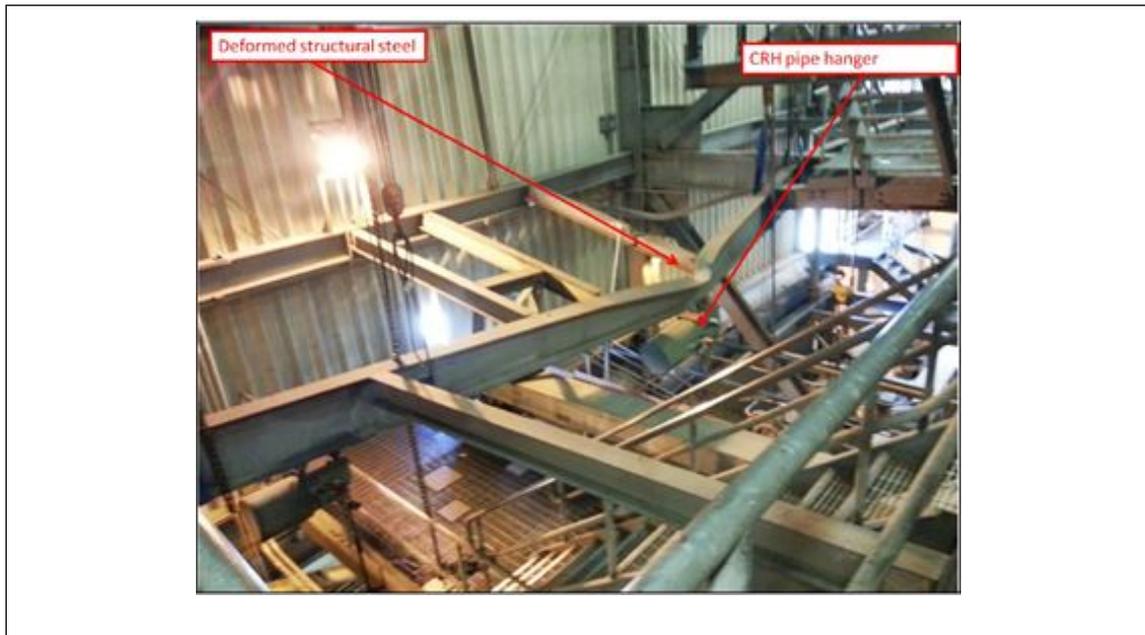
Fig. 17. Damage to the structural steel due to pipe movement

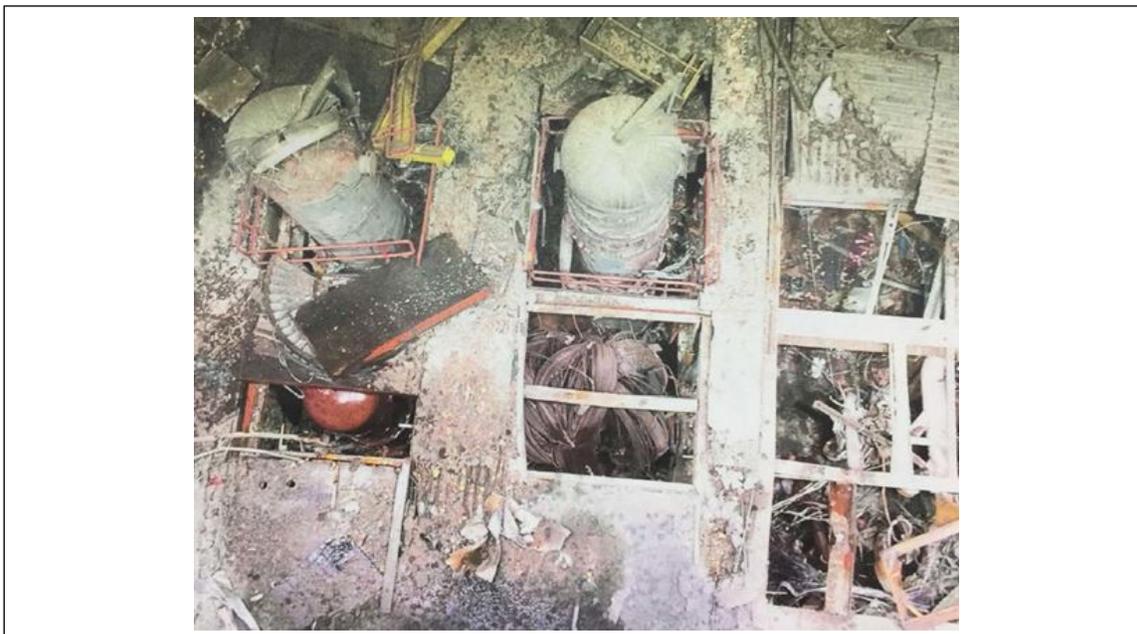
The water/steam flash damaged the turbine deck and mezzanine as well as major structural beams, adjacent feedwater heaters, various metal wall panels (~60,000 sq. ft [5,574 m<sup>2</sup>]), brick walls (~20,000 sq. ft [1,858

m<sup>2</sup>), doors, motor control centers, piping, switchgear, etc. Temporary bracing was required to allow personnel in for clean up/repairs. A photograph of the damage is provided in Fig. 18.

*Fig. 18. Damage due to heat exchanger failure*

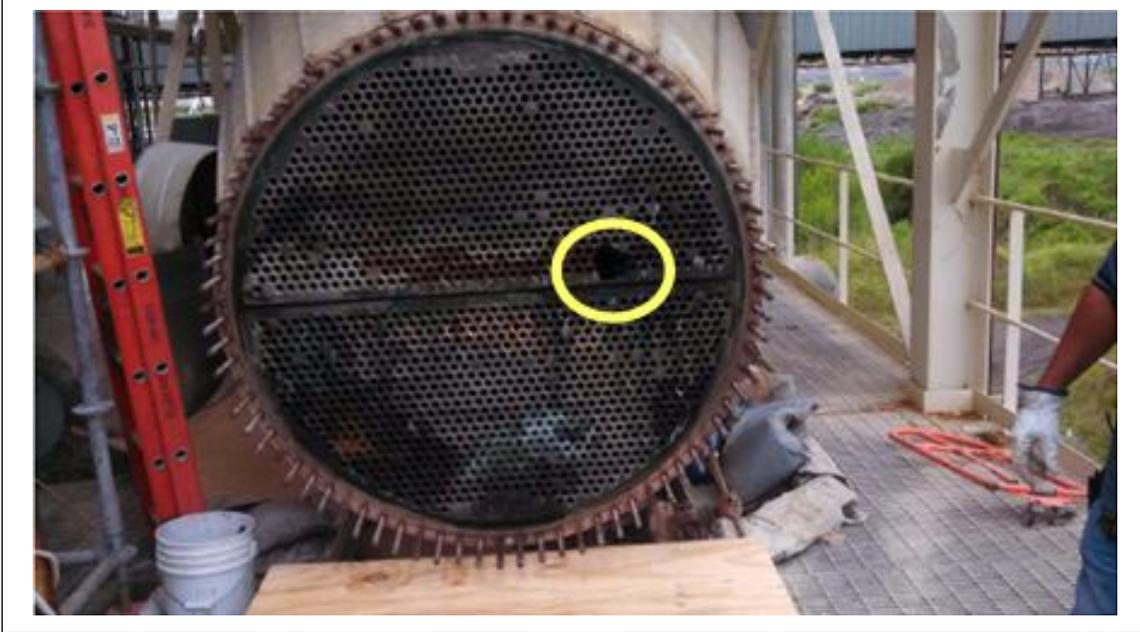
The damage was a result in failure of a seal weld of a previously plugged tube on the heat exchanger. These were not part of the yearly heat exchanger testing being performed. Photographs of the damage are provided below in Fig 19 and 20.

*Fig. 19. Tube bundle; damage is circled in yellow*

Replacement of the tube bundle was necessary since the damage was not repairable. Cleaning and inspection of the plant vessels was performed. Damage was revealed on the acid circulation pump and heat recovery system tower boot. Acid had also entered the gas side of the plant and damaged brick work, mist eliminators, ducting, and the heat recovery system tower distribution equipment. The plant was able to resume operation at a reduced rate (88% of normal). A total of 23 days of acid and steam production were lost.

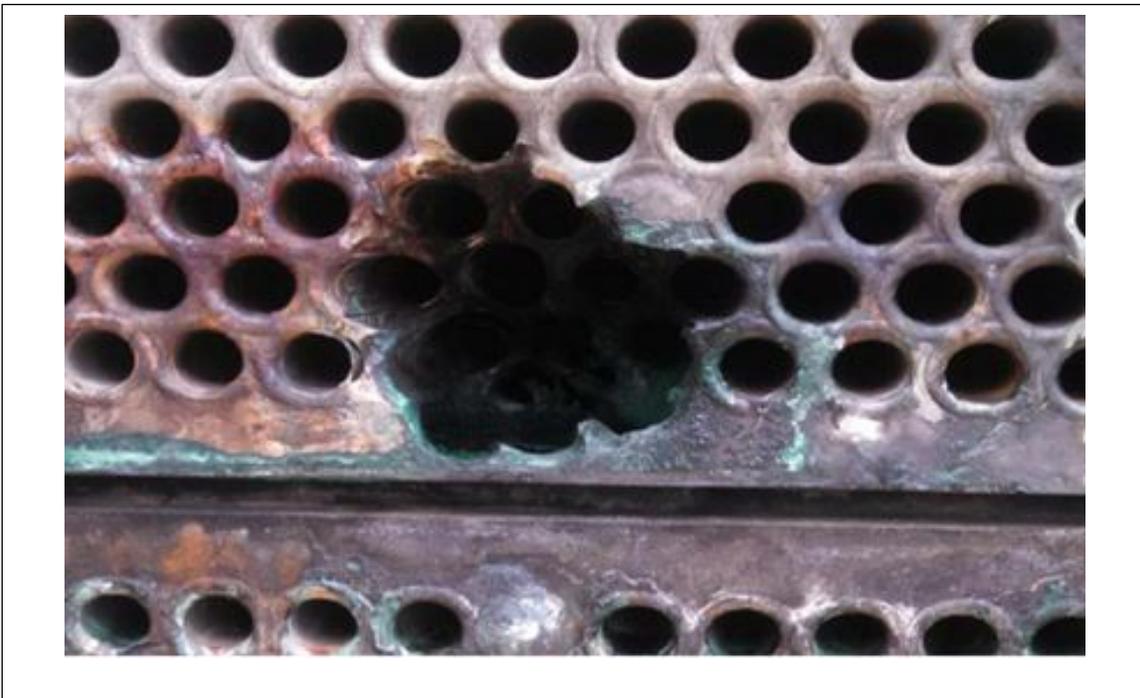
*Fig. 20. Closeup of damage to the tube bundle*

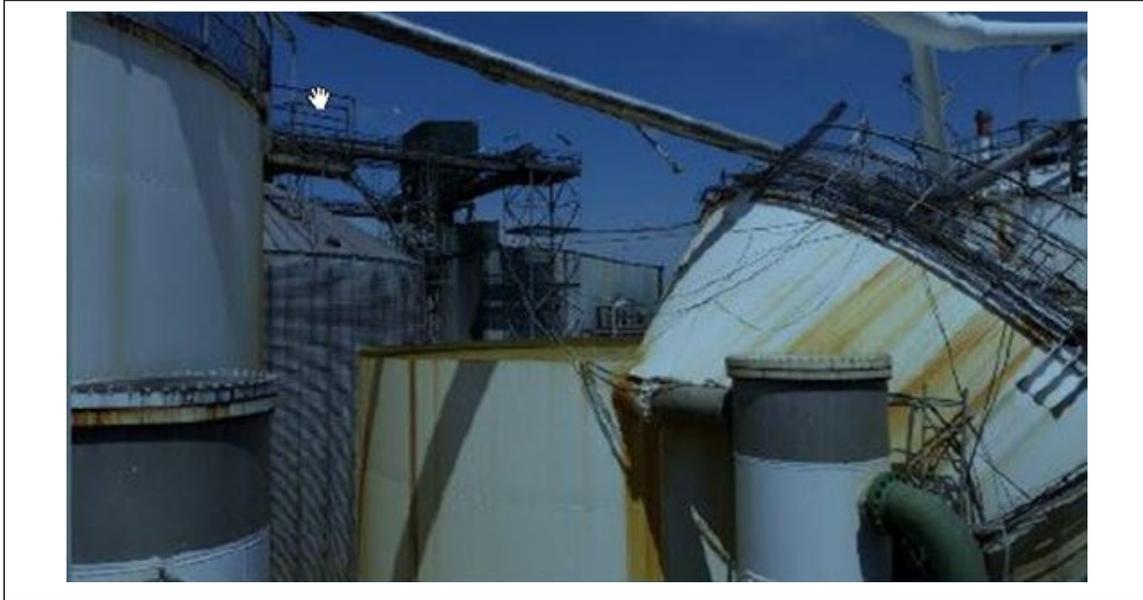
Upon starting the circulation pump to avoid sedimentation in the fermenters, fermenter C suddenly failed at the upper collar, leading to roof collapse. While falling, the roof damaged the structures supporting electrical cables, the CO<sub>2</sub> piping, and the cleaning-in-process piping system supplying the surrounding fermenters. This caused loss of use of 50% of production for 20 days, 25% loss of production for an additional 47 days.

The cause of the failure was likely a combination of significant corrosion that was not detected and increased pressure from the fermentation process.

*Fig. 22. Upper portion of fermenter after failure*

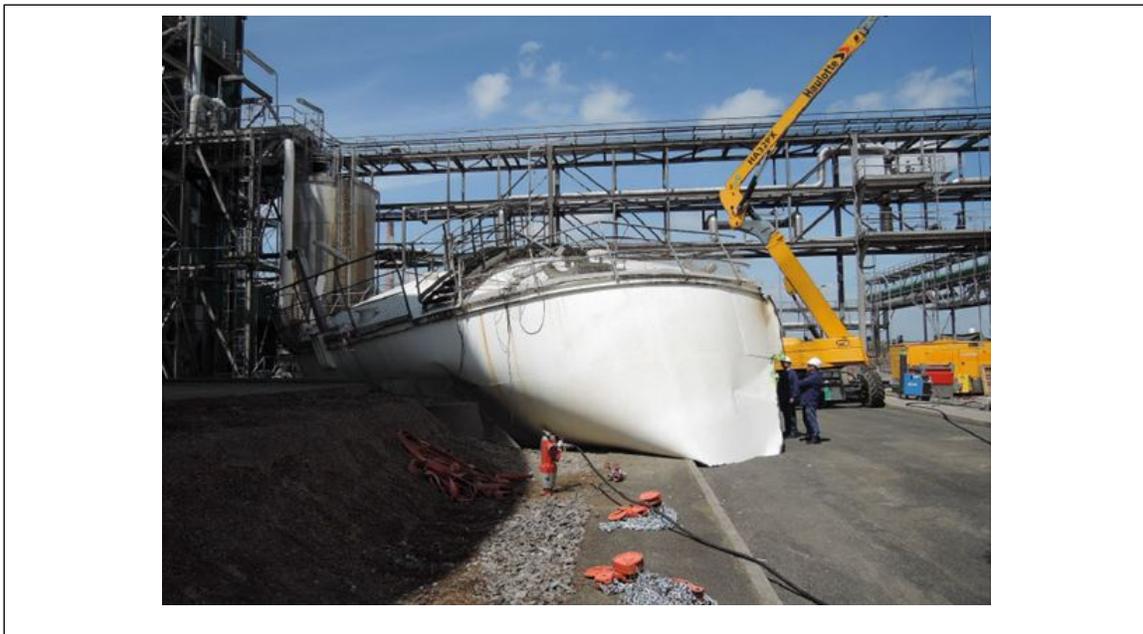
*Fig. 23. The roof of the fermenter after failure*

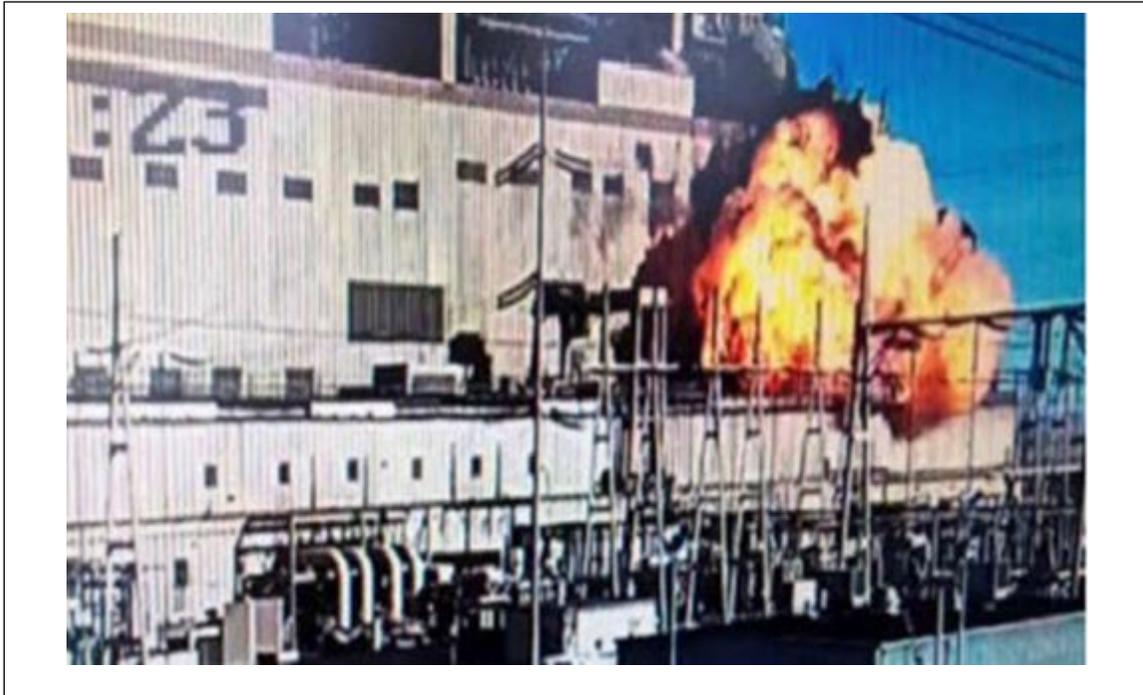
Immediately following the collapse, a coal dust deflagration occurred and blew off the metal wall panels and roof vents of the building. A fire did not follow. The building panels that were blown off hit the Unit 1 start up transformer deluge sprinkler piping and broke the piping fittings. Photographs of the deflagration and subsequent damage are provided in Figs. 24-26.

*Fig. 24. Deflagration fireball erupting from the silo enclosure collapsed feeder deck*

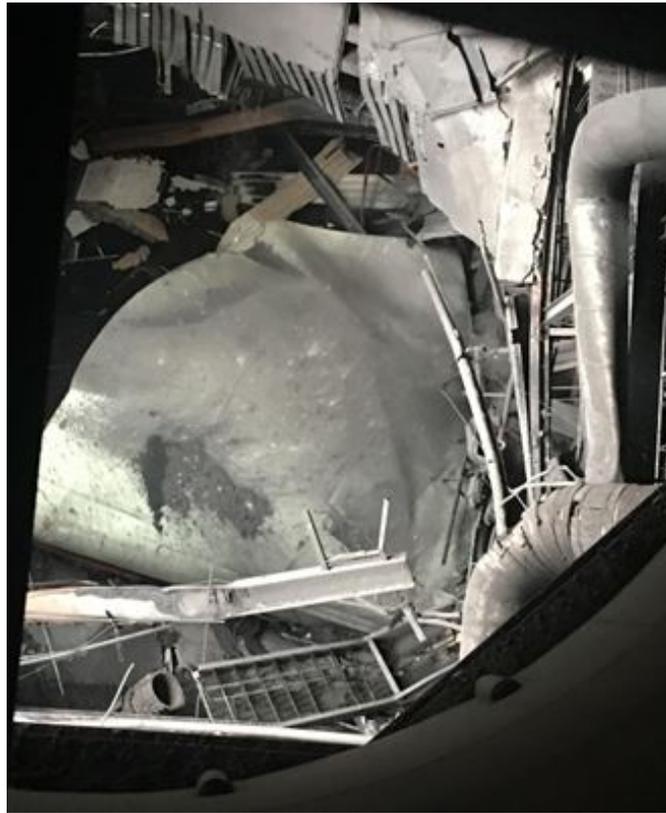
*Fig. 25. Collapsed feeder deck*

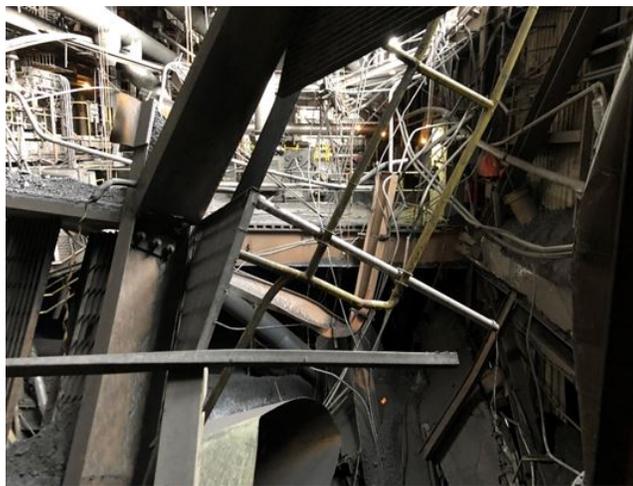
Unit No 4 was able to stay in operation. Significant wall thinning, and weld cracking were revealed on the failed silo.

*Fig. 26. Structural damage as a result of the silo failure*

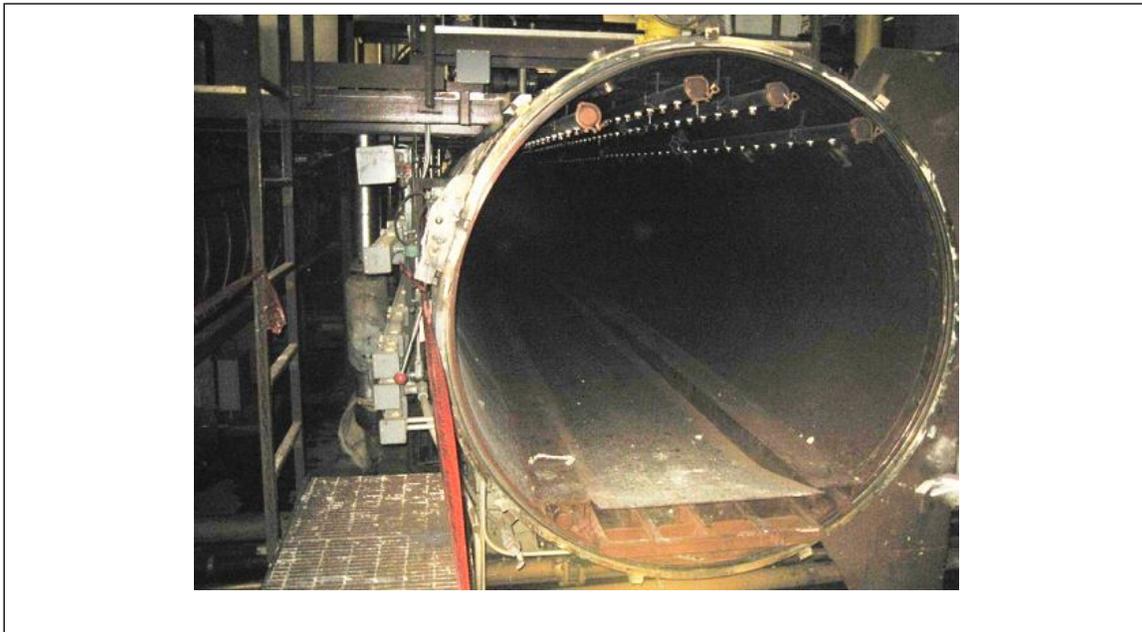
The root of the failure was the quick-actuating closure not being in a condition which was able to withstand design pressure. Regular inspection of the quick-actuating closure was not included in the autoclave maintenance program. This allowed the condition of the quick-actuating closure to deteriorate over time unknown to the operators. Photographs of the damage to the autoclave are provided as Figs. 27 and 28.

*Fig. 27. Autoclave front seal area with remains of locking rings*

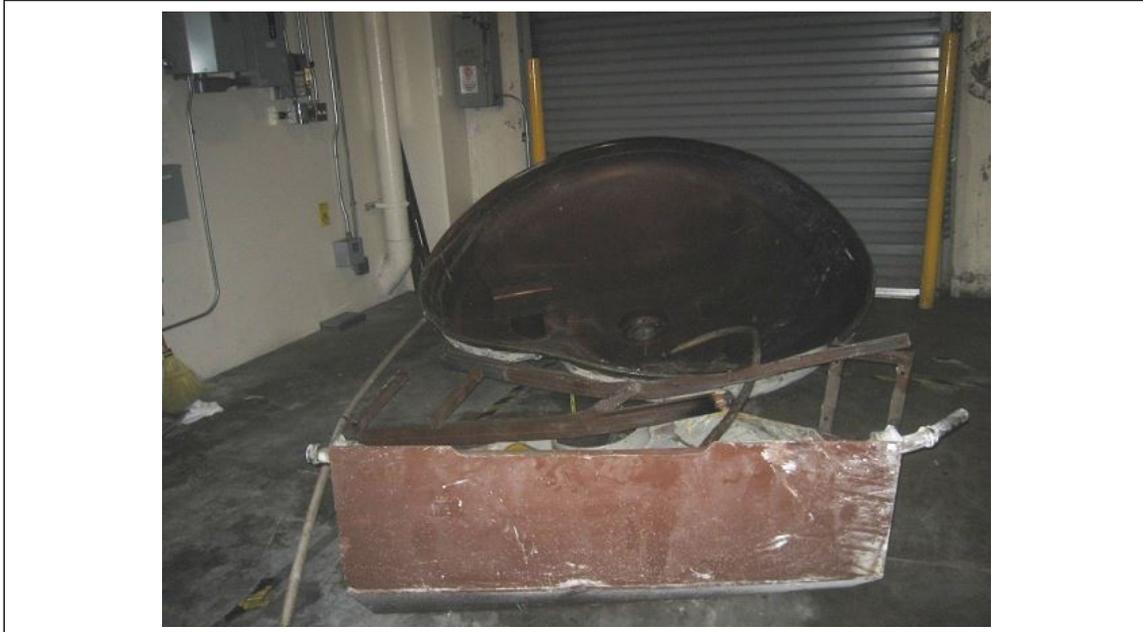
*Fig. 28. Autoclave door that failed and separated from the autoclave*

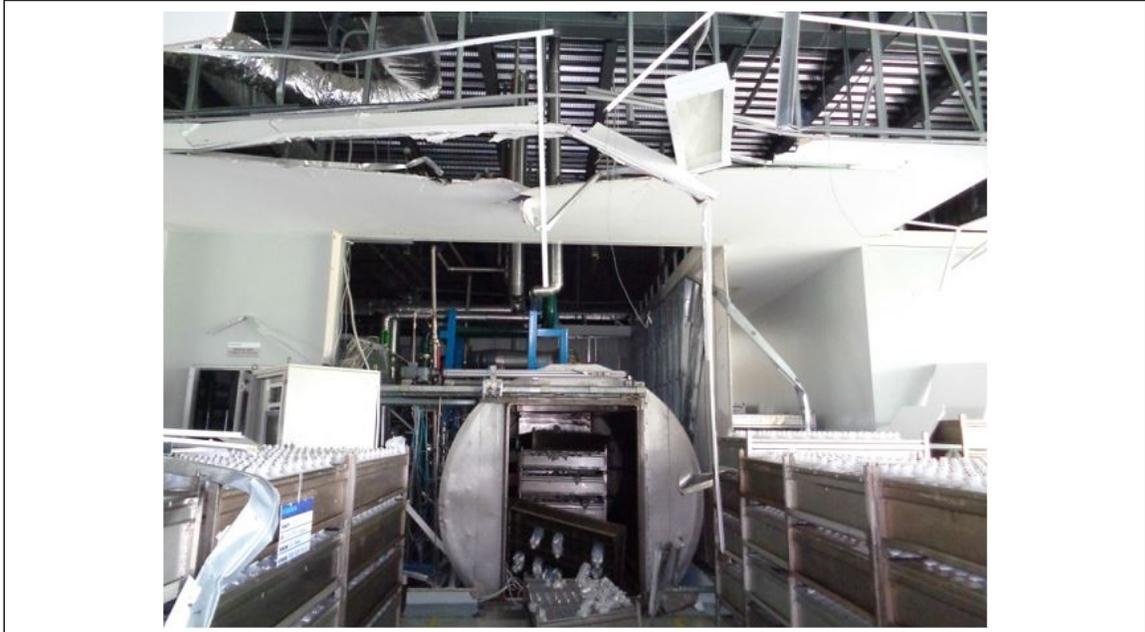
The autoclave operates at 44 psig (0.33 MPa) and 292°F (144°C). During the heating portion of the cycle, approximately 57 minutes after the autoclave started operating, a failure occurred that caused leakage of the contained water. Leakage leading to a rapid cascade of events led to the complete failure of the autoclave door. The failure of the door led to a steam explosion (rapid vaporization of the hot water in the vessel). The steam and shockwave liberated from the explosion sent the 1,320 lb. (600 kg) door approximately 50 ft (15.2 m) across the room and landed in an office area. The autoclave was displaced 6 in. (154 mm) back from its original position and rotated slightly counterclockwise. The welds and bolts were torn apart at the base of the autoclave. The door was projected horizontally and caused damage to in-process containers to be sterilized, gypsum walls, ceiling tiles and the epoxy floor. Fortunately, it did not damage other critical equipment. The autoclave required full replacement. The facility was completely shut down for six days. Partial operations started four weeks later (50% of the Parenteral Fluids line), and it took 12 months to restore the facility to full production. Photographs of the damage to the Autoclave are provided as Figs. 29 and 30.

The autoclave manufacturer had previously reported an issue with a position limit switch used to serve as an interlock to prevent pressurizing of the vessel unless the closing mechanism was fully engaged. This was found at another installation (not specified), where the position switch did not properly detect that the closing mechanism was not fully engaged. The manufacturer sent two bulletins regarding this issue and recommended to install a second position switch to ensure the autoclave doors closed completely, and the sides engaged adequately in the side rail. These had not been installed prior to the explosion and may have prevented this loss from happening. Secondly, NDE should have been done on the horizontal lower and upper edges of the sliding door of the autoclave to identify any cracks.

*Fig. 29. Autoclave after the steam explosion*
