VESSELS AND PIPING

This document contains loss prevention recommendations and supporting information for vessels, piping, and systems used in the storage, transfer, or processing of solids (powders, granules, etc.), liquids, and gases.

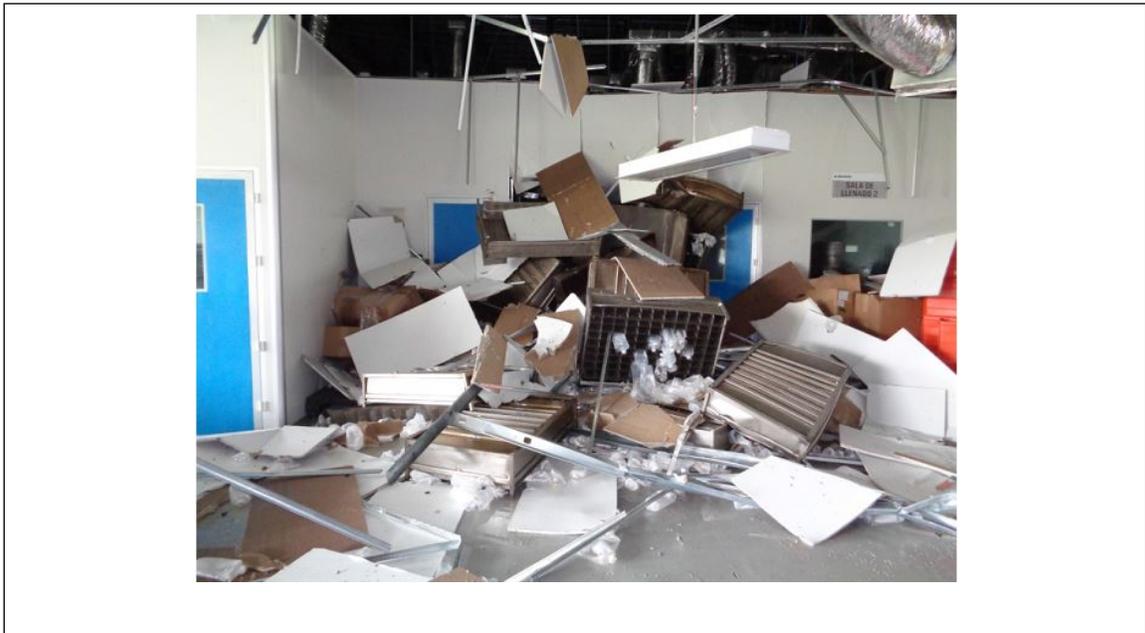
*Fig. 30. Autoclave door and internal trays that were propelled 50 ft (15.2 m) across the room*
