Impact of a High Volume Low Speed Fan on Sprinkler Performance in Rack Storage Fires

Benjamin Ditch

FM Global Research Division

January 2011

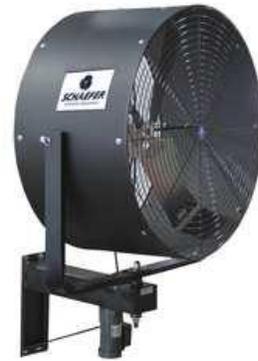
Figure 1-1: HVLS fan in industrial occupancy*

HVLS fan installations are typically mounted on the ceiling above open areas, such as wide aisle spaces or above loading dock areas as shown in Figure 1-1. However, a review by FM Global and Property Insurance Research Group (PIRG) members during this project identified a wide range of fan installations, including high bay rack storage. Depending on environmental conditions, many fans can be designed to blow air downward or upward. In addition, the blade pitch on some models also can be adjusted to maximize efficiency at different operating speeds. The corresponding traditional industrial fans are smaller diameter with the blades often contained within a cage, Figure 1-2. These fans are typically floor-standing or wall-mounted and rely on blade speed to move large volumes of air. Because of the smaller diameter, the displaced air tends to be channeled in a high velocity column in front of the fan.

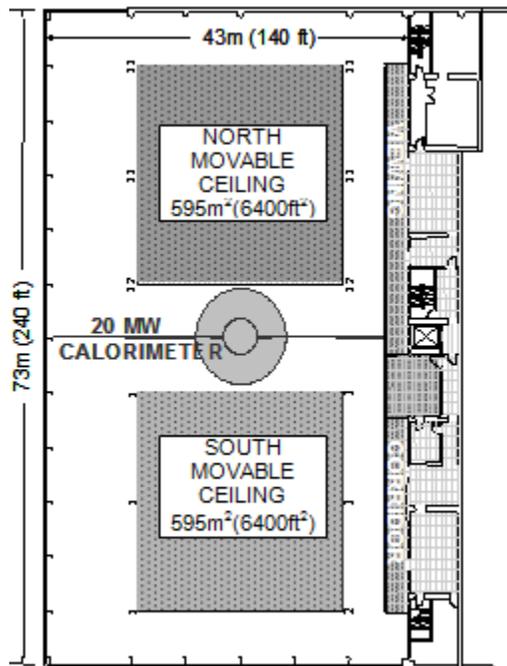
Figure 4-1: Illustration of FM Global Large Burn Laboratory test locations

The tests for this program were conducted under the south movable ceiling in the Large Burn Laboratory (LBL) located in the Fire Technology Laboratory at the FM Global Research Campus in West Glocester, Rhode Island, USA. Figure 4-1 is a plan view of the LBL showing the north movable ceiling, the south movable ceiling, and the 20-MW Calorimeter. The air emission control system (AECS) exhaust ducting for each movable ceiling consists of four extraction points, located at the lab ceiling, that merge into a single duct with a cross sectional area of 6.1 m^2 (66 ft^2). Gas concentration, velocity, temperature and moisture measurements are made downstream of the manifold. Beyond the measurement location, the exhaust duct connects to a wet electrostatic precipitator (WESP) prior to the gases venting to the atmosphere. The movable ceilings measure $24.4 \times 24.4 \text{ m}$ ($80 \times 80 \text{ ft}$) and are adjustable for heights above the floor ranging from 3.1 to 18.3 m (10 to 60 ft). All tests were conducted at an exhaust rate of $94 \text{ m}^3/\text{s}$ ($200,000 \text{ ft}^3/\text{min}$).

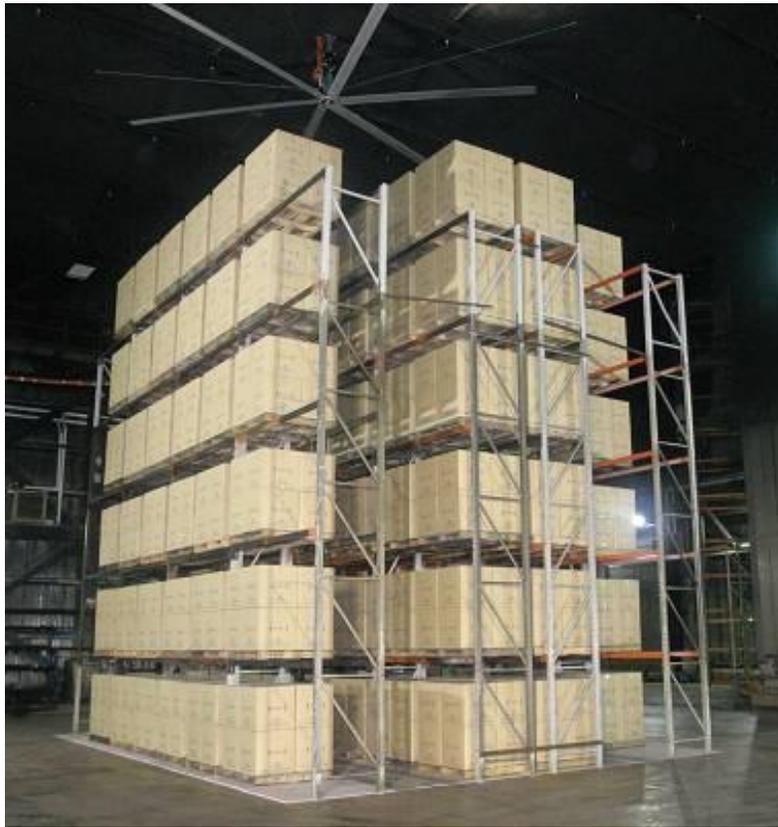
Figure 4-3: Typical rack storage array of standard plastic commodity

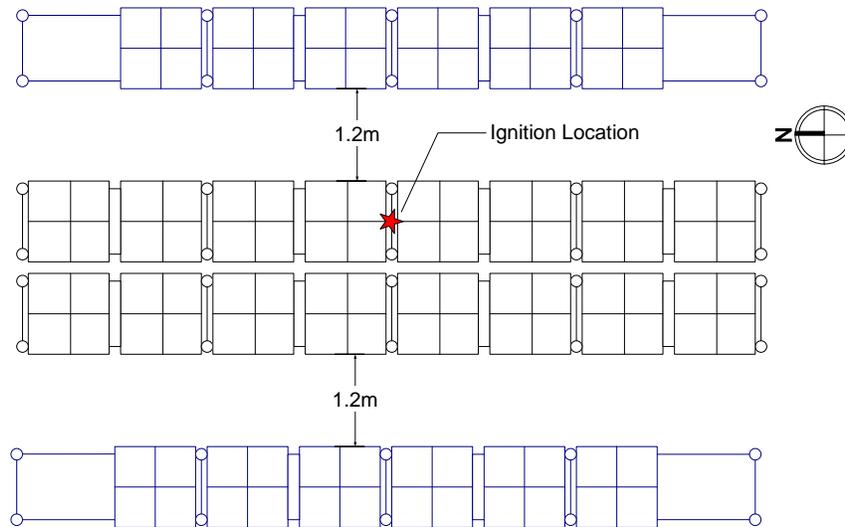
Figure 4-4: Plan view of main and target arrays

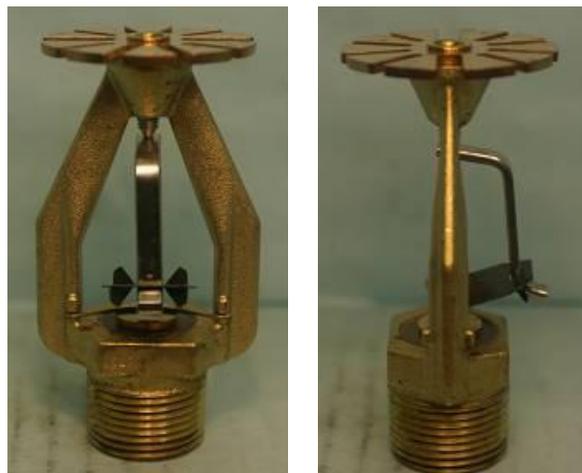
Figure 4-5: Tyco TY6226 photos

For each test, the Tyco Fire Products (TYCO) TY6226 sprinkler was used. The sprinkler has a nominal K-Factor of $202 \text{ L/min/bar}^{1/2}$ ($14 \text{ gpm/psi}^{1/2}$) and is an FM Approved, pendent-type, sprinkler with a nominal 18 mm (0.7 in.) diameter orifice and 71°C (160°F) temperature rating. The actuation mechanism was rated at a nominal RTI of $27.6 \text{ m}^{1/2}\text{s}^{1/2}$ ($50 \text{ ft}^{1/2}\text{s}^{1/2}$). Consistent with FM Global standard procedures for a large-scale fire test, each sprinkler was oriented with the sprinkler frame arms parallel to the sprinkler pipe and the sprinkler's heat sensing link facing towards the north.

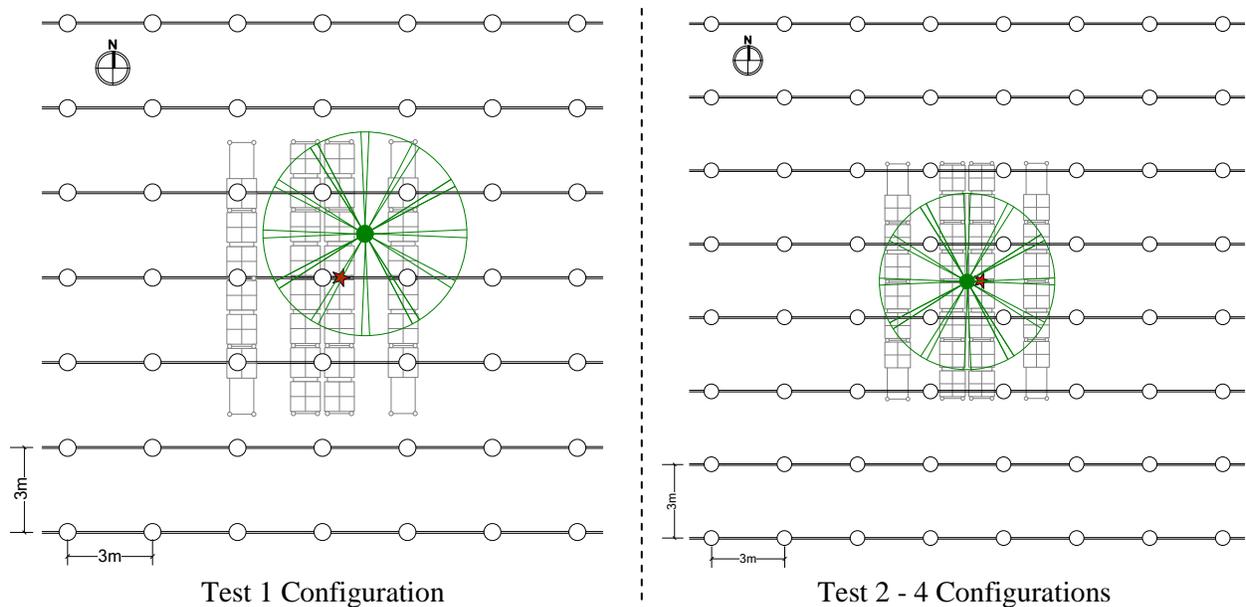
Figure 4-7: Sprinkler layout for Tests 1 – 4

The configurations for Tests 1 - 4 are shown in Figure 4-7. For Test 1, the main array was centered below one sprinkler and the fan was offset 2.2 m (7.1 ft) to the northeast. For Tests 2 - 4, the main array was centered among four sprinklers and the fan was nominally centered* over the main array. Sprinklers were installed on 3.0 x 3.0 m (10 x 10 ft) spacing. To fit within the extent of the ceiling, a total of 49 sprinklers were installed for Test 1 and 64 sprinklers were installed for Tests 2 - 4. For consistency with common installation practices and manufacturer recommendations, the HVLS fans were always centered among four sprinklers.

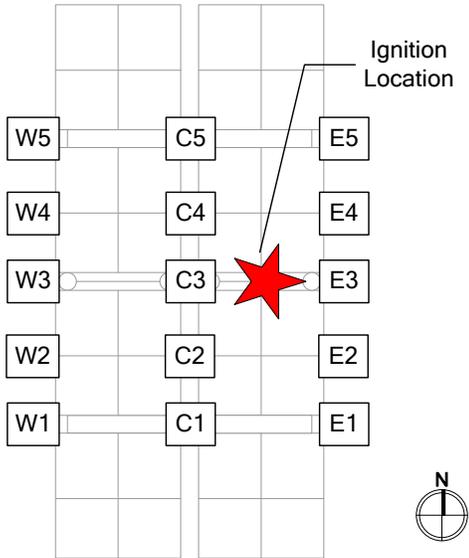
Figure 4-8: Plan view of air-flow measurement instrumentation layout

Air-flow velocities were measured continually at 15 locations 12.7 cm (5 in.) above the top of the main array, surrounding the ignition bay. As shown in Figure 4-8, the measurement locations were separated into three groups: W1 – W5 were 7.6 cm (3 in.) from the main array commodity in the west aisle, C1 – C5 were centered above the longitudinal flue, and E1 – E5 were 7.6 cm (3 in.) from the main array commodity in the east aisle. Each measurement was derived from the combination of a vertically oriented 19 mm (¾ in.) diameter bidirectional probe and a 20-gage exposed bead thermocouple [10], Figure 4-9. The bidirectional probes were connected to Setra Model 2641R25WB2DT1F pressure transducers, which have a range of ± 62.5 Pa (0.25 in. H₂O) and a 0.25% accuracy. This method is consistent with FM Global Large Burn Lab practices for near-ceiling gas velocities and the method described by Ingason [11] for fire plume gas velocities within a rack storage array. Only vertical measurements were taken, since bidirectional probes have an angular insensitivity up to 50 degrees.

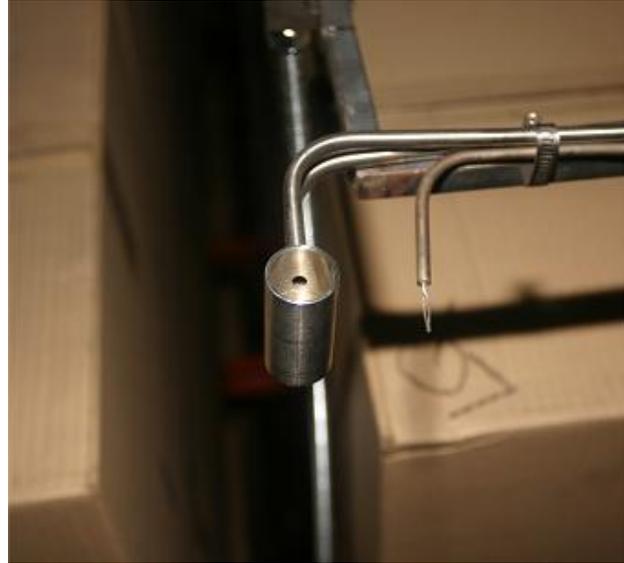
Figure 4-9: Top view of air-flow instrumentation design

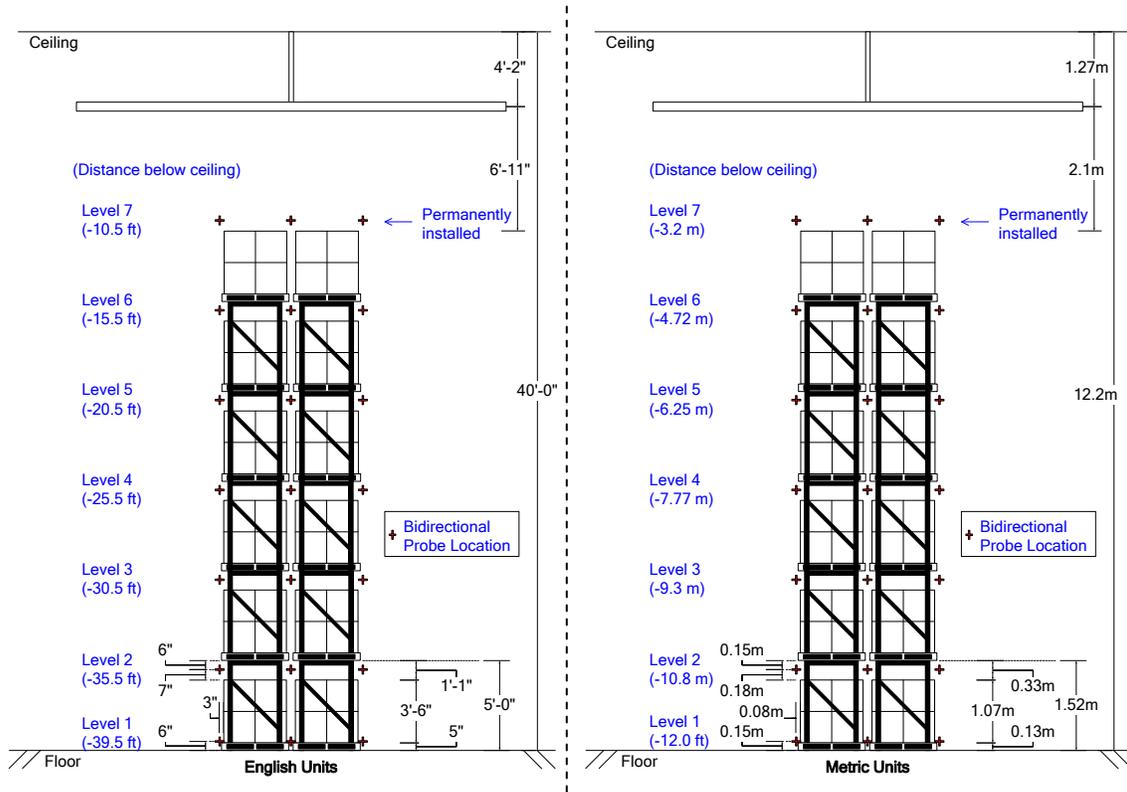
Figure 4-10: Supplementary air-flow measurements within main array for Tests 2 and 3 configuration (English and metric units)

Additional air-flow velocity measurements were acquired at six elevations within the array with only the fan operating, *i.e.*, no fire. These are referred to as ‘Cold Flow’ measurements in this report. As shown in Figure 4-10, the selected elevations were 12.7 mm (5 in.) above the commodity at tiers one through five and 15.2 mm (6 in.) above the floor. At each elevation, 15 measurements were acquired to correspond with the locations shown in Figure 4-8, resulting in an additional 90 locations for a six-tier high array and 45 locations for a three-tier-high array.

Consistent with the air-flow measurements taken above the top of the array, detailed in Section 4.8.1, the measurement locations were separated into three groups per elevation. Group W1 – W5 were 7.6 cm (3 in.) from the main array commodity in the west aisle, C1 – C5 were centered within the longitudinal flue, and E1 – E5 were 7.6 cm (3 in.) from the main array commodity in the east aisle. At each location data were acquired for five minutes.

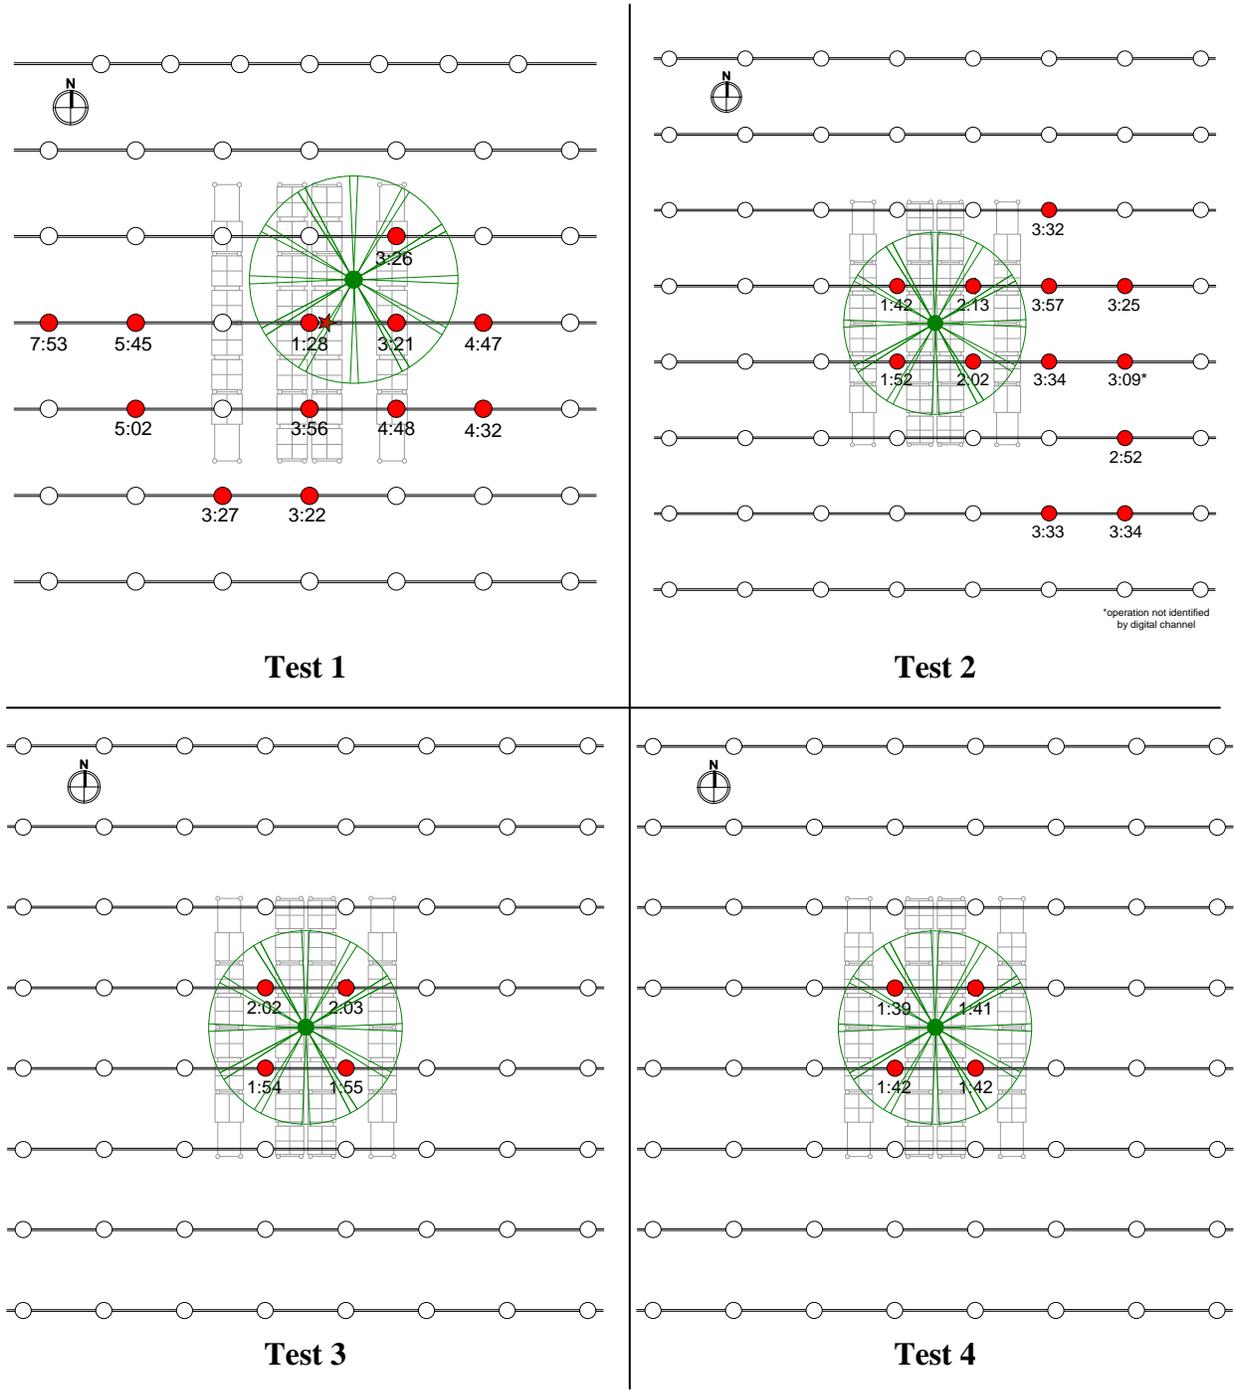
Figure 5-1: Sprinkler operation pattern for Tests 1 - 4

A plan view of the sprinkler operation pattern for each test is presented in Figure 5-1. The location of the test array and the HVLS fan are included for reference. A total of 12 sprinklers operated in Tests 1 and 2, and a total of four sprinklers operated in Tests 3 and 4.

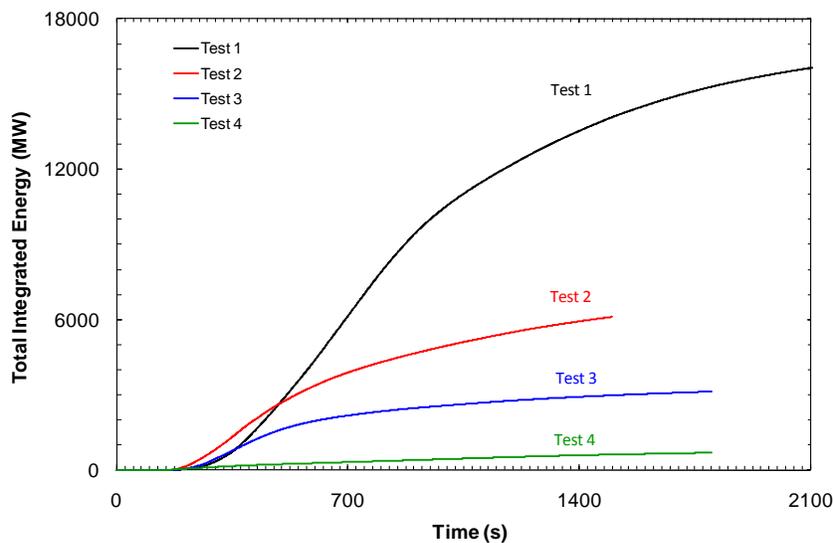
Figure 5-2: Total integrated energy for Tests 1 - 4

Figure 5-2 presents the total integrated energy produced during Tests 1 - 4. The presented data are based on the generation rates of carbon dioxide and carbon monoxide as described in Section 4.9.5. To allow for a meaningful comparison, each test was conducted until the fire was largely extinguished by the sprinkler system with only small lingering fires remaining. Therefore, the actual duration varies between tests. The estimated total energy for each test was $18,000 \pm 2,000$ MJ ($17,000 \pm 3,400$ BTU $\times 10^3$) for Test 1, $7,500 \pm 1,100$ MJ ($7,100 \pm 1,000$ BTU $\times 10^3$) for Test 2, $3,500 \pm 500$ MJ ($3,300 \pm 500$ BTU $\times 10^3$), and 750 ± 100 MJ (700 ± 100 BTU $\times 10^3$) for Test 4.

Note that the above graph only includes total energy collected during the fire test. As discussed in Section 4.9.5, the total energy released for each test also includes an estimation of the combustions gases remaining in the laboratory space after the test is terminated.

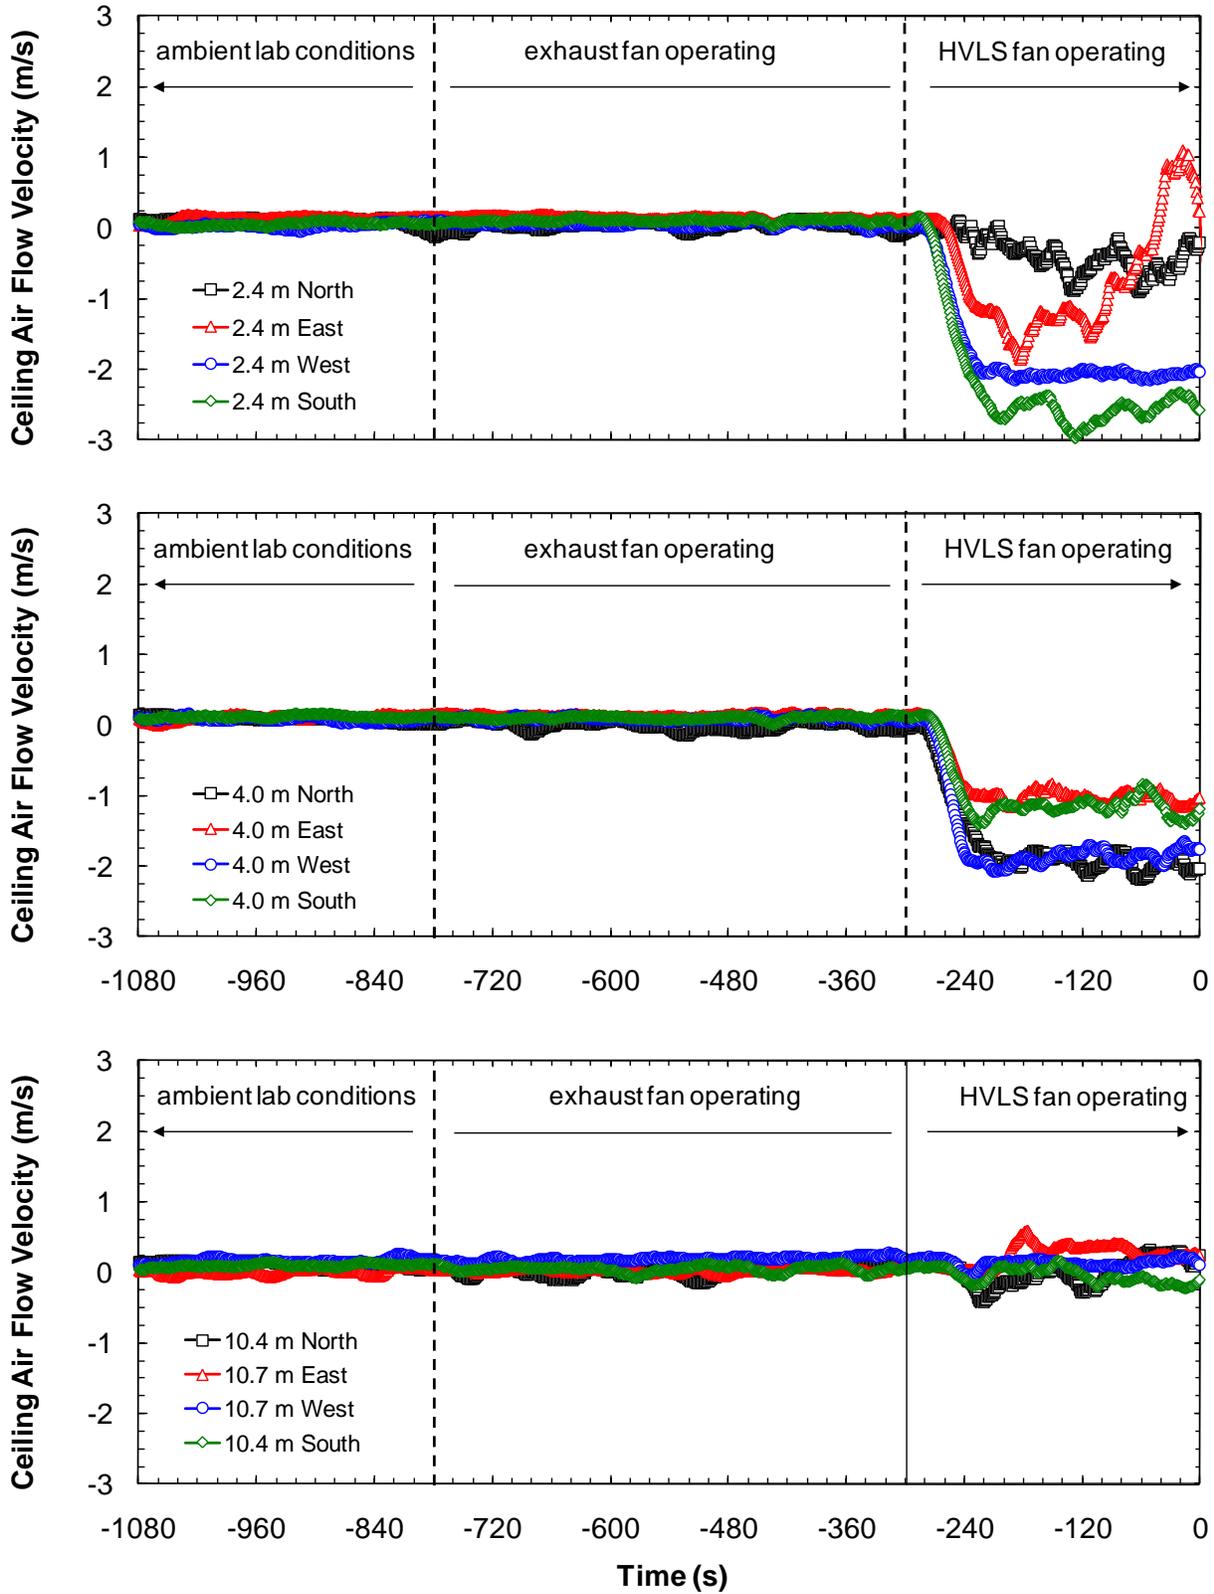
Figure 5-4: Ceiling level air flow resulting from building exhaust only for Test 1

Under ambient lab conditions, the air flow across the ceiling is minimal with the greatest velocity of ± 0.25 m/s (0.8 ft/s) occurring at the outermost measurement locations of 12.2 m (40 ft). The range of measured flows decreased to ± 0.15 m/s (0.5 ft/s) for the 4.0 m (13.1 ft) and 1.2 m (4 ft) measurement locations. The inclusion of the building control system exhaust fan at -780 s resulted in a negligible change in the air flow. However, the addition of the HVLS fan at -300 s resulted in a significant increase in the air flow at the ceiling, with the disturbance decreasing with distance from the fan. The specific air velocities ranged from -2.9 to 1.1 m/s at a radial distance of 2.4 m (8 ft), -2.1 to -0.8 m/s at a radial distance of 4.0 m (13.1 ft) and -0.3 to 0.6 m/s at a radial distance of approximately 10.4 m (34 ft). Similar results were found for Tests 2 - 4.

These results indicate that the air flow generated by the HVLS has the dominant influence on the ceiling level gas flow prior to the fire.

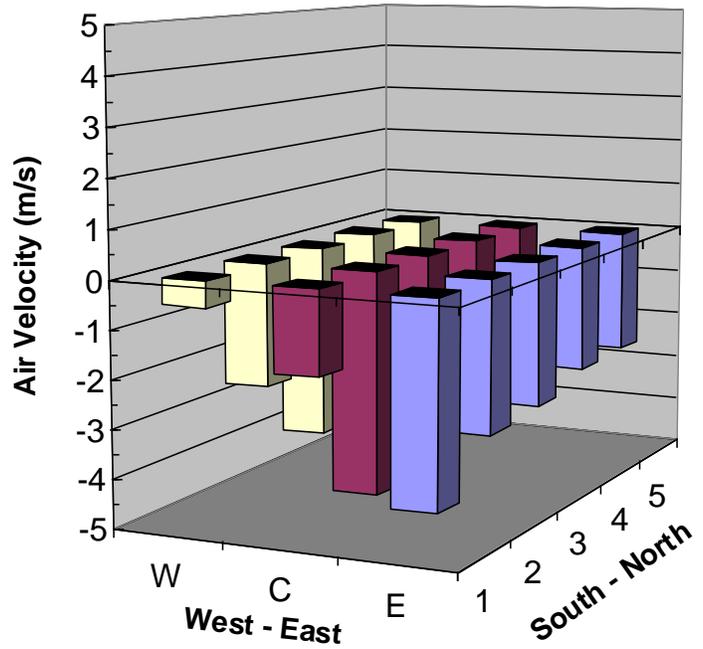
Figure 5-5: Air-flow at top of array [3.2 m (10.5 ft) below ceiling] with fan operating at 66 rpm for Test 1

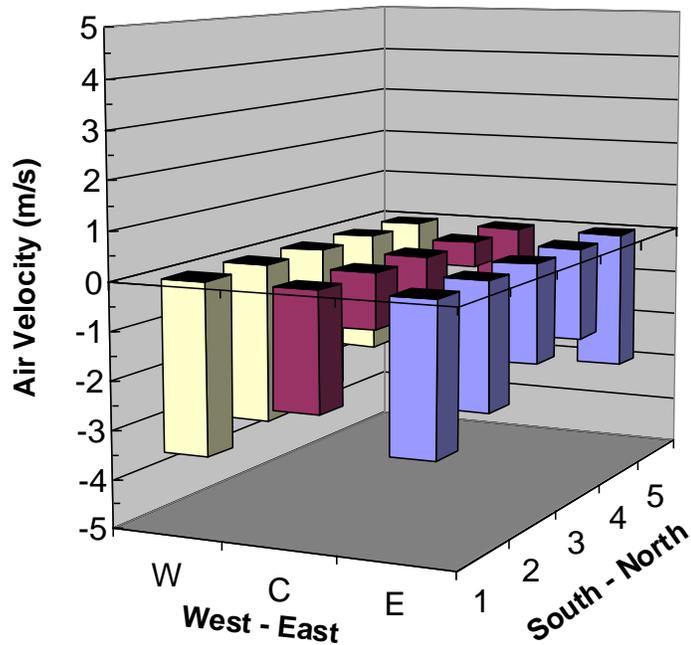
Figure 5-6: Air-flow at top of array [3.2 m (10.5 ft) below ceiling] with fan operating at 66 rpm for Tests 2 and 3

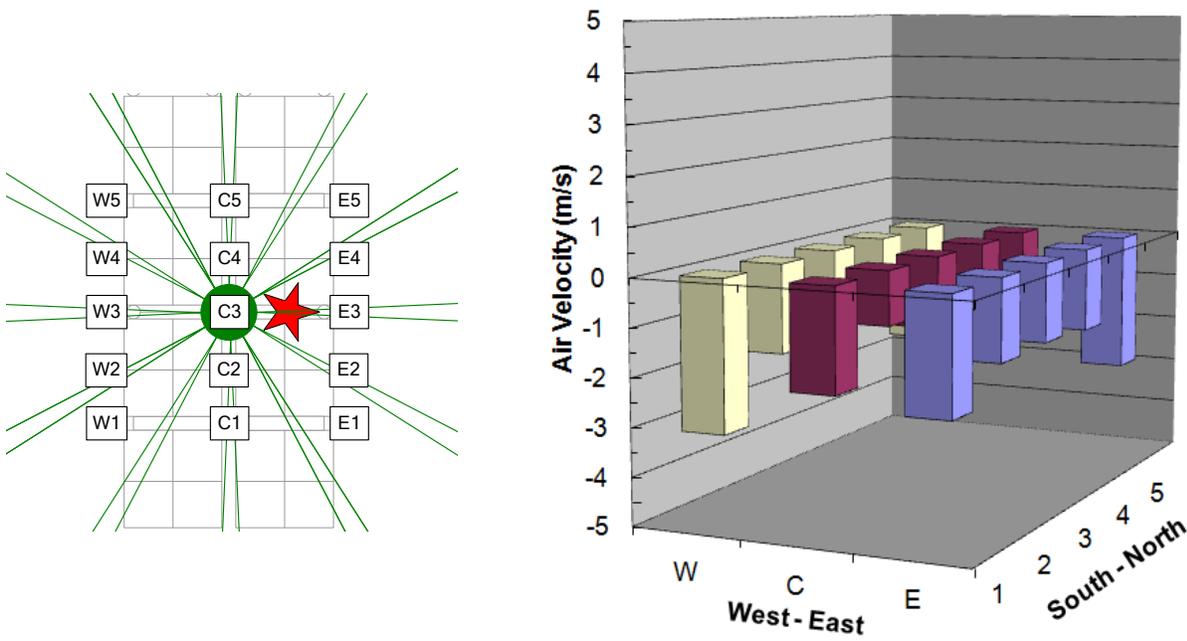
Figure 5-7: Air-flow at top of array [7.8 m (25.5 ft) below ceiling] with fan operating at 66 rpm for Test 4

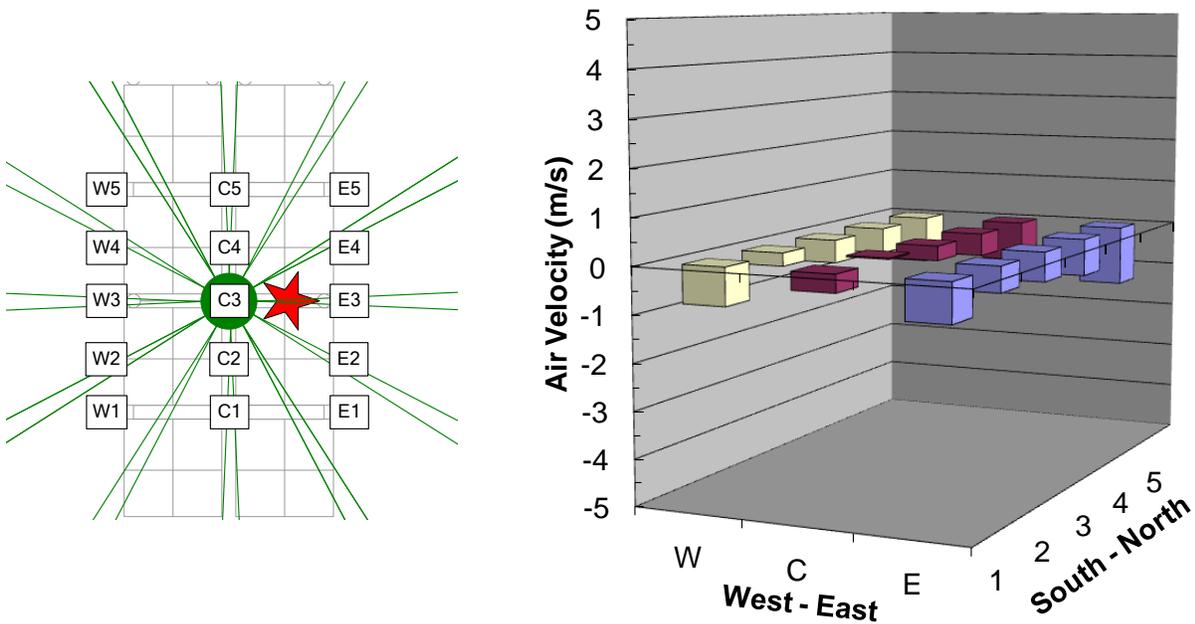
Figure 5-8: Air-flow at top of array [7.8 m (25.5 ft) below ceiling] with fan operating at 33 rpm for Test 4

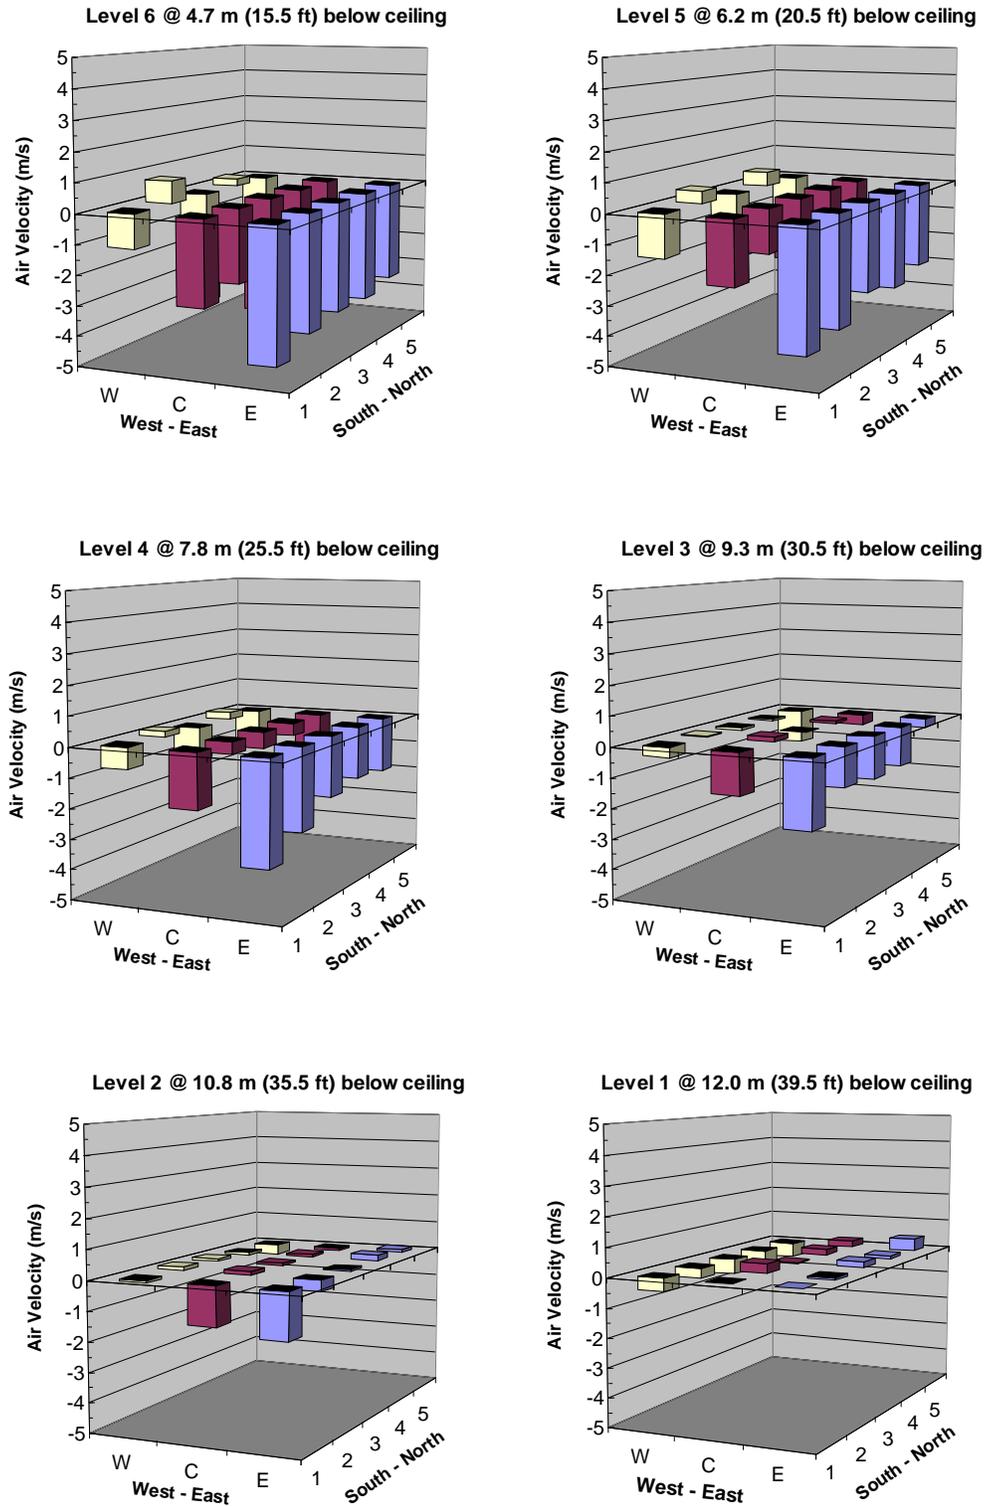
Figure 5-9: Air velocity through array with the fan at 66 rpm for Test 1 [no fire]

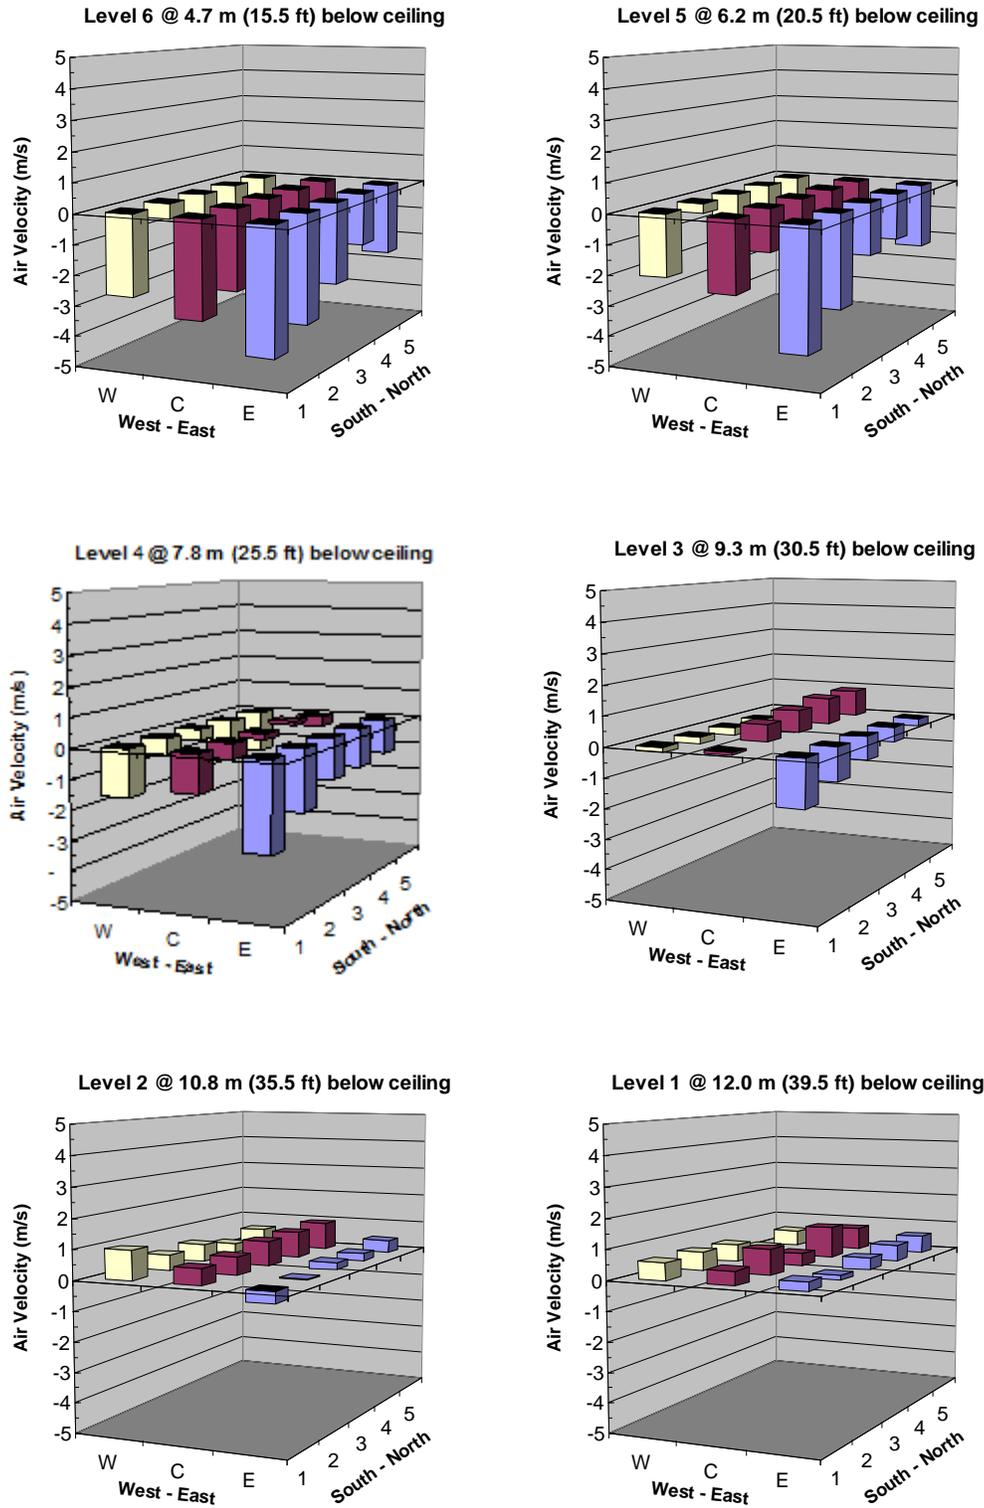
Figure 5-10: Air velocity through array with the fan at 66 rpm for Tests 2 and 3 [no fire]

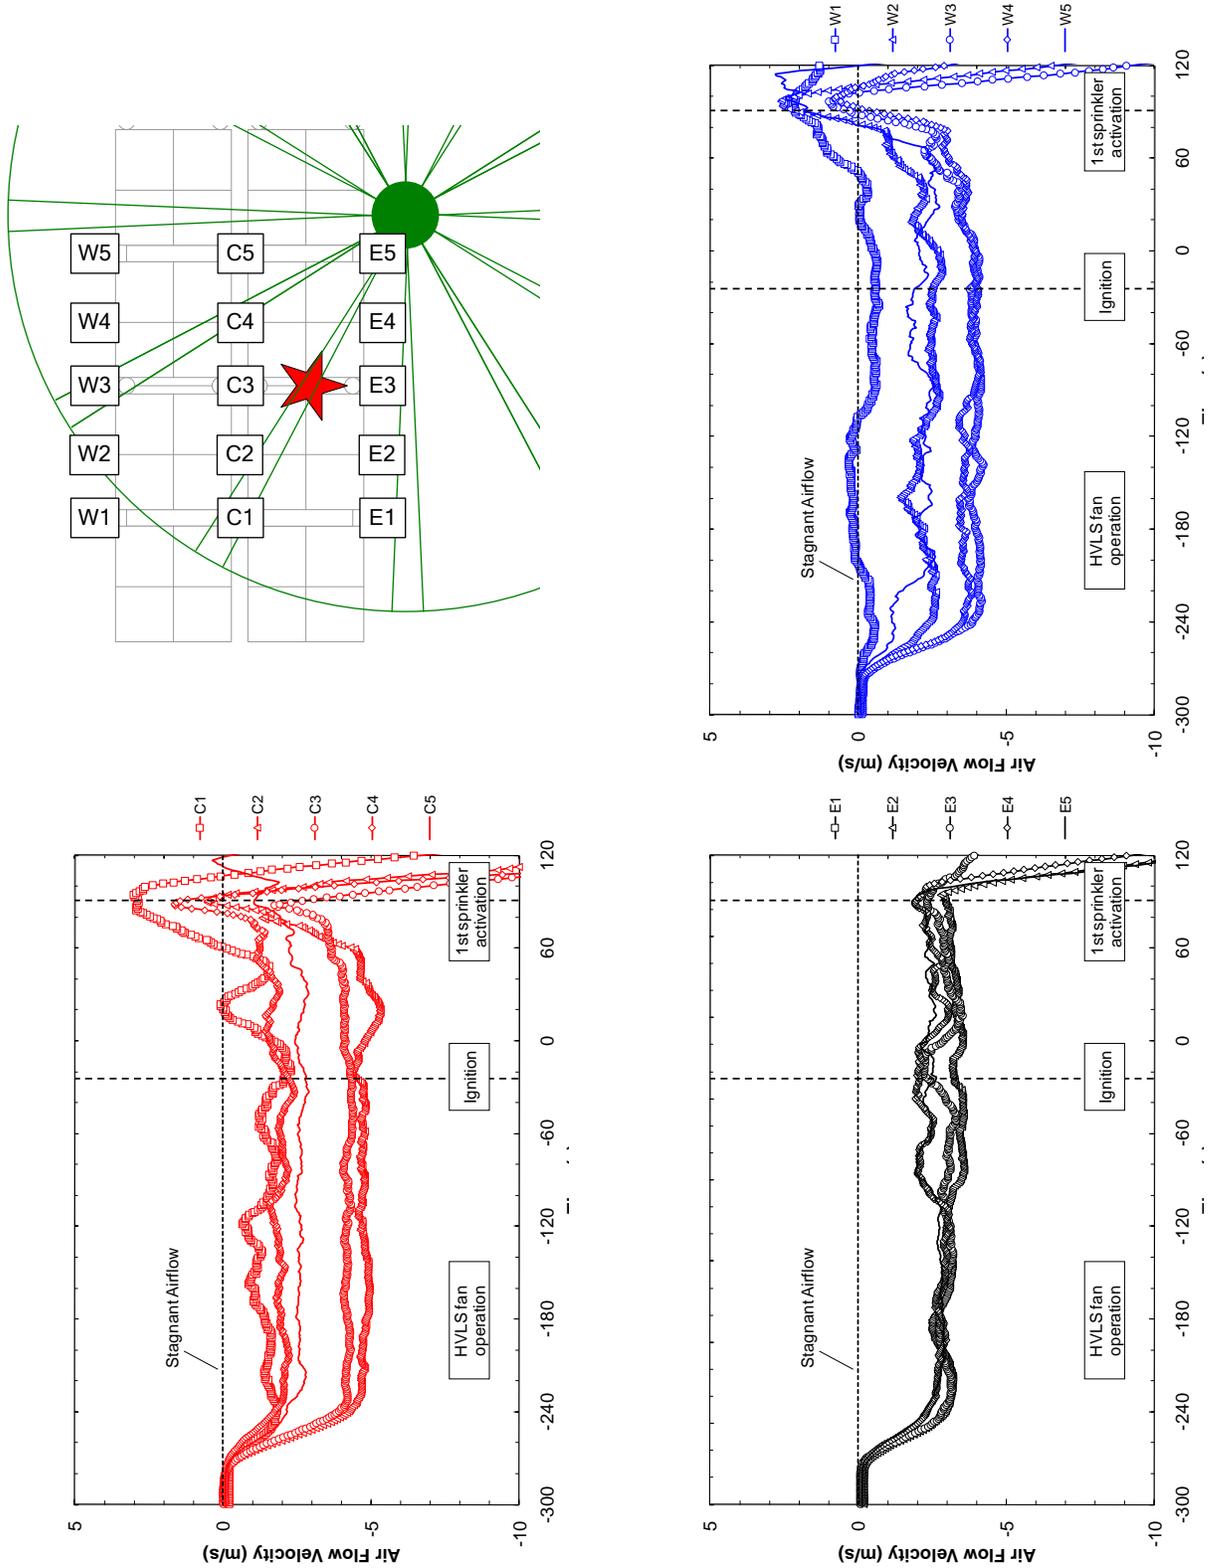
Figure 5-12: Air flow velocities at top of array during Test 1 (until first sprinkler operation)

Similar to the cold flow measurements presented in Section 5.5, these data illustrate the strong downward air velocity generated by the fan with peak sustained velocities of over 4 m/s (13 ft/s). After ignition, the buoyant air flow from the fire plume was evident as a net reduction in the downward flow velocity. As the fire grows, the fire plume gases overcome the fan air flow as indicated by upward air velocities at locations W1 – W5 and C4, which coincide with the actual location of the fire plume.

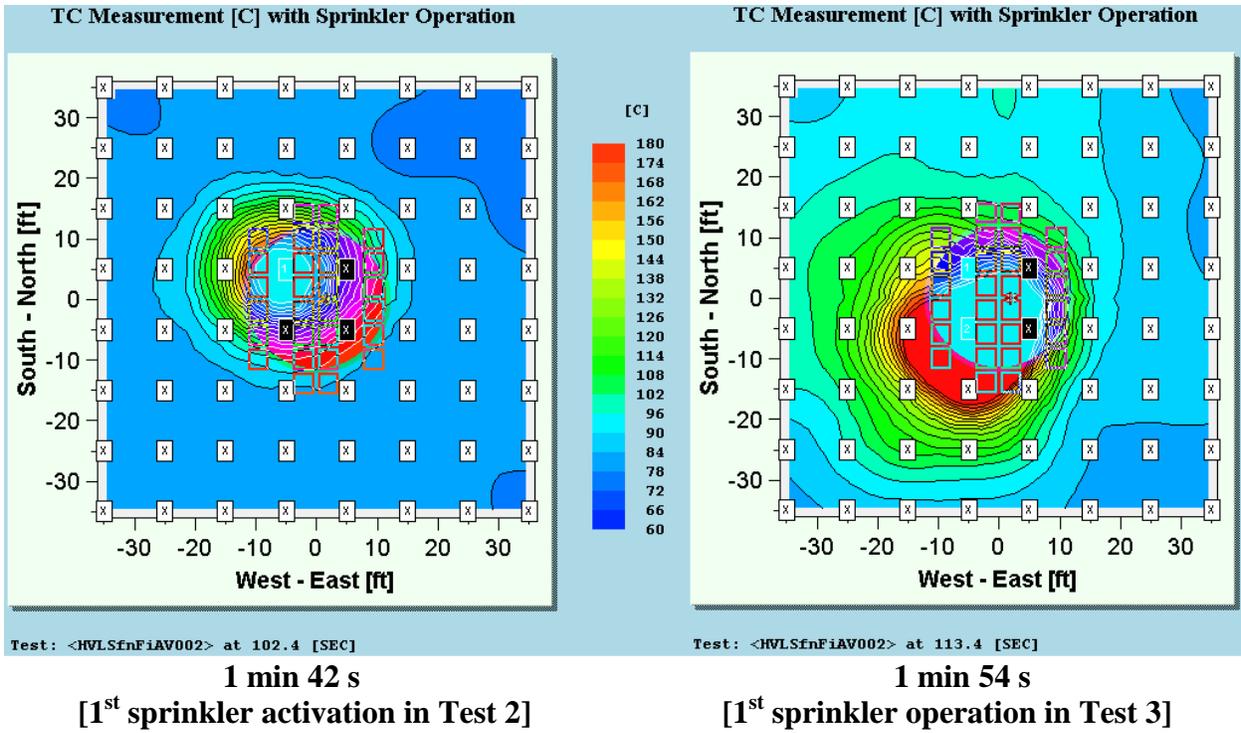
Figure 6-3: Ceiling TC measurement contour plot for Test 2

Ceiling TC measurements can provide insight into the actual location of ceiling gases leading to the initial sprinkler operations. Figure 6-3 and Figure 6-4 present contour plots of the ceiling TC measurements for Tests 2 and 3, respectively. The times shown in each plot are consistent with first sprinkler operation in Test 2 (1 min 42 s) and Test 3 (1 min 54 s). It can be seen for both tests that at 1 min 42 s, the fire plume was similarly located northwest of the ceiling center. In the case of Test 2, this resulted in sprinkler operation of the local sprinkler. However, the corresponding temperatures were slightly lower in Test 3 and that sprinkler did not operate. The plume then moved to the south in both tests by 1 min 54 s, resulting in the operation of the local sprinklers.

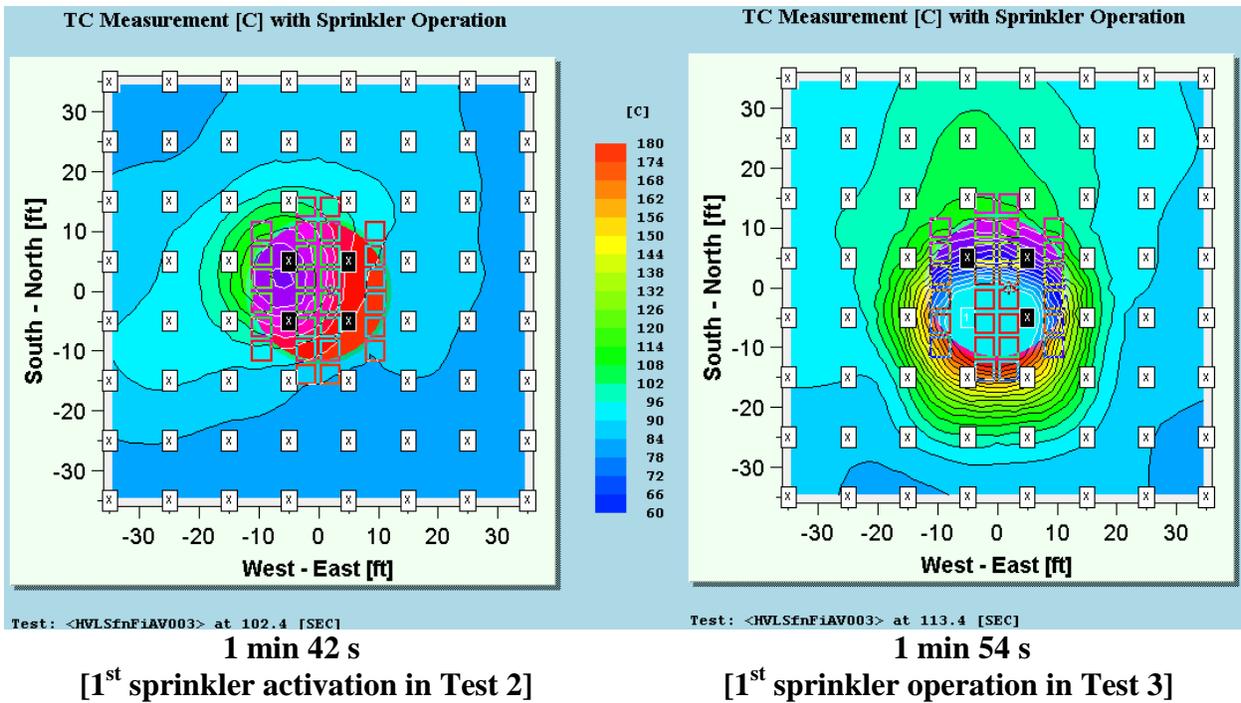
Figure 6-4: Ceiling TC measurement contour plot for Test 3

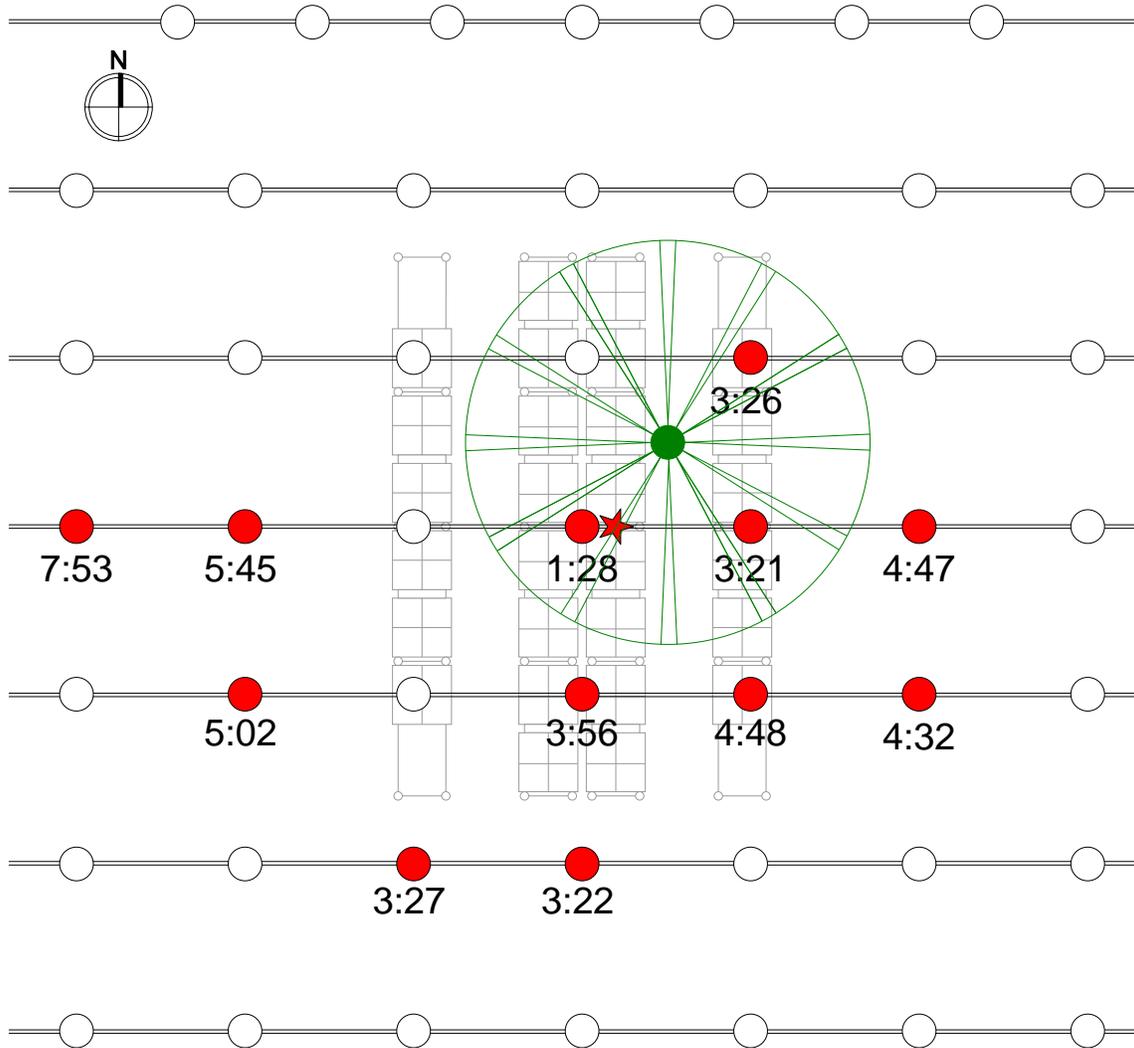
Figure B-1: Plan view of sprinkler operation pattern - Test 1
