Impact of a High Volume Low Speed Fan on Sprinkler Performance in Rack Storage Fires

Benjamin Ditch

FM Global Research Division

January 2011

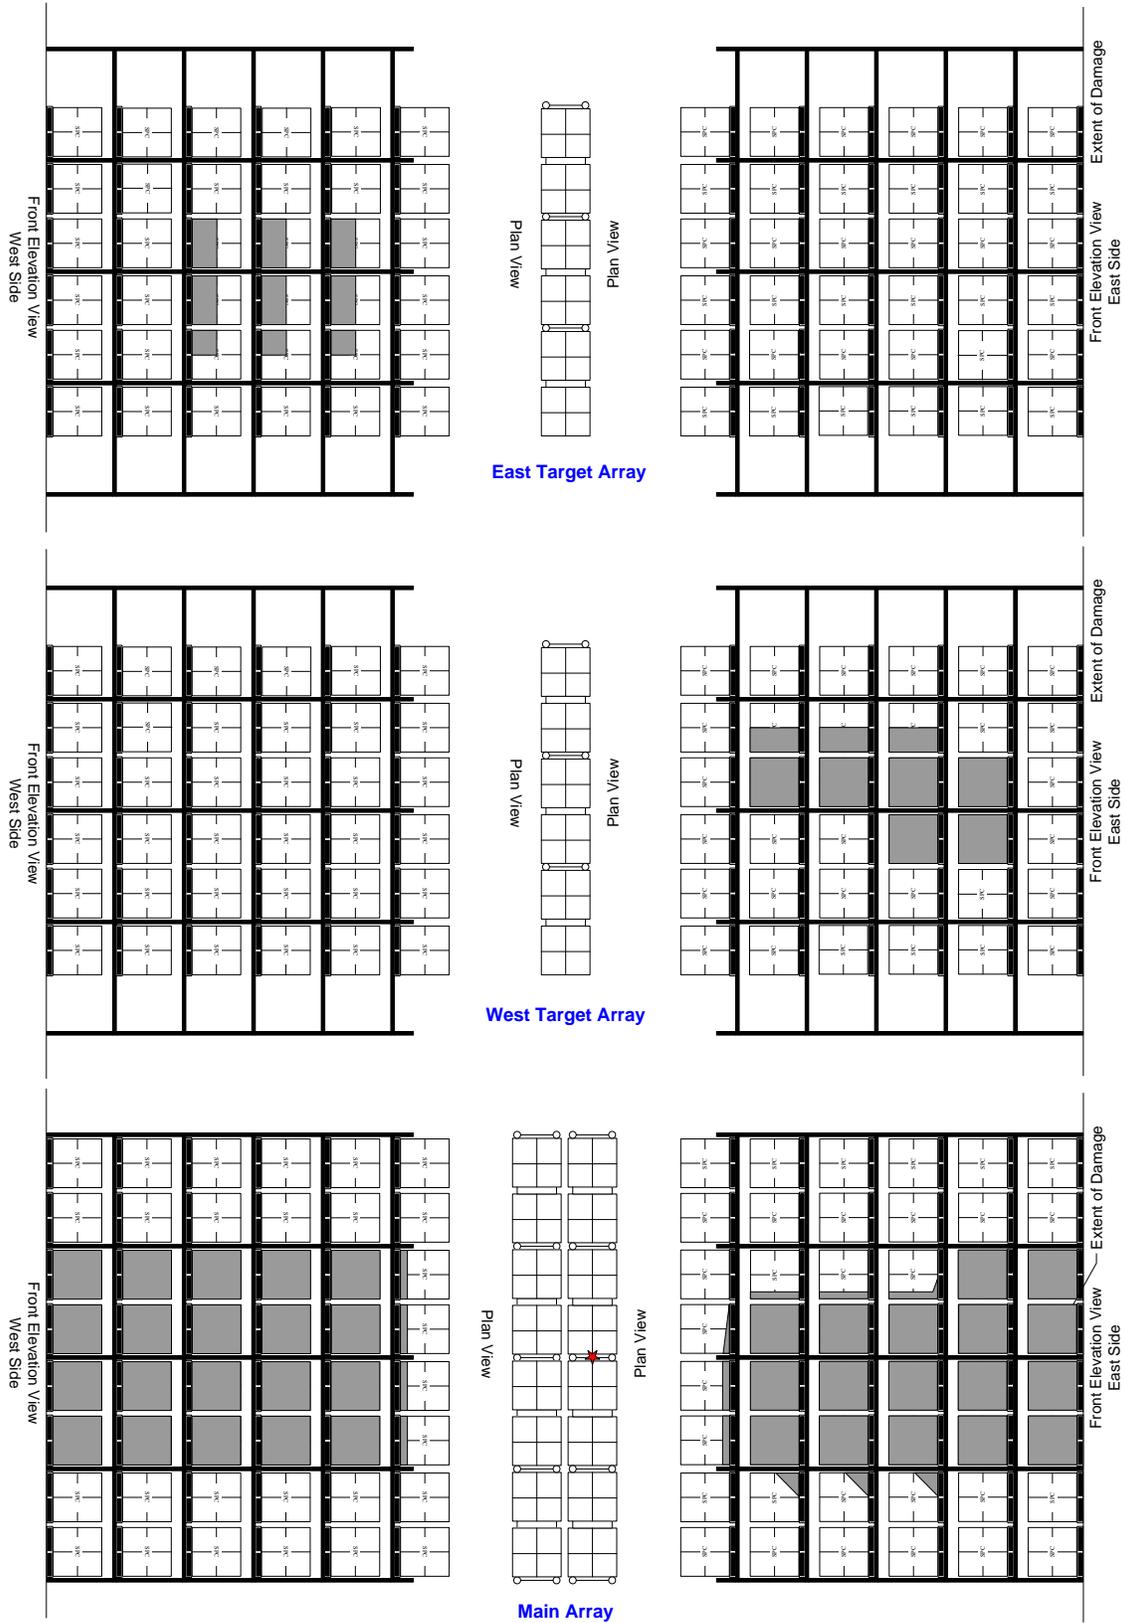
Figure B-2: Damage assessment - Test 1

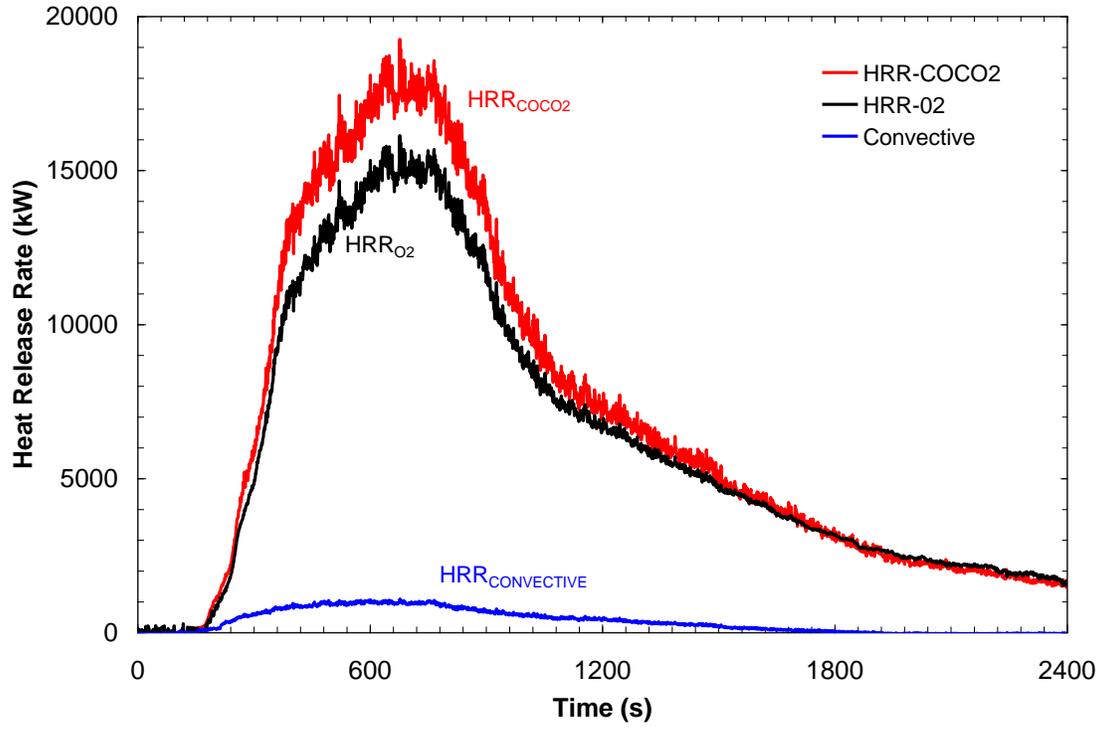
Figure B-5: Heat release rate – Test 1

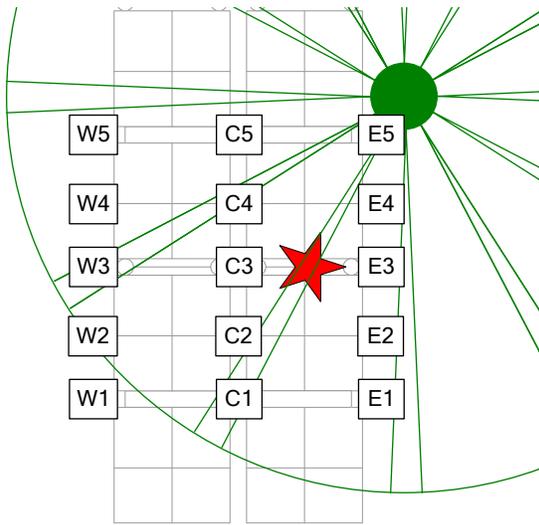
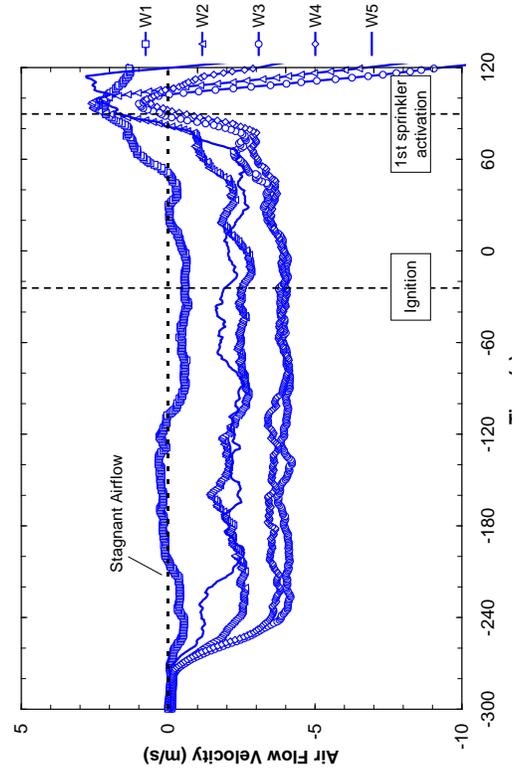
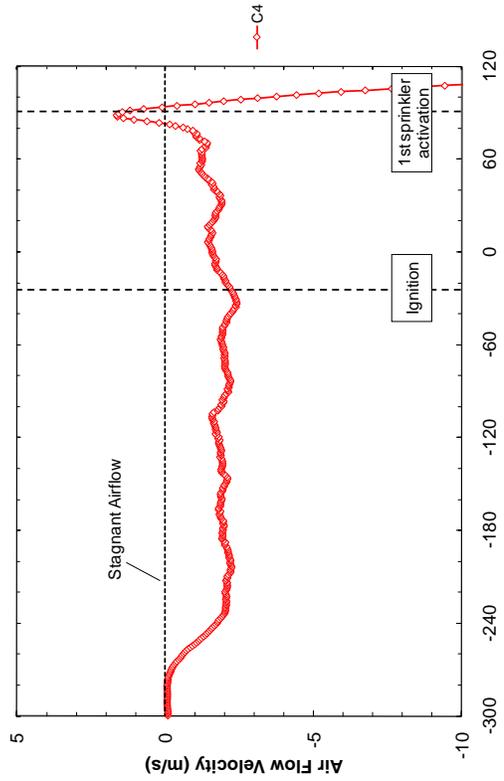
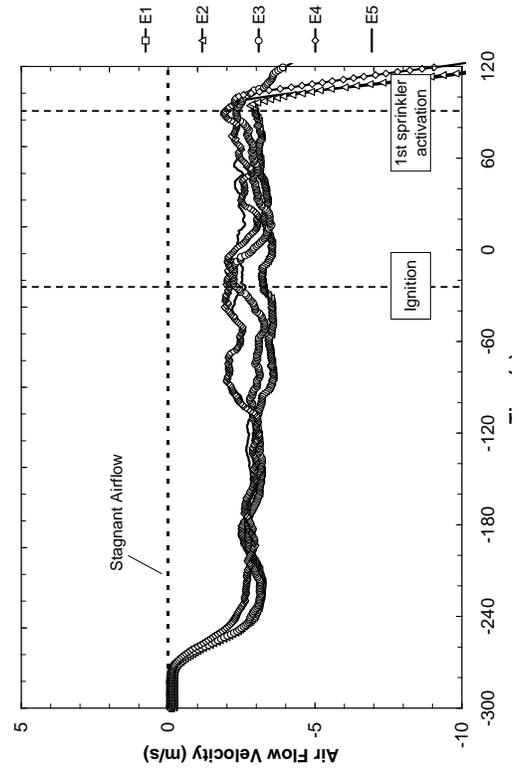
Figure B-8: Air-flow above array at ignition bay – Test 1

the upward air velocities are greatest at locations W1 – W5 and C4, which coincide with the actual location of the fire plume.

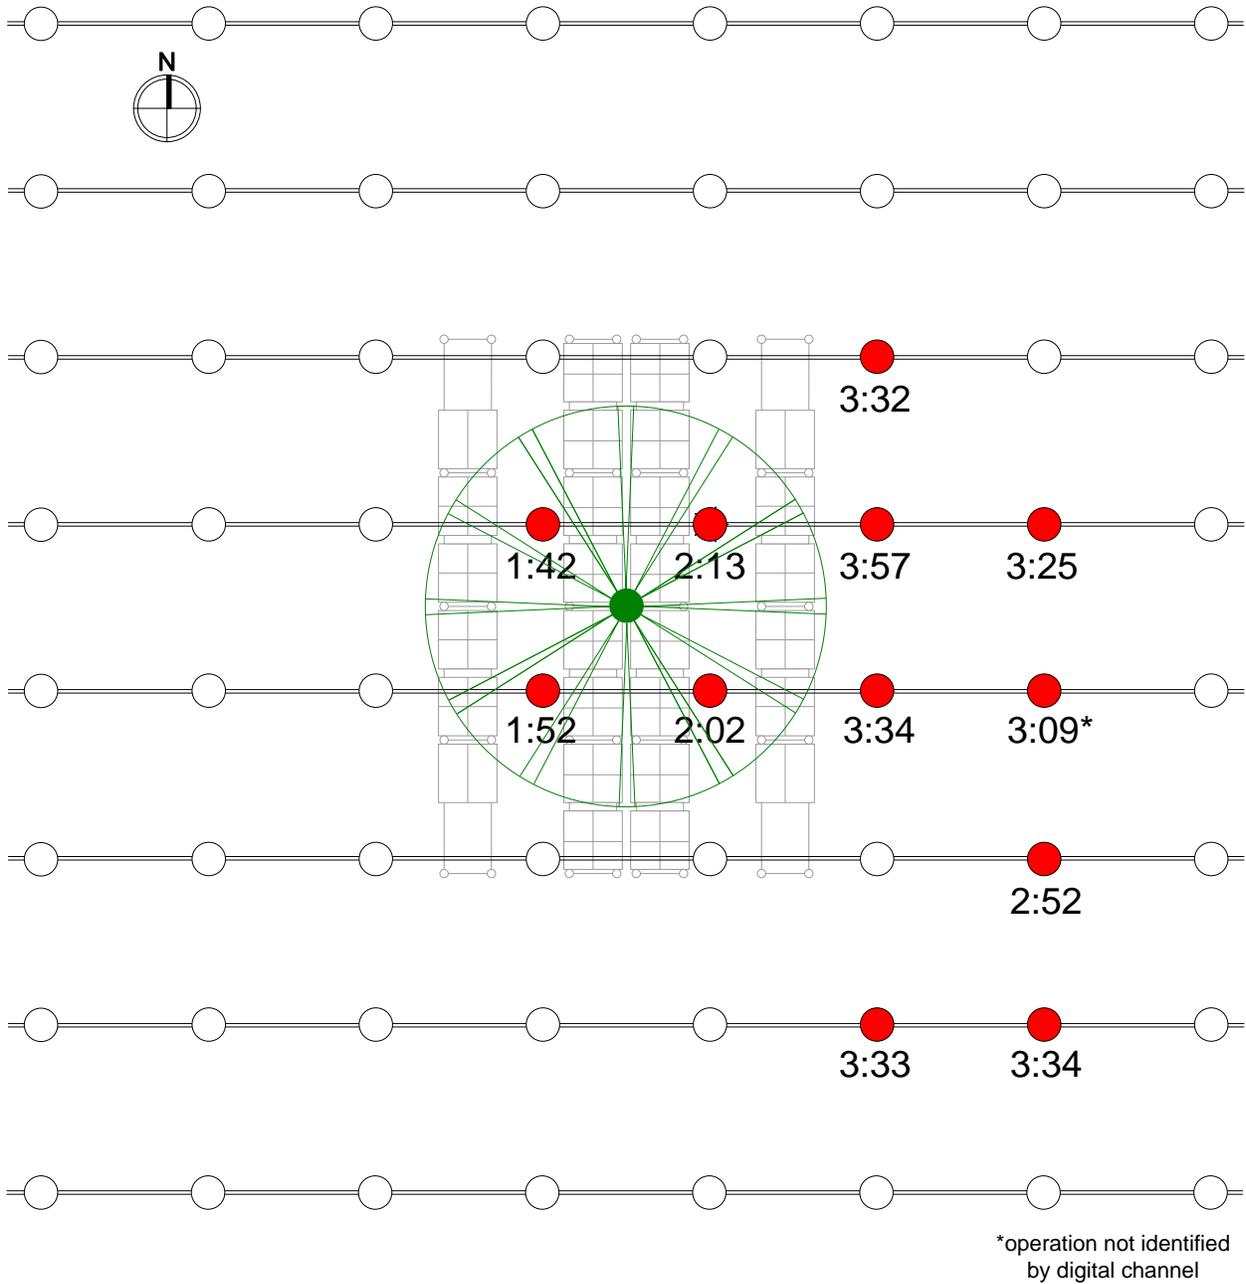
Figure C-1: Plan view of sprinkler operation pattern - Test 2

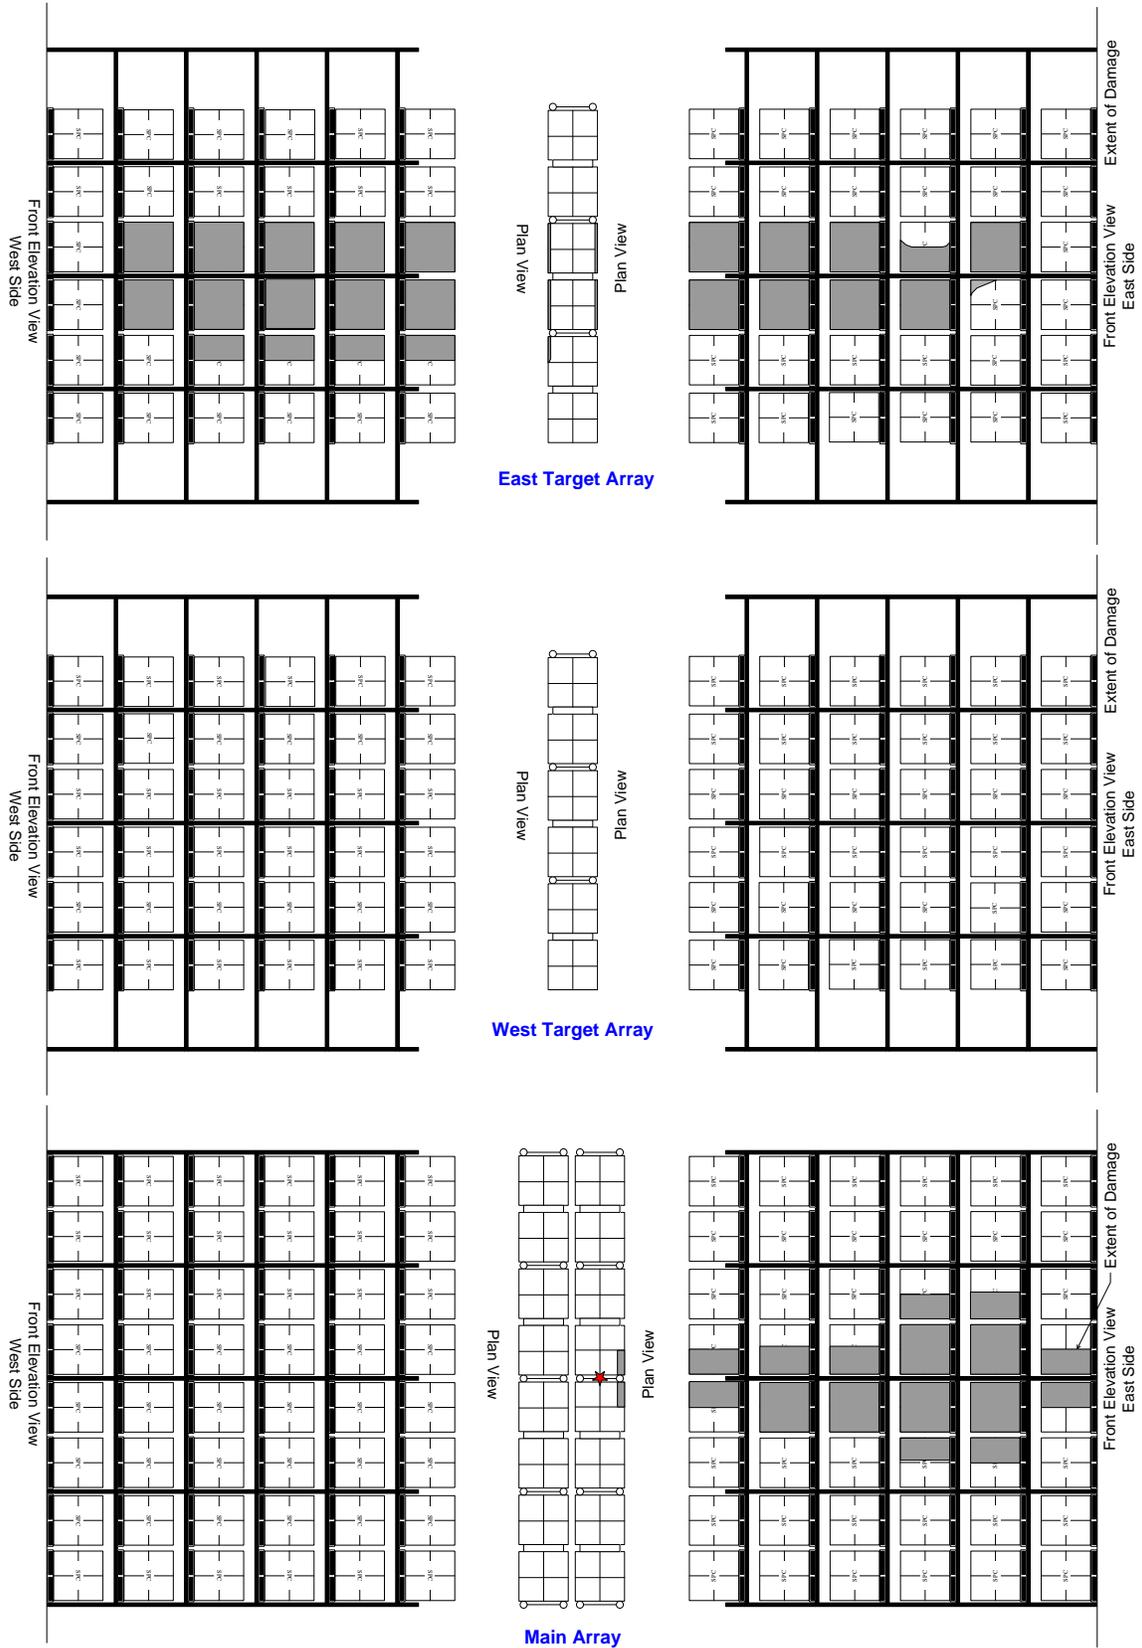
Figure C-2: Damage assessment - Test 2

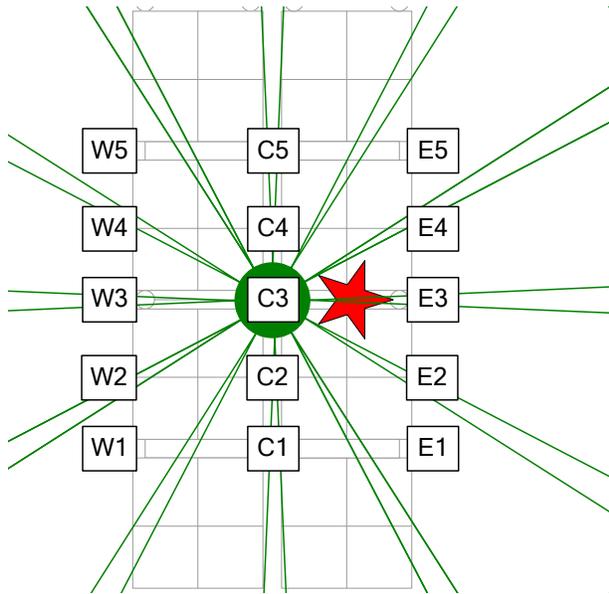
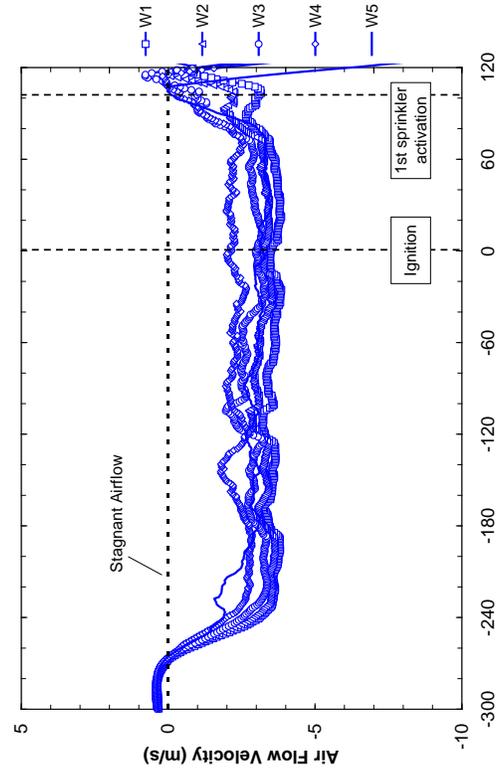
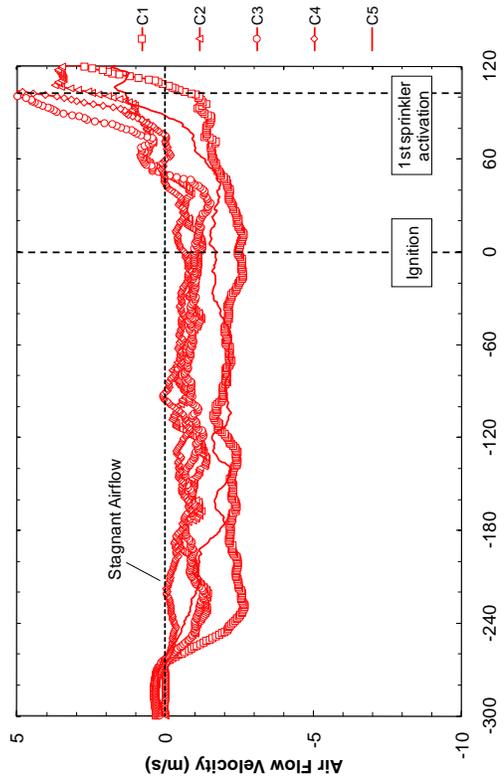
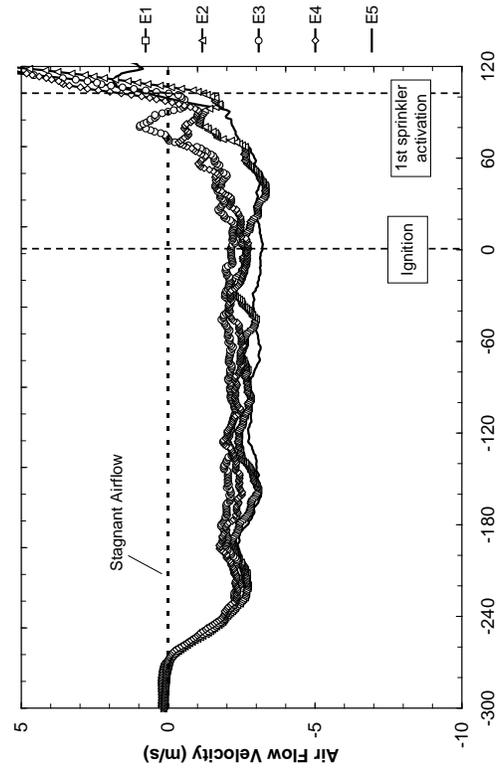
Figure C-8: Air-flow above array at ignition bay – Test 2

Figure C-8 presents the air velocity measurements taken during the fire test at the 15 locations above the top of the array over the ignition bay. Each graph contains data from the five measurement locations over either the east face of the array, west face of the array, or above the longitudinal flue. As shown, negative values indicated downward air flow. A plan view schematic of the measurement locations relative to the array and the fan is included for reference. These data illustrate the strong downward air velocity generated by the fan with peak sustained velocities up to 3.5 m/s (11.5 ft/s). After ignition, the buoyant air flow from the fire plume is evident as either a reduction in the downward flow velocity or in some locations an upward air flow. The strongest upward air velocities were measured at locations C2 - C4, E3, and E4, which coincide with the actual location of the fire plume.

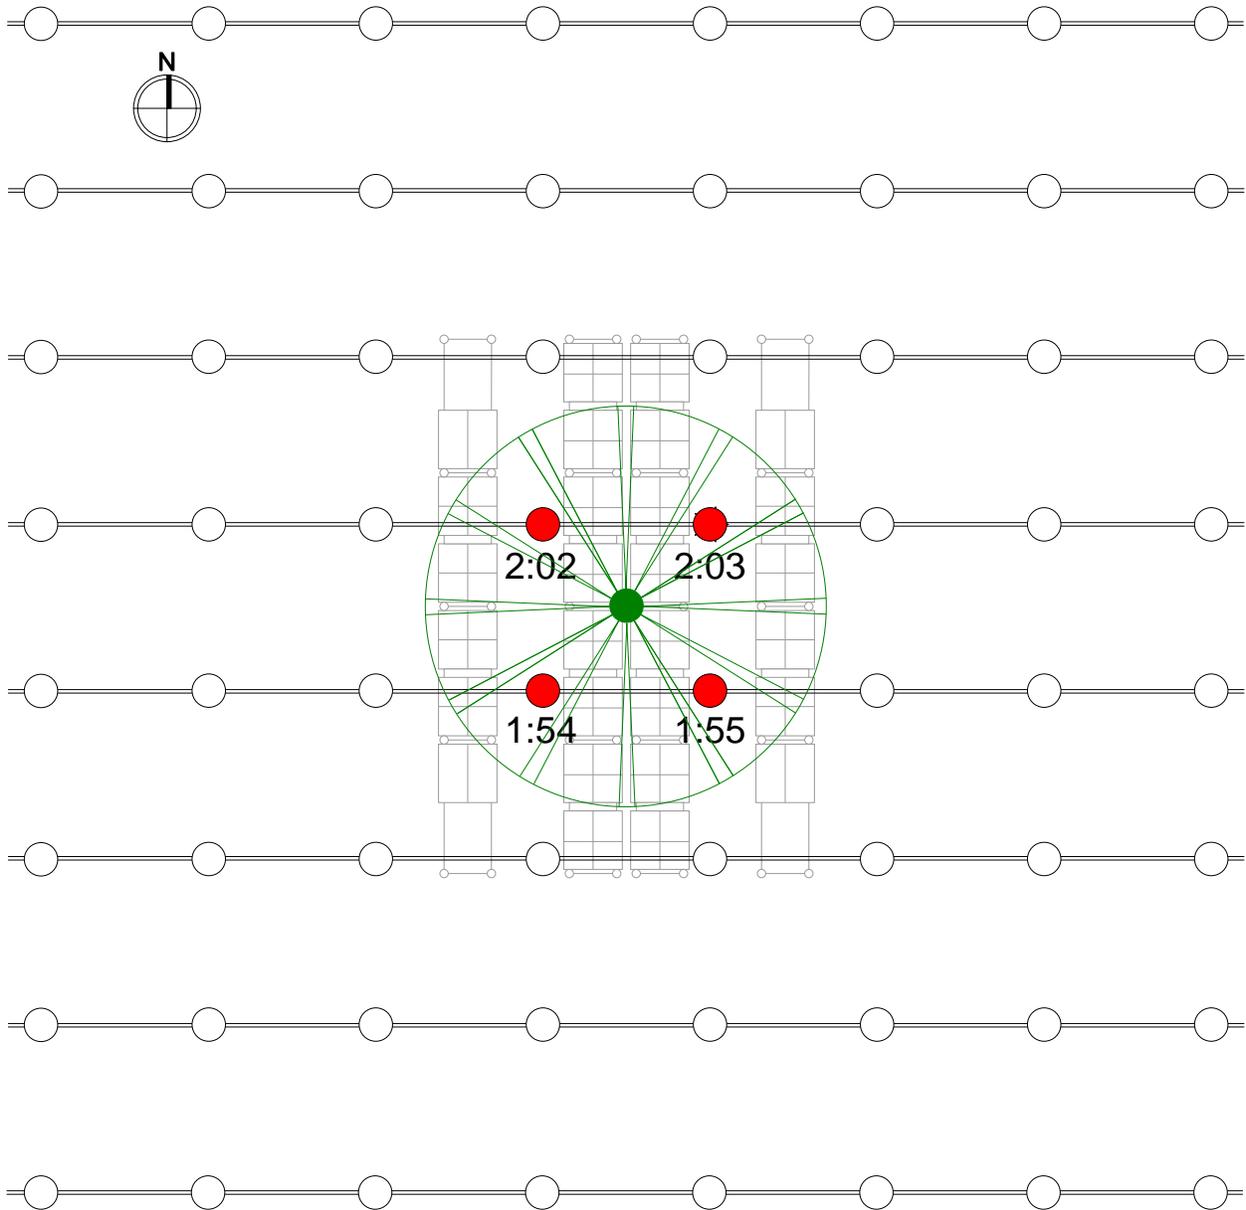
Figure D-1: Plan view of sprinkler operation pattern - Test 3

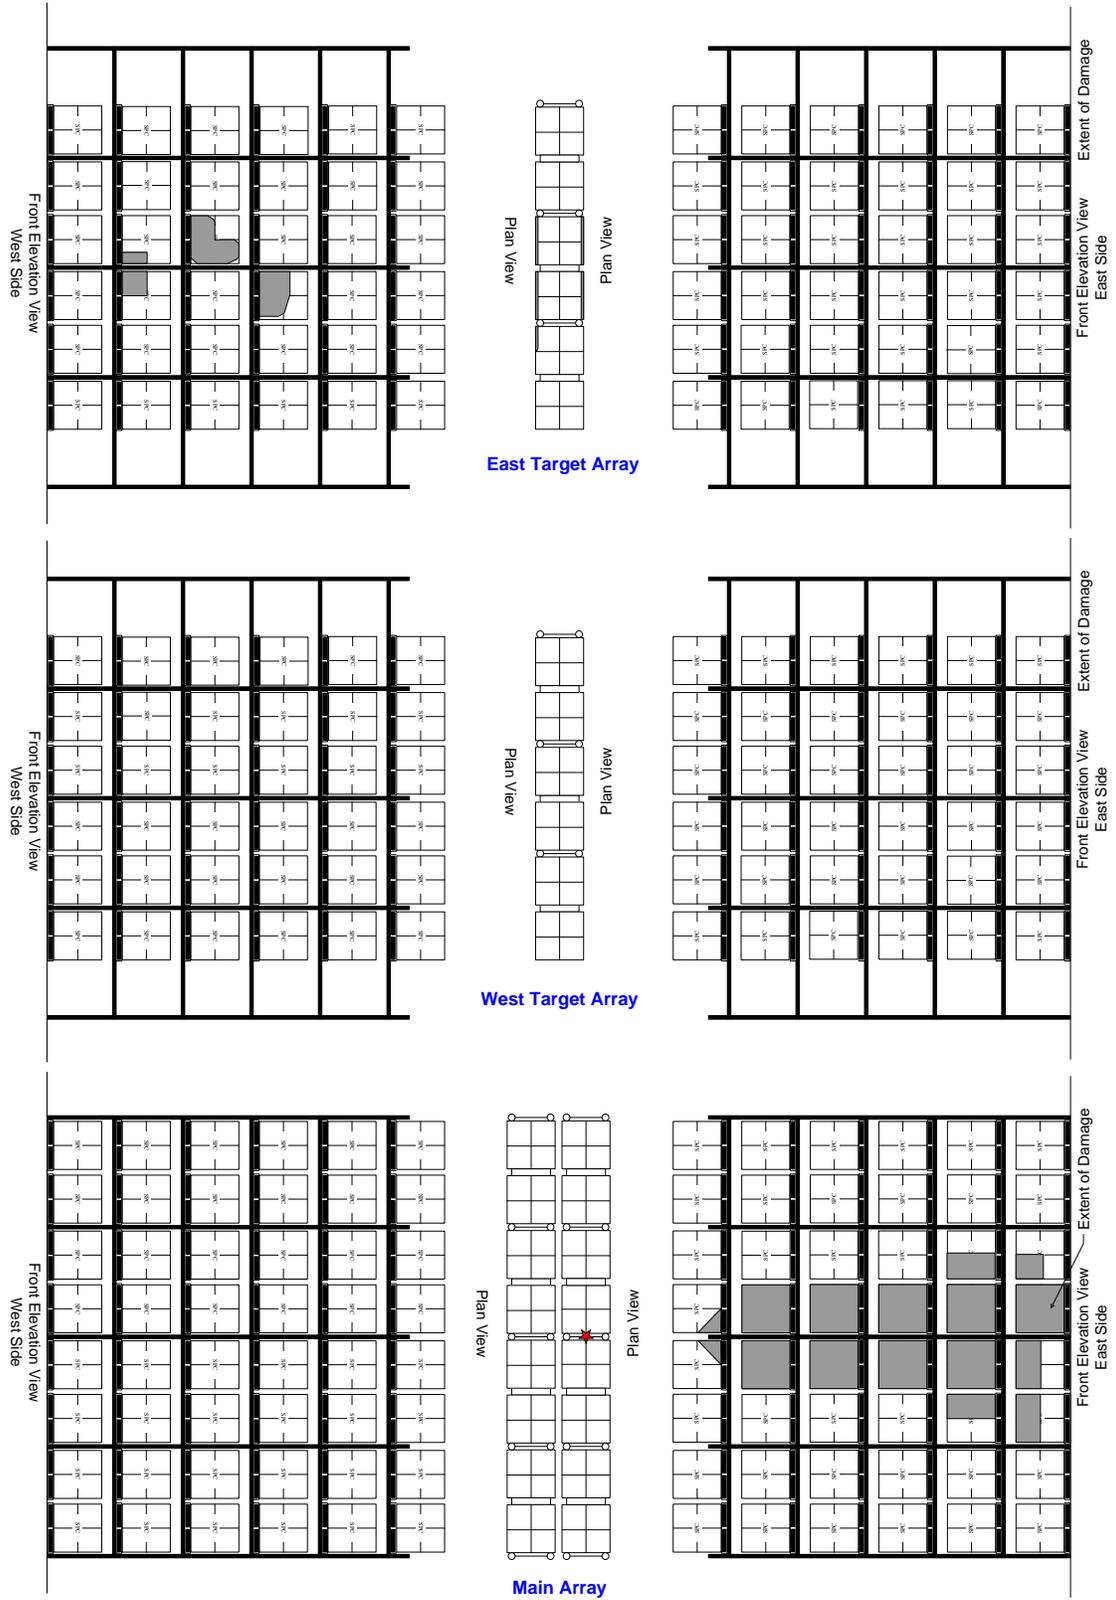
Figure D-2: Damage assessment - Test 3

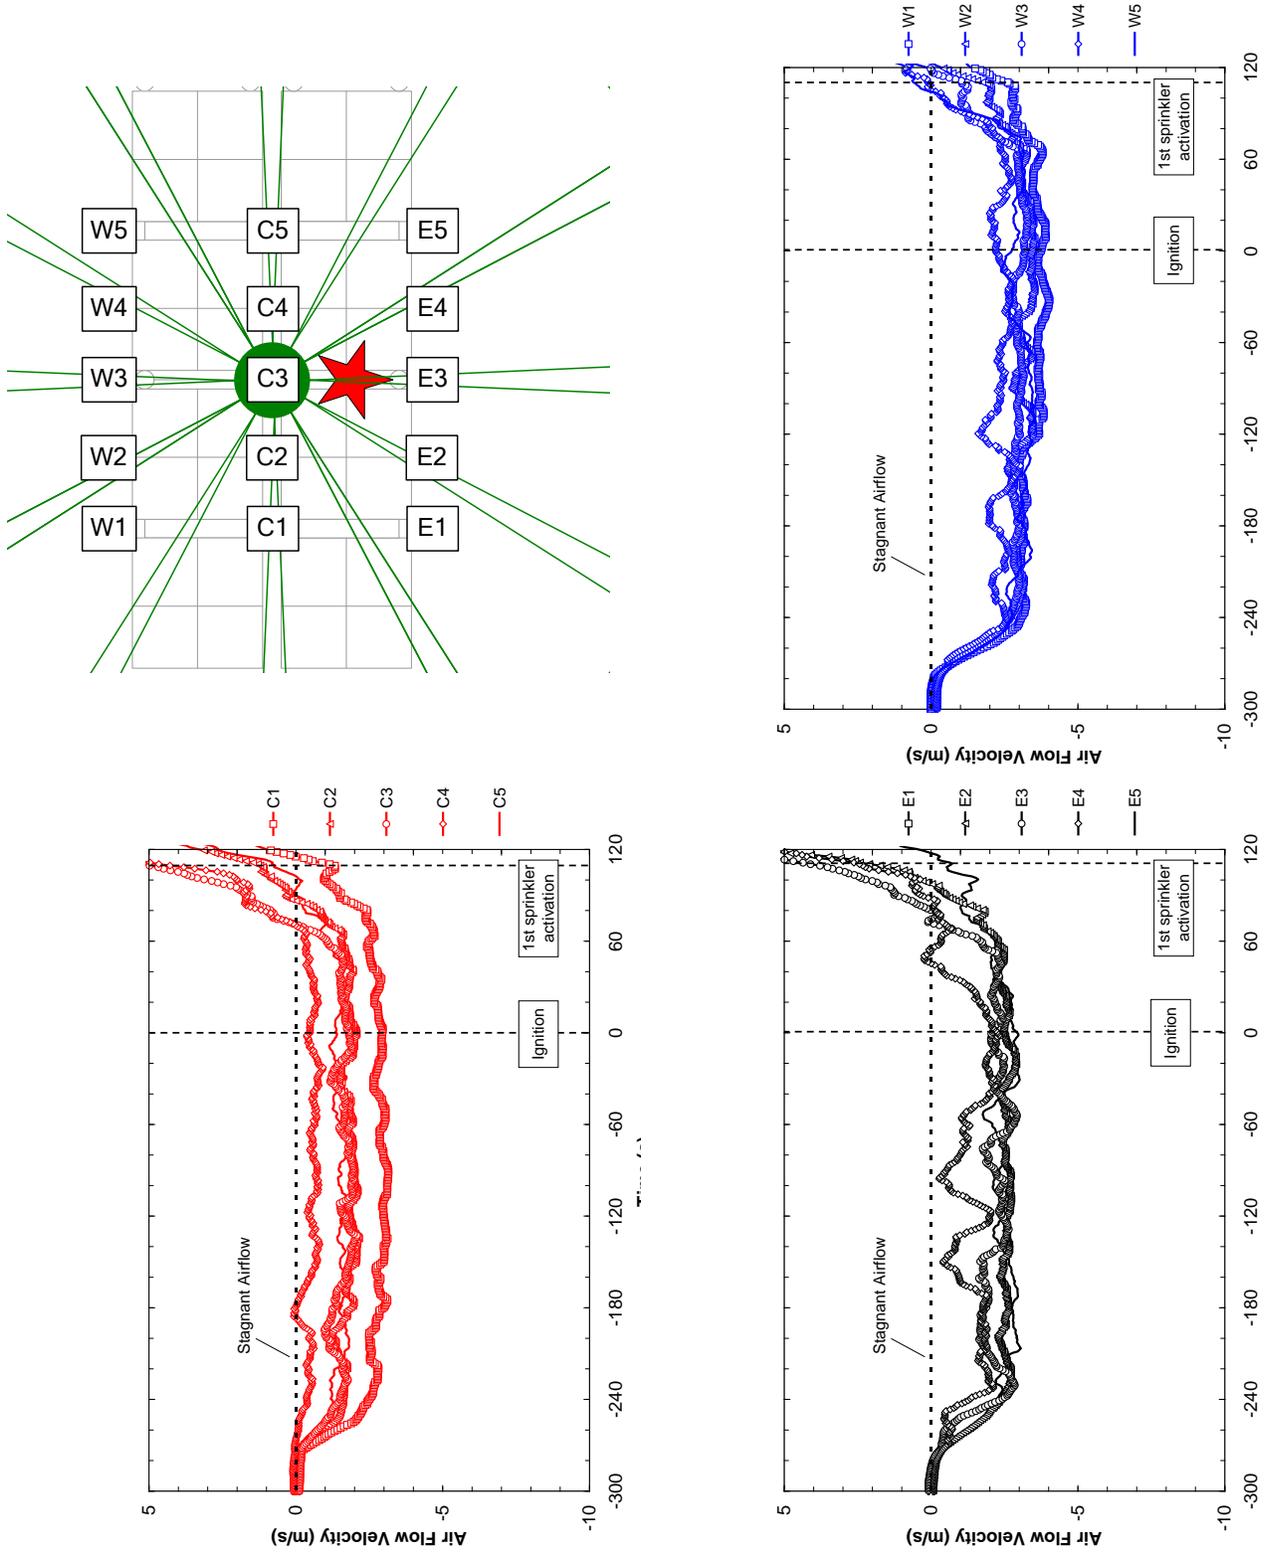
Figure D-8: Air-flow above array at ignition bay – Test 3

Figure D-8 presents the air velocity measurements taken during the fire test at the 15 locations above the top of the array over the ignition bay. Each graph contains data from the five measurement locations over either the east face of the array, west face of the array, or within the longitudinal flue. As shown, negative values indicate downward air flow. A plan view schematic of the measurement locations relative to the array and the fan is included for reference. These data illustrate the strong downward air velocity generated by the fan with peak sustained velocities of up to 3.5 m/s (11.5 ft/s). After ignition, the buoyant air flow from the fire plume is evident as either a reduction in the downward flow velocity or in some locations an upward air flow. The strongest upward air velocities were measured at locations C2 - C4 and E2 - E4, which coincide with the actual location of the fire plume.

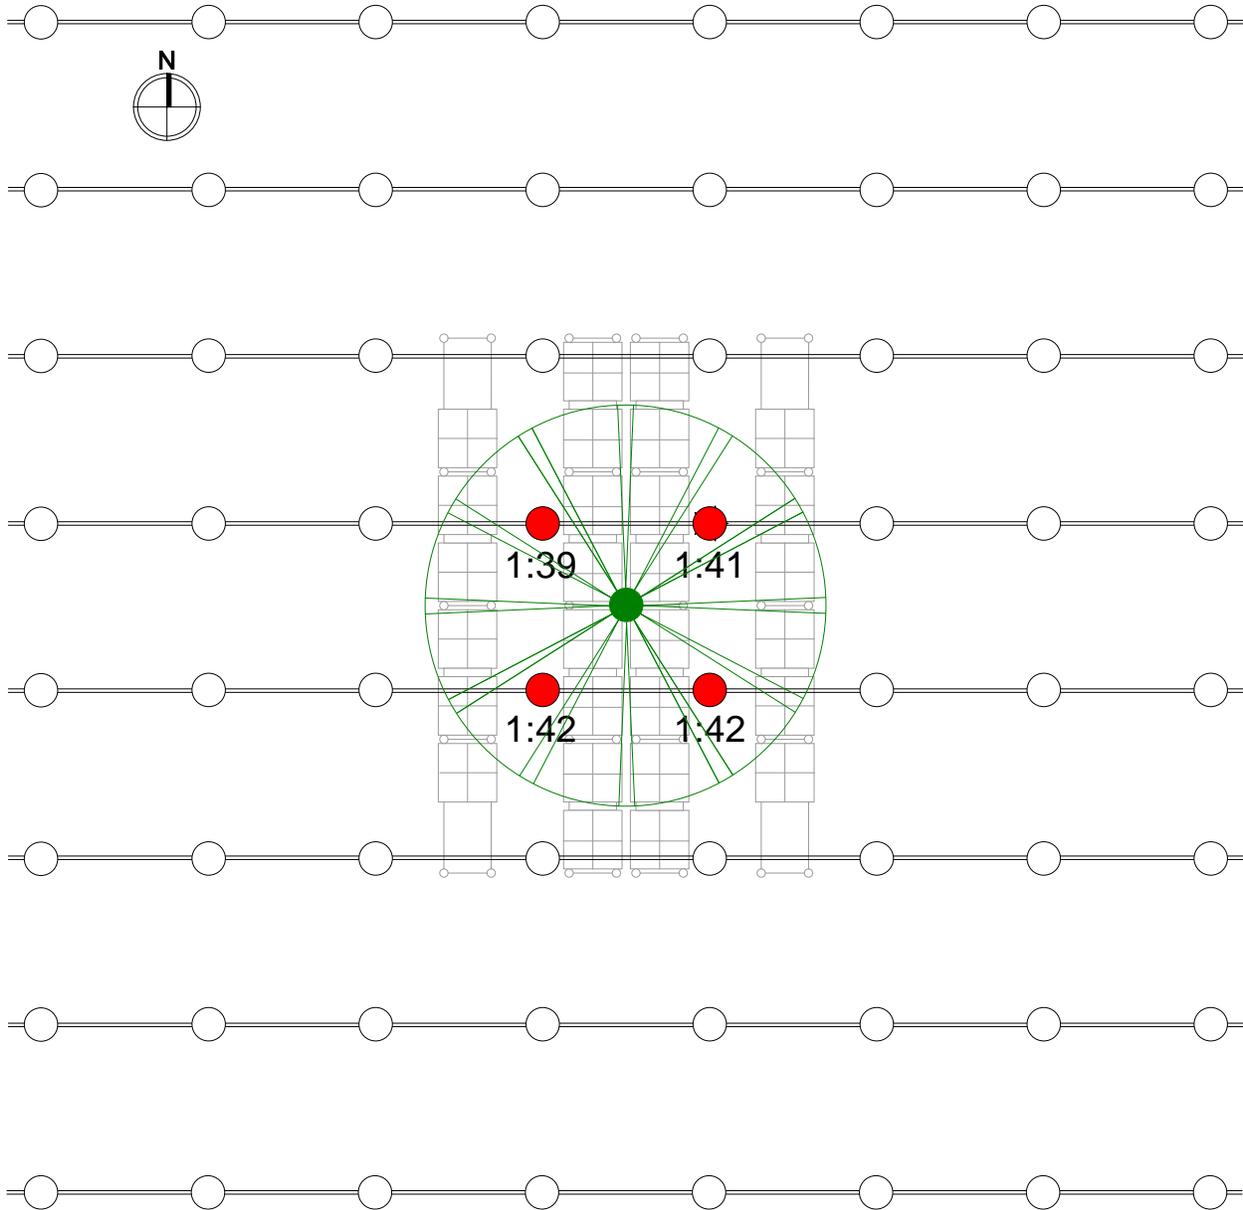
Figure E-1: Plan view of sprinkler operation pattern - Test 4

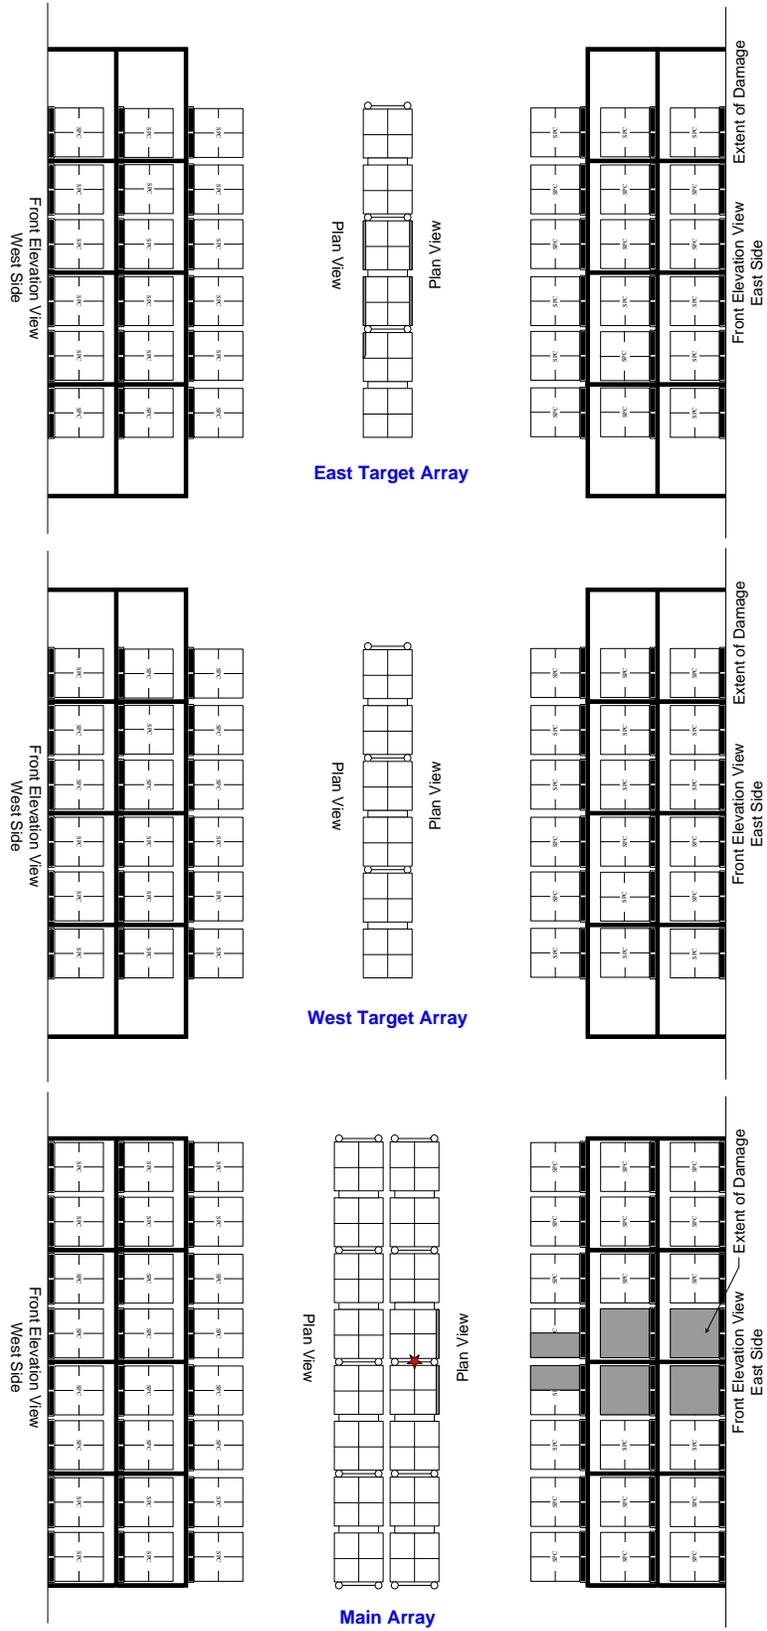
Figure E-2: Damage assessment - Test 4

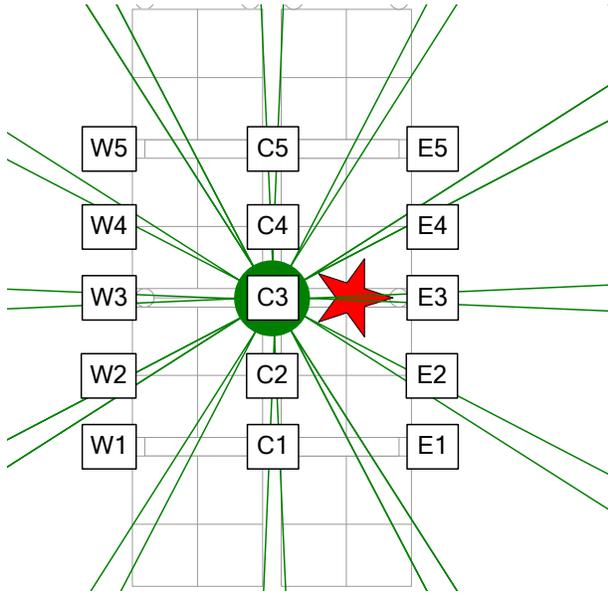
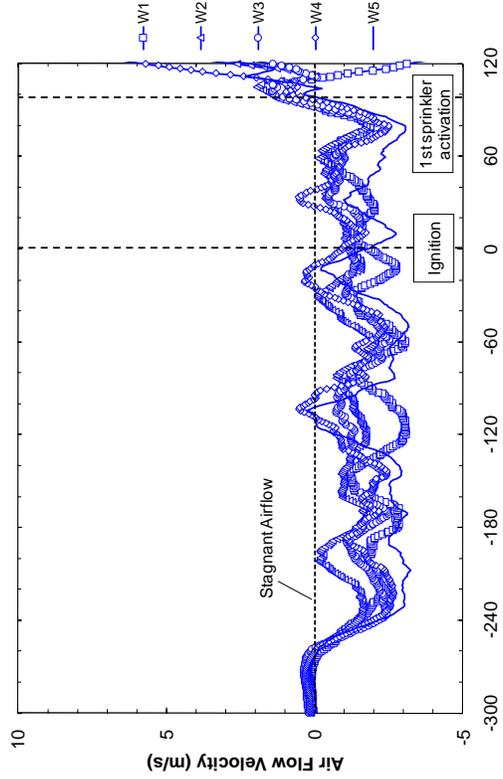
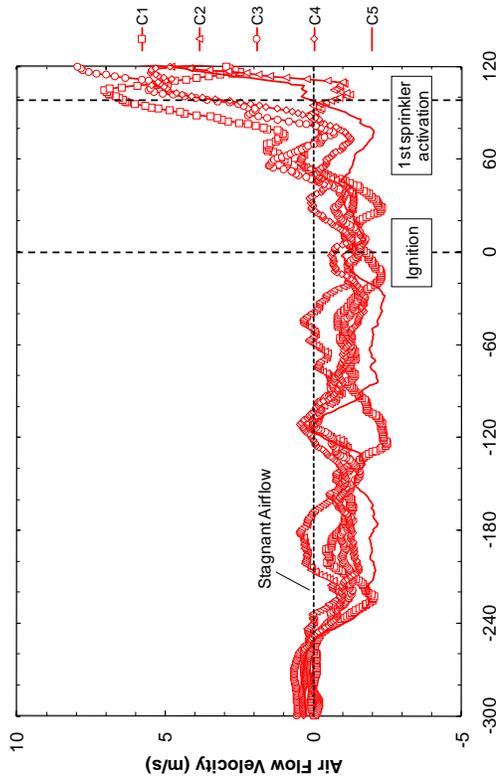
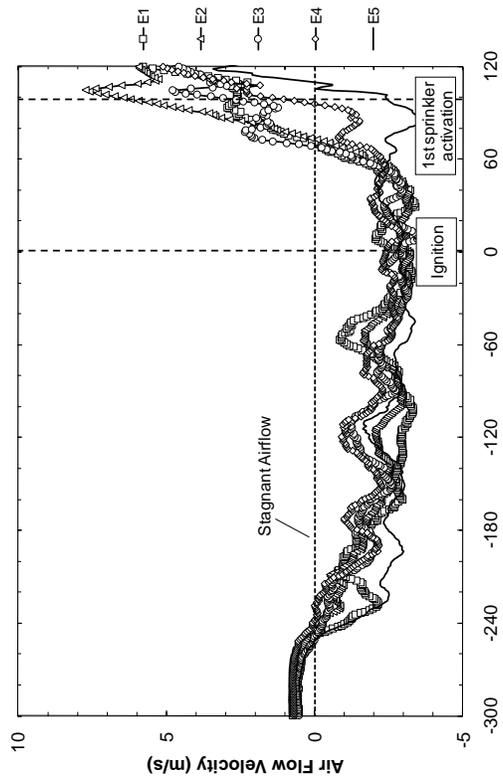
Figure E-8: Air-flow above array at ignition bay – Test 4

operation with peak values greater than 5 m/s (16.4 ft/s) measured at locations C3, C4, E2, E4, and W4.
