TECHNICAL REPORT **FOR NFPA 13**

**ESFR Sprinkler Protection of Exposed Nonexpanded
Group A Plastics for Ceilings over 30 ft (9.1 m) and
up to 40 ft (12.2 m) High**

July 2019

FM Global

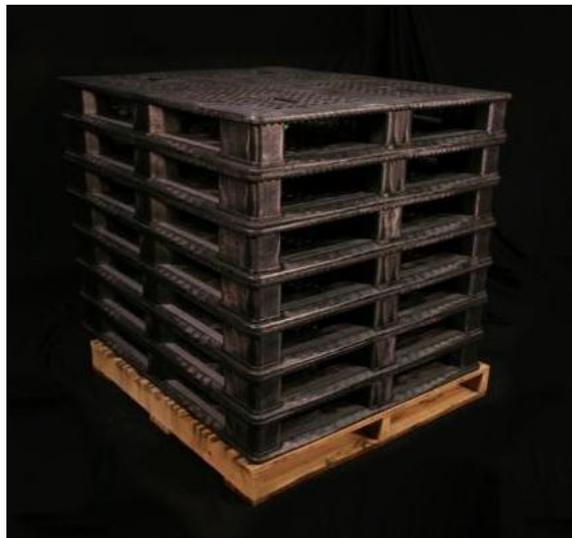
The exposed, nonexpanded Group A plastic test commodity (referred to as uncartoned, unexpanded plastic [UUP] by FM Global) consists of high-density polyethylene RACK'R plastic pallets from ORBIS Corporation®. The four-way entry plastic pallets are not FM Approved and do not contain fire retardant materials. The pallets have dimensions of 40 in. (1.02 m) long by 48 in. (1.22 m) wide by 5.6 in. (14 cm) high and weigh about 56 lb (25.4 kg) each.

For rack storage tests, an individual pallet load consists of seven plastic pallets stacked on top of an ordinary, two-way, slatted deck, hardwood pallet resulting in an overall dimension of 42 in. x 48 in. x 44 in. (1.07 m x 1.22 m x 1.11 m). The total combustible weight of this pallet load is 441.6 lb (200.3 kg); the plastic pallets weigh approximately 392.2 lb (177.9 kg), and the hardwood pallet that supports the commodity weighs approximately 49.4 lb (22.4 kg). A photo of this test commodity is provided in Figure 2-2.

Figure 2-2: FM Global Standard Uncartoned Unexpanded Plastic (UUP) Test Commodity for Rack Storage Tests (Considered Exposed, Nonexpanded Group A Plastic per NFPA 13).

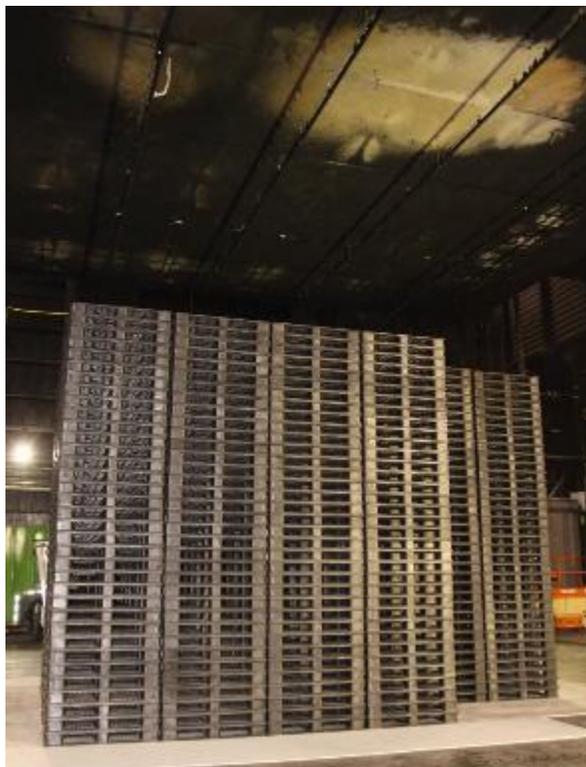
Test 5 was conducted under the South Movable Ceiling. Figure 3-5 shows the test setup in plan and elevation views. Figure 3-6 shows a photograph of the test array prior to ignition. A total of 700 plastic pallets was used as fuel. As shown in Figure 3-5, the main fuel array was double-row solid pile, 6 pallets long, 35 pallets high with a 1 ft (0.3 m) flue space in the longitudinal direction (N-S) and with the pallets butted together in the other direction. The storage height was 16 ft (4.9 m). In addition, two rows that were 4 pallets long and 16 ft (4.9 m) high were placed both east and west of the main array with a 1 ft (0.3 m) flue space.

Figure 3-6: Photo of Test 5 Captured from the East Side of the Test Arrangement.

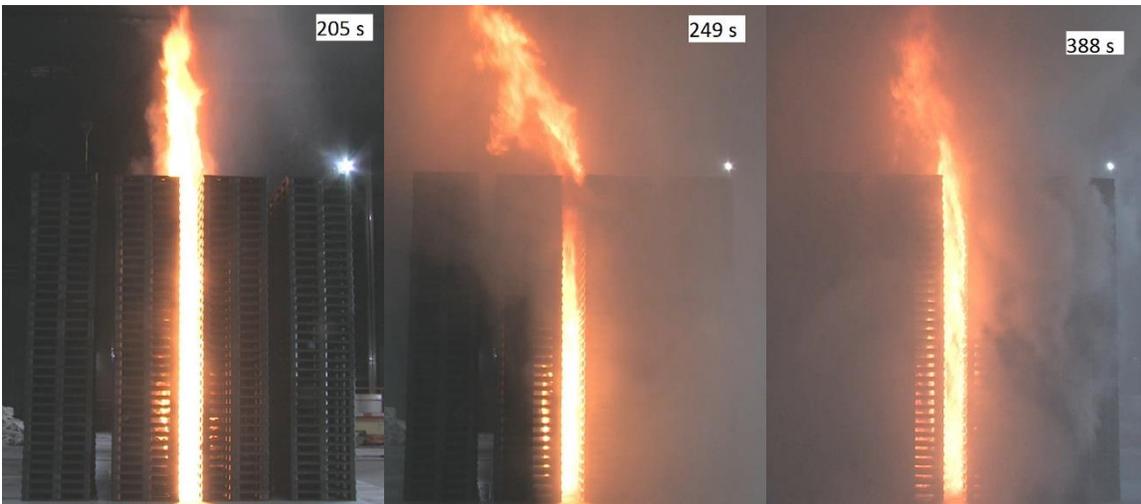
Figure 3-8: Photos of Test 5 from South Side at 205 s, 249 s and 388 s After Ignition.

After first sprinkler actuation, the fire size decreased for a short time period and then continued to increase. At 249 s after ignition, just before second sprinkler (No. 24 in Figure 3-7) actuation, a strong flame appeared at the top of the fuel array. Because the ignition was offset west from the first sprinkler actuation, the center image of Figure 3-8 also shows that the flame was pushed to the west side by the downward spray.

At the time of eighth sprinkler actuation (No. 20 at 388 s), the fire was still very strong. From this time, the whole burning area was filled with smoke and water vapor and the fire could not be observed. Only the infrared imagery showed that the fire continued in the fuel array. Several seconds later, two additional sprinklers – Nos. 18 and 33 in Figure 3-7 – actuated at 6 min 32 s and 6 min 46 s after ignition, respectively. The fire appeared to be controlled; however, the fire size started to increase again at 20
