RESEARCH TECHNICAL REPORT
*Sprinkler Performance under
Non-Sloped Obstructed
Ceiling Construction*

Prateep Chatterjee

FM Global

December 2018

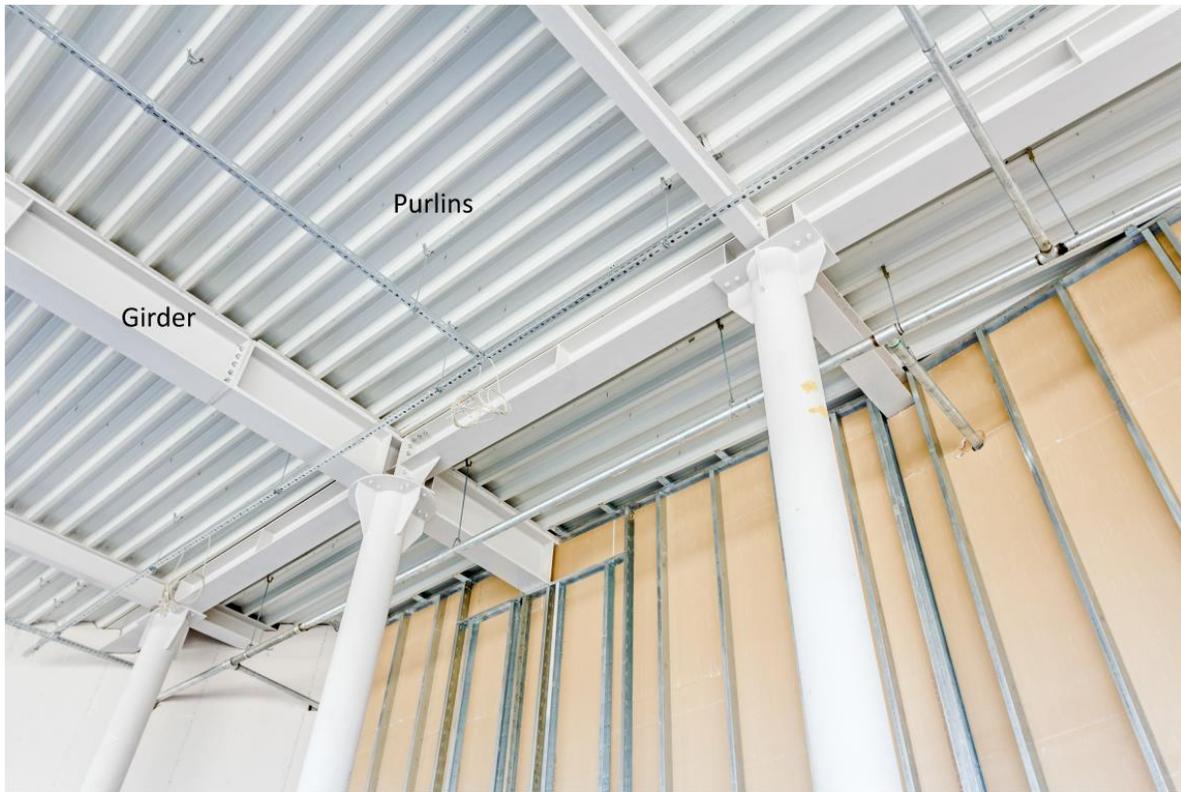
(a) Purlins and girders below the ceiling [3]

Industrial facilities with obstructed ceiling construction are commonly found worldwide (see Figure 1-1 for examples). Obstructed ceiling construction is defined in FM Global Loss Prevention Data Sheet (DS) 2-0, *Installation Guidelines for Automatic Sprinklers* [1], as a ceiling assembly forming channels that cannot hold more than one sprinkler branch line. The hot gases produced during a fire event therefore cannot reach the nearest four ceiling-level sprinklers anywhere within a single channel (see Figure 1-1 (a) for an example of channels formed by purlins). In this context, a channel consists of structural ceiling members that extend down from the ceiling at least 100 mm (4 in.), is less than 70% open in cross-sectional area, and has structural members spaced horizontally that would prevent two sprinkler branch lines from being installed within it. This type of construction is typically caused by the presence of purlins, girders, beams, and other similar types of structural roof supporting materials at the ceiling level. In some cases, the channels formed by the purlins are filled with insulation, as shown in Figure 1-1(b), effectively reducing the channel depth. Other construction elements, like truss structures shown in Figure 1-2(a), do not provide significant obstruction to the hot gas flow. Irrespective of the shape of the purlins popular in the industry, as can be observed in Figure 1-2(b), these structures tend to keep the flow of hot combustion products originating from fires confined in the channels, possibly delaying the activation of sprinklers. Other common ceiling assemblies that are considered obstructed ceiling construction use either steel beams or concrete tees. While the construction industry manufactures purlins in common depths ranging from 150 to 360 mm (6 to 14 in.), other ceiling assemblies, such as steel beams and concrete tees, are commonly deeper than 610 mm (24 in.). Trends in warehouses around the world are also toward using deeper purlins. To address the impact of obstructed ceiling construction on sprinkler operation, DS 2-0 [1] currently recommends that sprinklers be installed within every channel formed by obstructed ceiling construction for the following:

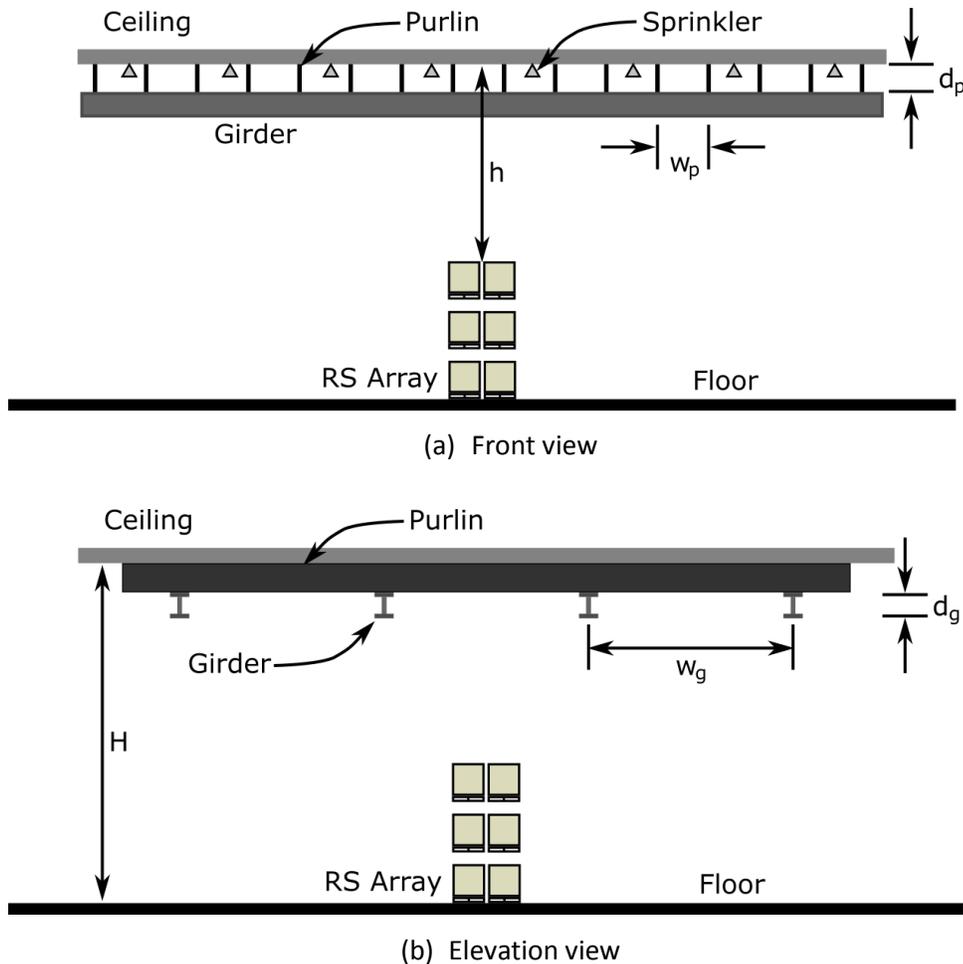
Figure 1-4 shows drawings of the computational setup of an unconfined, non-sloped ceiling with purlins and girders, located above a 3-tier-high rack storage arrangement of CUP commodity. Purlins present below the ceiling have depths d_p and are spaced w_p distance apart. The girder depth is d_g , which is fixed at 610 mm (24 in.), and girder separation distance is w_g . The depth, d_g , is measured from the bottom of the purlins since in industrial facilities girders are mostly installed below the purlins.

Figure 1-4: Drawings (not to scale) showing a 3-tier-high rack storage array as a fire source, the clearance height above the top of the array (h) and the ceiling height (H) from the floor: (a) front view showing purlins of depth d_p , spaced w_p width apart, and (b) elevation view showing girders below the purlins, of depth d_g , spaced w_g width apart.

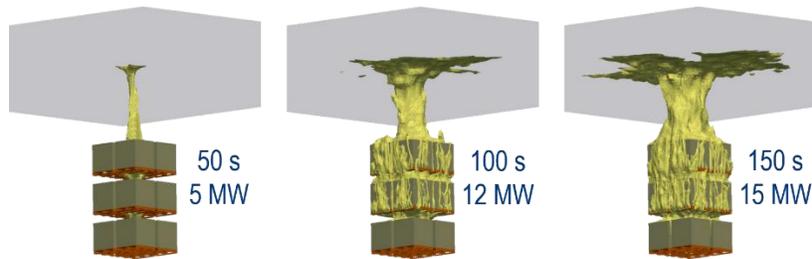
stoichiometric mixture fraction isocontour, is shown impinging on a horizontal ceiling. The fire chemical HRR reaches ~17 MW at 100 s and the peak HRR is ~25 MW at 150 s, as shown in Figure 2-3. Correspondingly, the convective HRR at 100 s is ~12 MW and its peak value is ~15 MW at 150 s. The radiant fraction, also shown in Figure 2-3, varies with time, beginning with a 0.5 value for the igniter, then reducing to ~0.22 for corrugated burning and finally approaching ~0.35 with increased burning of the polystyrene cups inside the cartons.

Figure 2-2: Fire growth over the CUP rack-storage array. Flames are impinging on a horizontal ceiling with no obstructed ceiling construction present.

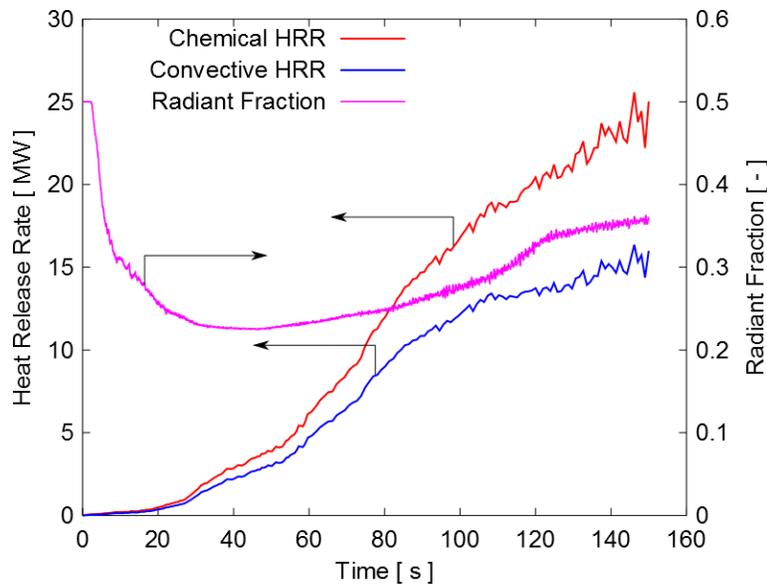
Figure 2-3: Modeled HRR (chemical and convective) and radiant fraction variation as a function of time for the 2 x 2 x 3 array of CUP commodity.

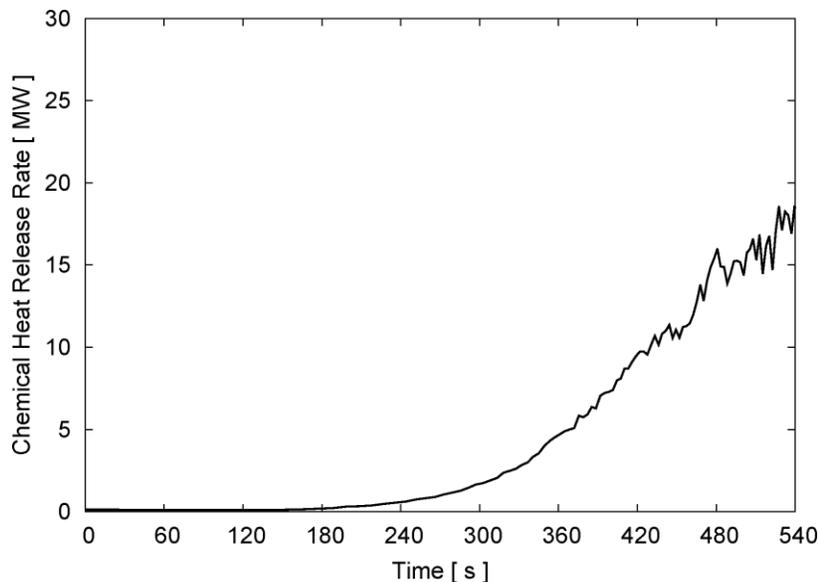
A fire growth model was not available for the UUP commodity. Therefore, a prescribed fuel mass loss rate (MLR) was imposed on a 2.4 m x 2.4 m (8 ft x 8 ft) inlet on the ground level. The MLR data were obtained from a free-burn test conducted with two pallet loads of UUP commodity under the 20 MW fire products collector (FPC) at the FM Global Research Campus. The resulting chemical HRR computed in the simulations is shown in Figure 2-4. A constant radiant fraction of 0.46 was used in the simulations. The maximum convective HRR at 540 s was ~9 MW.

Figure 2-4: Prescribed model chemical HRR as a function of time for the UUP commodity.

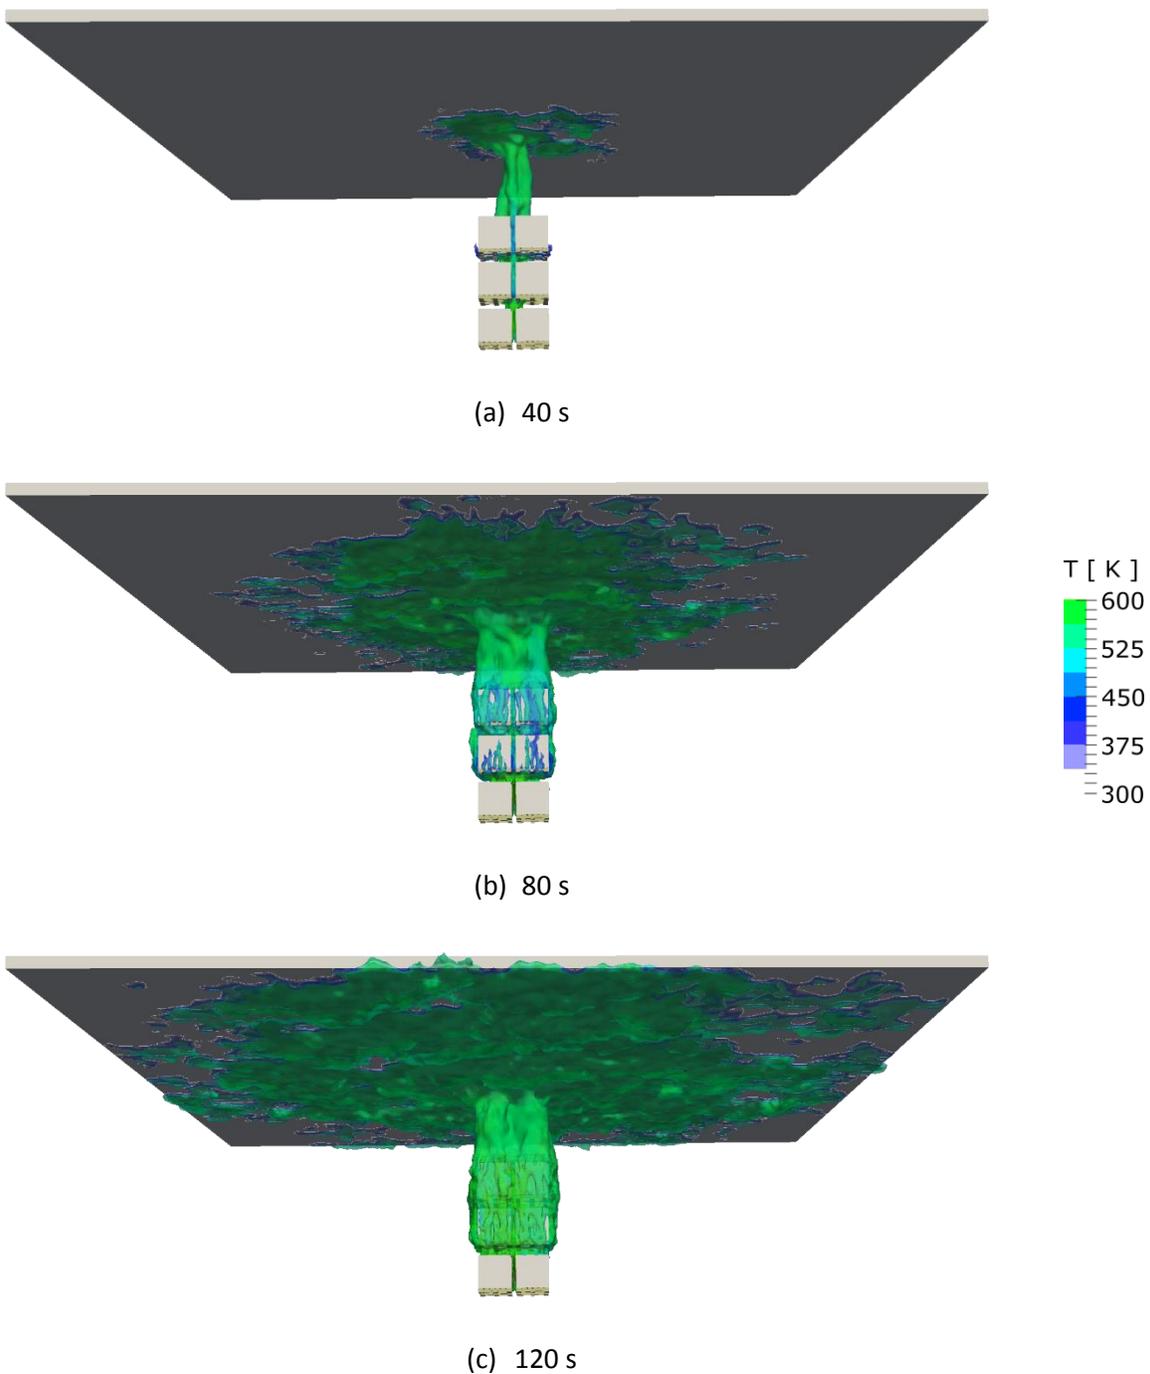
Figure 3-1: Ceiling jet depicted by CO₂ contours ($Y_{CO_2} = 0.02-0.04$) shown under a ceiling located 3.0 m (10 ft) above the CUP rack-storage array. The ceiling does not have any obstructed construction in the form of girders or purlins.

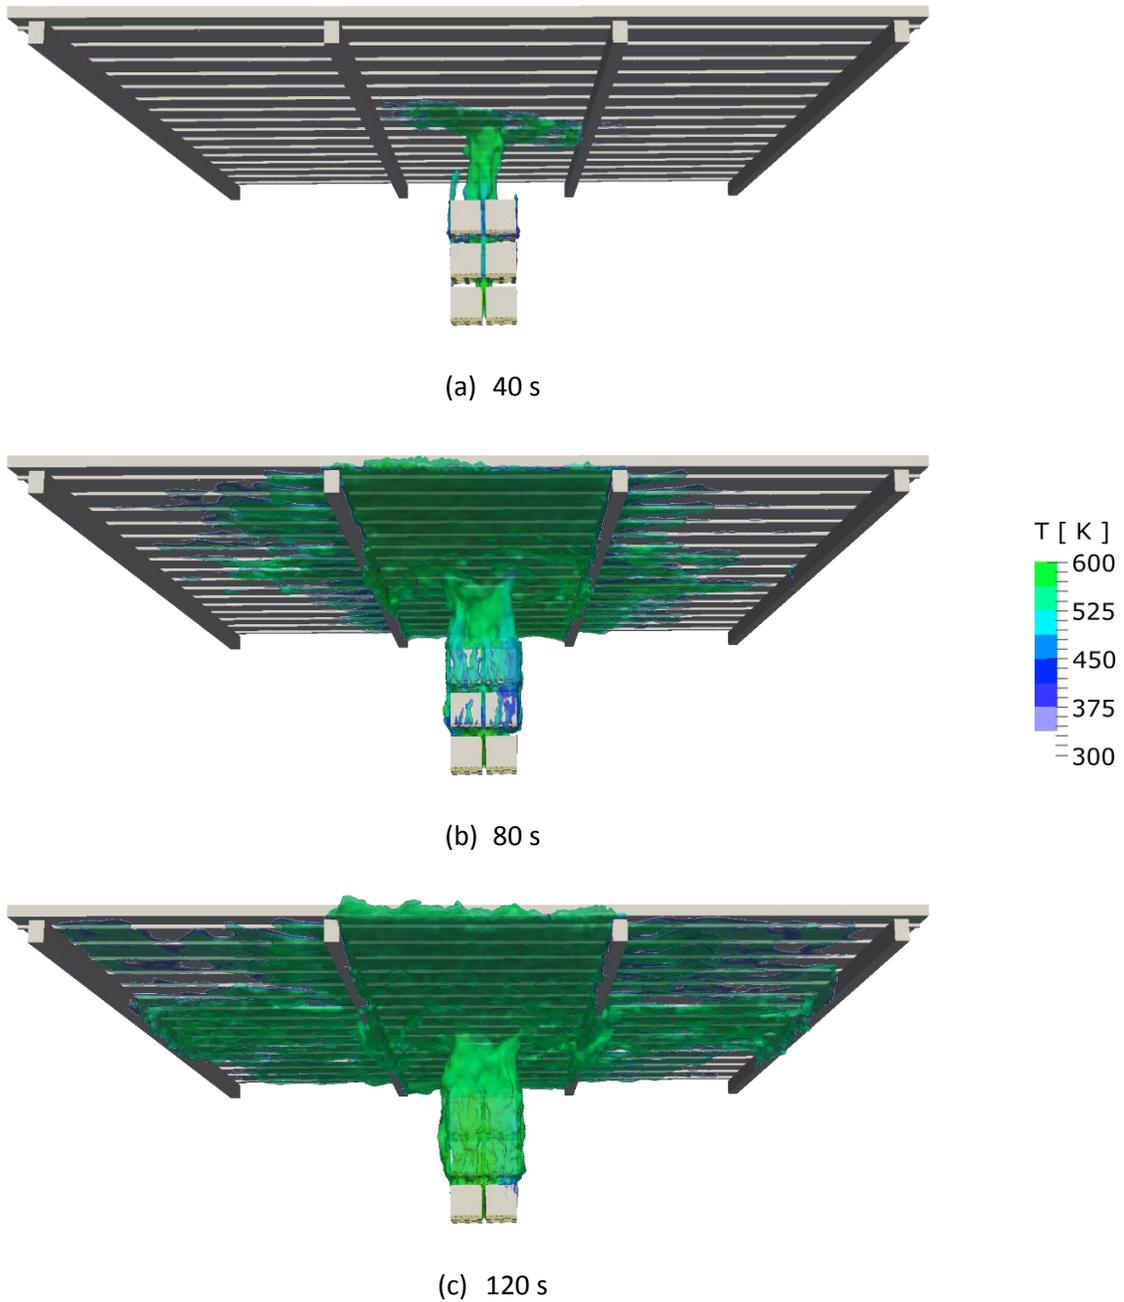
Figure 3-2: Ceiling jet depicted by CO_2 contours ($Y_{\text{CO}_2} = 0.02-0.04$) under a ceiling located 3.0 m (10 ft) above the CUP rack-storage array. The ceiling has 100 mm (4 in.) deep purlins separated by 1.5 m (5 ft) and 610 mm (24 in.) deep girders separated by 7.6 m (25 ft).

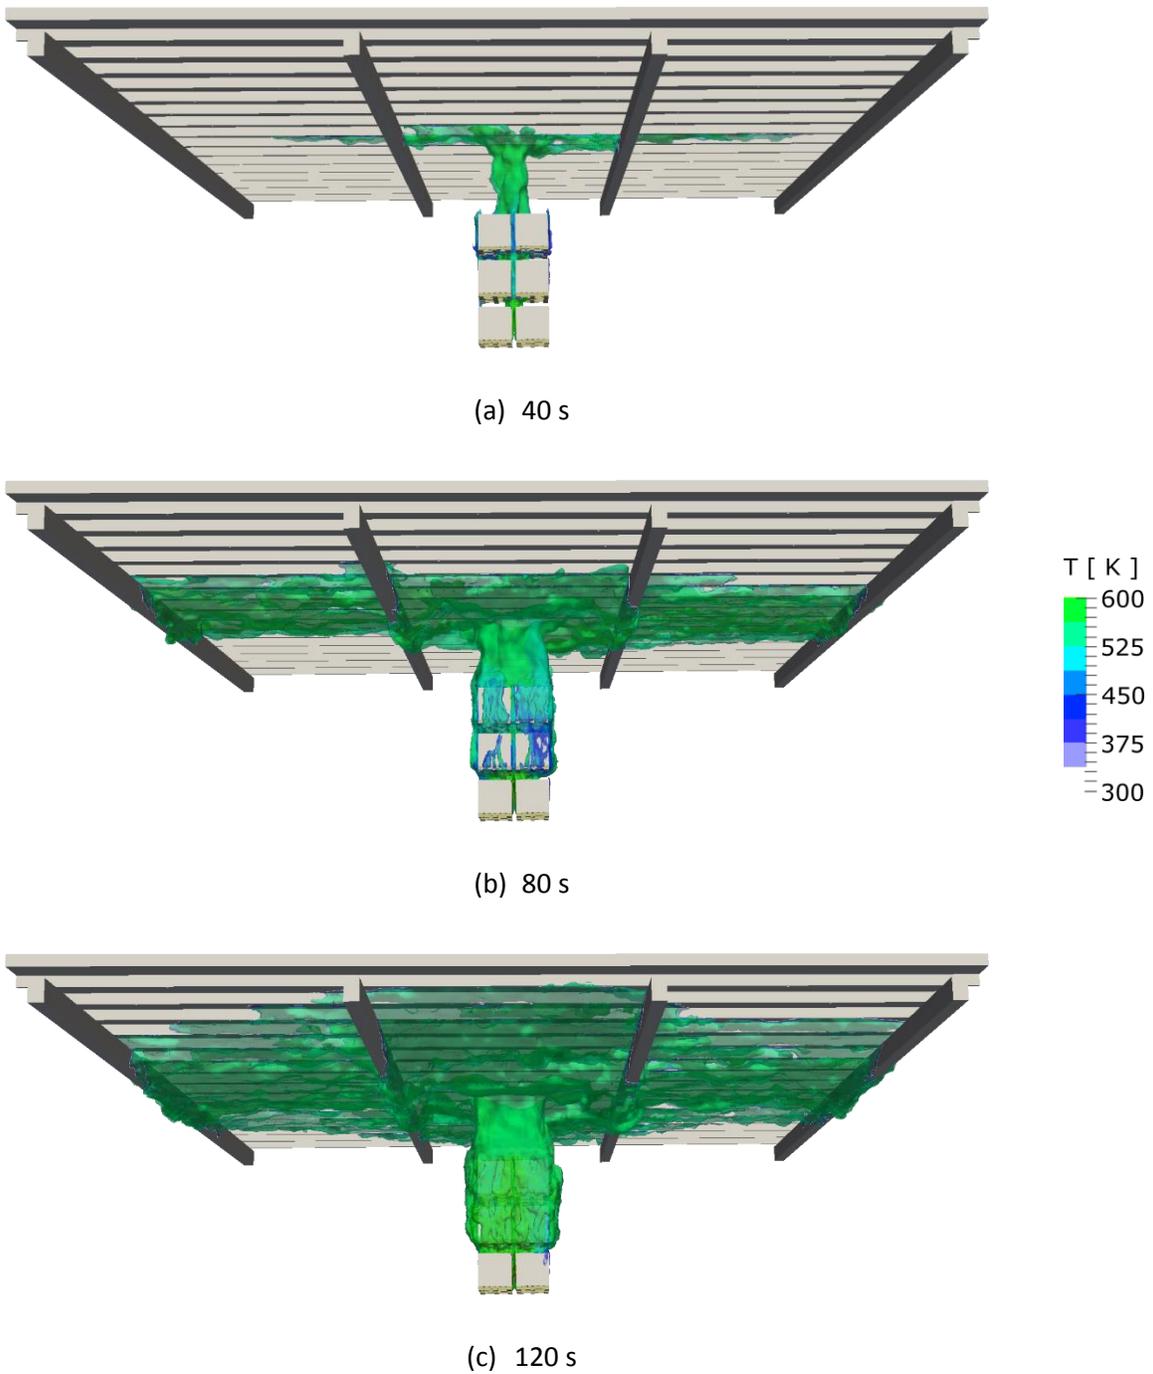
Figure 3-3: Ceiling jet depicted by CO₂ contours ($Y_{CO_2} = 0.02-0.04$) under a ceiling located 3.0 m (10 ft) above the CUP rack-storage array. The ceiling has 300 mm (12 in.) deep purlins separated by 1.5 m (5 ft) and 610 mm (24 in.) deep girders separated by 7.6 m (25 ft).

For a purlin depth of 300 mm (12 in.), the flow at 40 s develops in the purlin channels between the two central girders, as can be seen in Figure 3-3. At 120 s, the ceiling jet develops perpendicular to the purlin channels, but significant flow along the purlin channels can also be observed. Doubling the purlin depth to 610 mm (24 in.) shows that the purlins create deep channels and the core flow region remains confined in the central channels (see Figure 3-4).

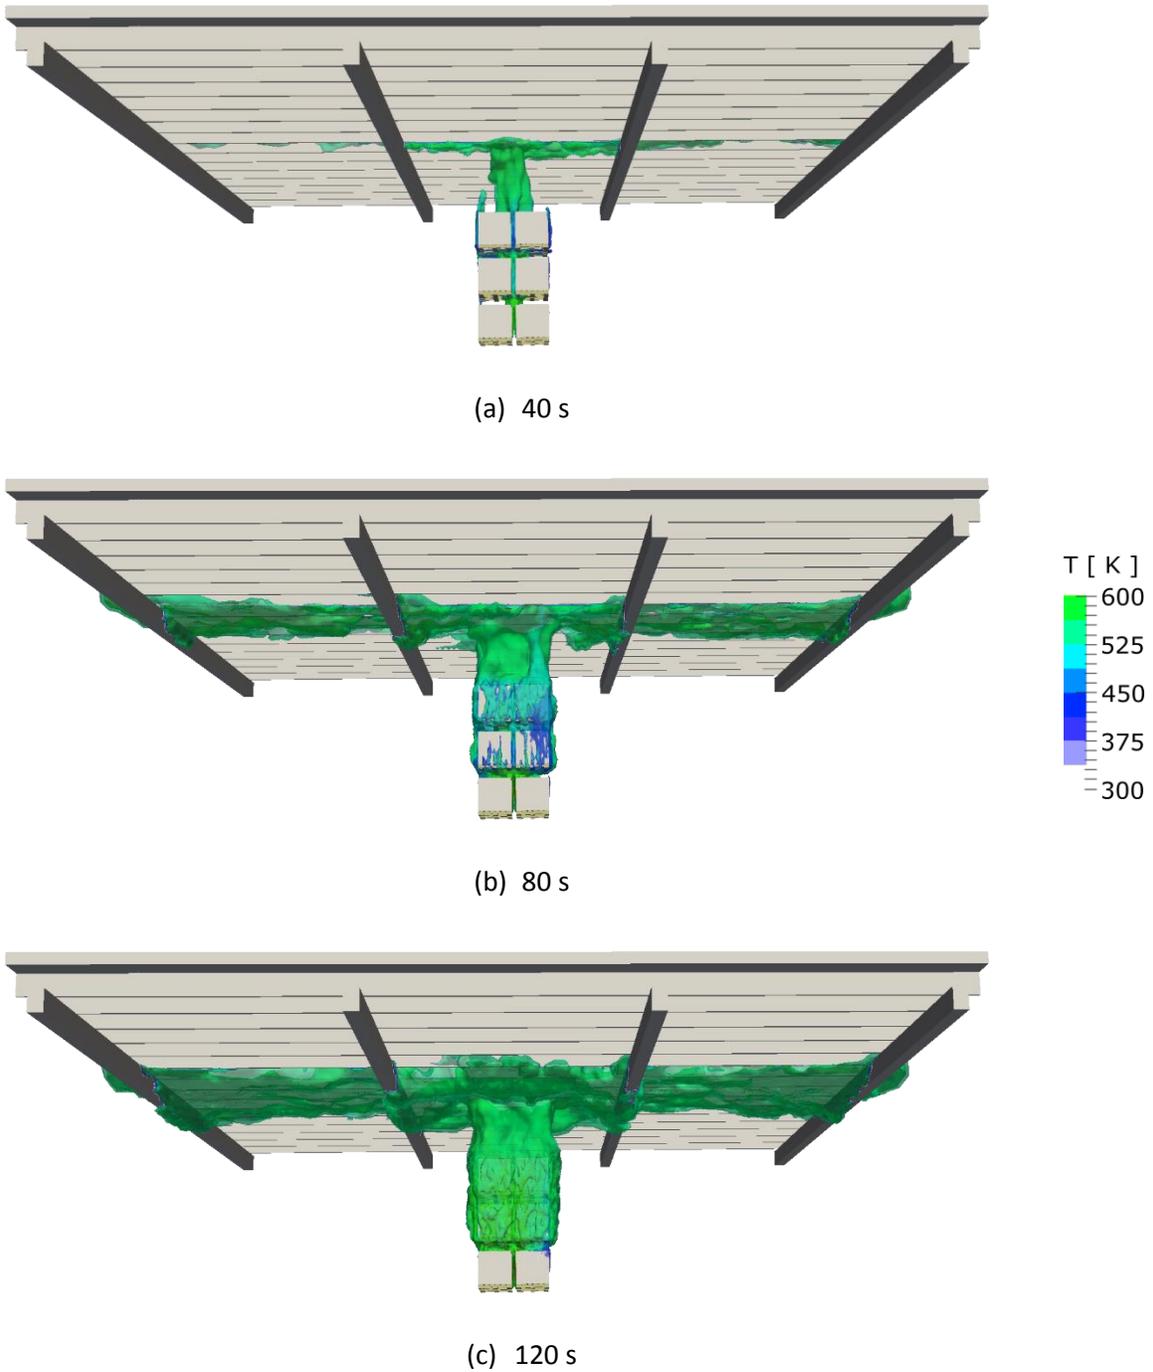
Figure 3-4: Ceiling jet depicted by CO_2 contours ($Y_{\text{CO}_2} = 0.02-0.04$) under a ceiling located 3.0 m (10 ft) above the CUP rack-storage array. The ceiling has 610 mm (24 in.) deep purlins separated by 1.5 m (5 ft) and 610 mm (24 in.) deep girders separated by 7.6 m (25 ft).

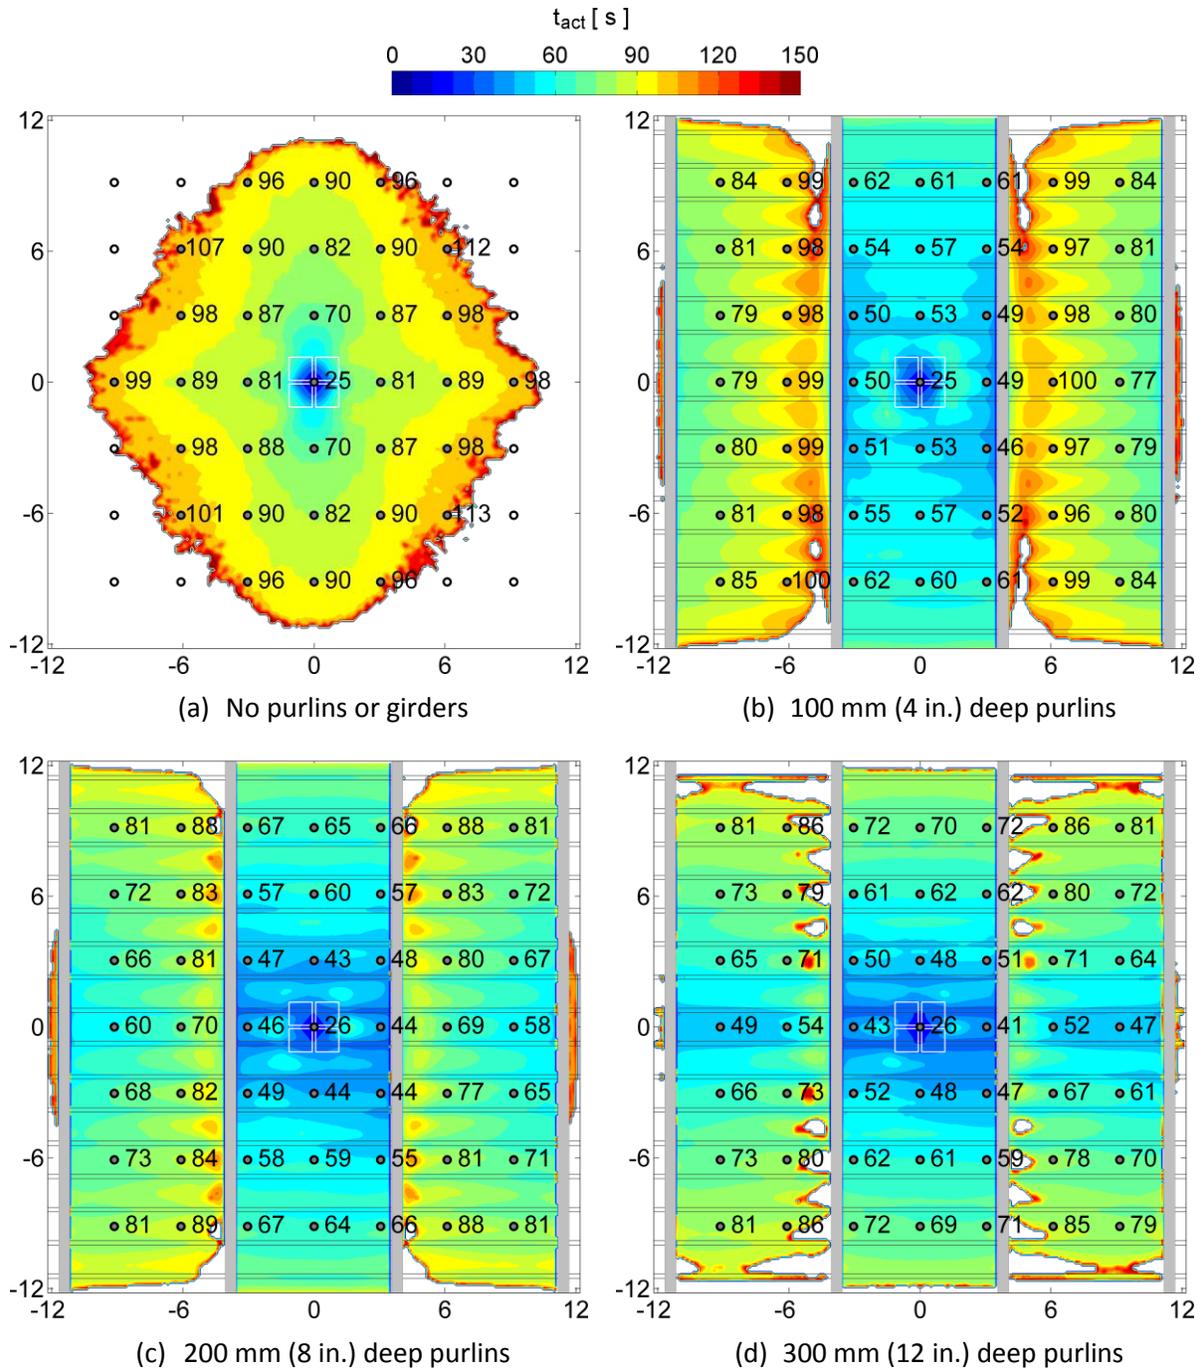
Figure 3-5: Activation time contours for QR/OT sprinkler links at 430 mm (17 in.) below a ceiling located 3.0 m (10 ft) above the CUP rack-storage array in (a) the absence of obstructed ceiling construction, and in the presence of 610 mm (24 in.) deep girders separated by 7.6 m (25 ft) and purlins with a separation distance of 1.5 m (5 ft) and depths of (b) 100 mm (4 in.), (c) 200 mm (8 in.), and (d) 300 mm (12 in.). Discrete locations of sprinkler links arranged in a 3.0 m × 3.0 m (10 ft × 10 ft) spacing with one sprinkler centered on the CUP array are also shown with the corresponding activation times.

As can be observed in Figure 3-5(c), when doubling the purlin depth to 200 mm (8 in.), the first ring sprinkler average activation time decreases by ~4 s (from ~50 s for the 100 mm or 4 in. deep purlins to ~46 s for the 200 mm or 8 in. deep purlins, as shown in Table 3-1). The open area between the girder and the ceiling doubles for the 200 mm (8 in.) purlins. Flow escapes through this area to the outside of the central girder region causing earlier activations to occur in the purlin channels.

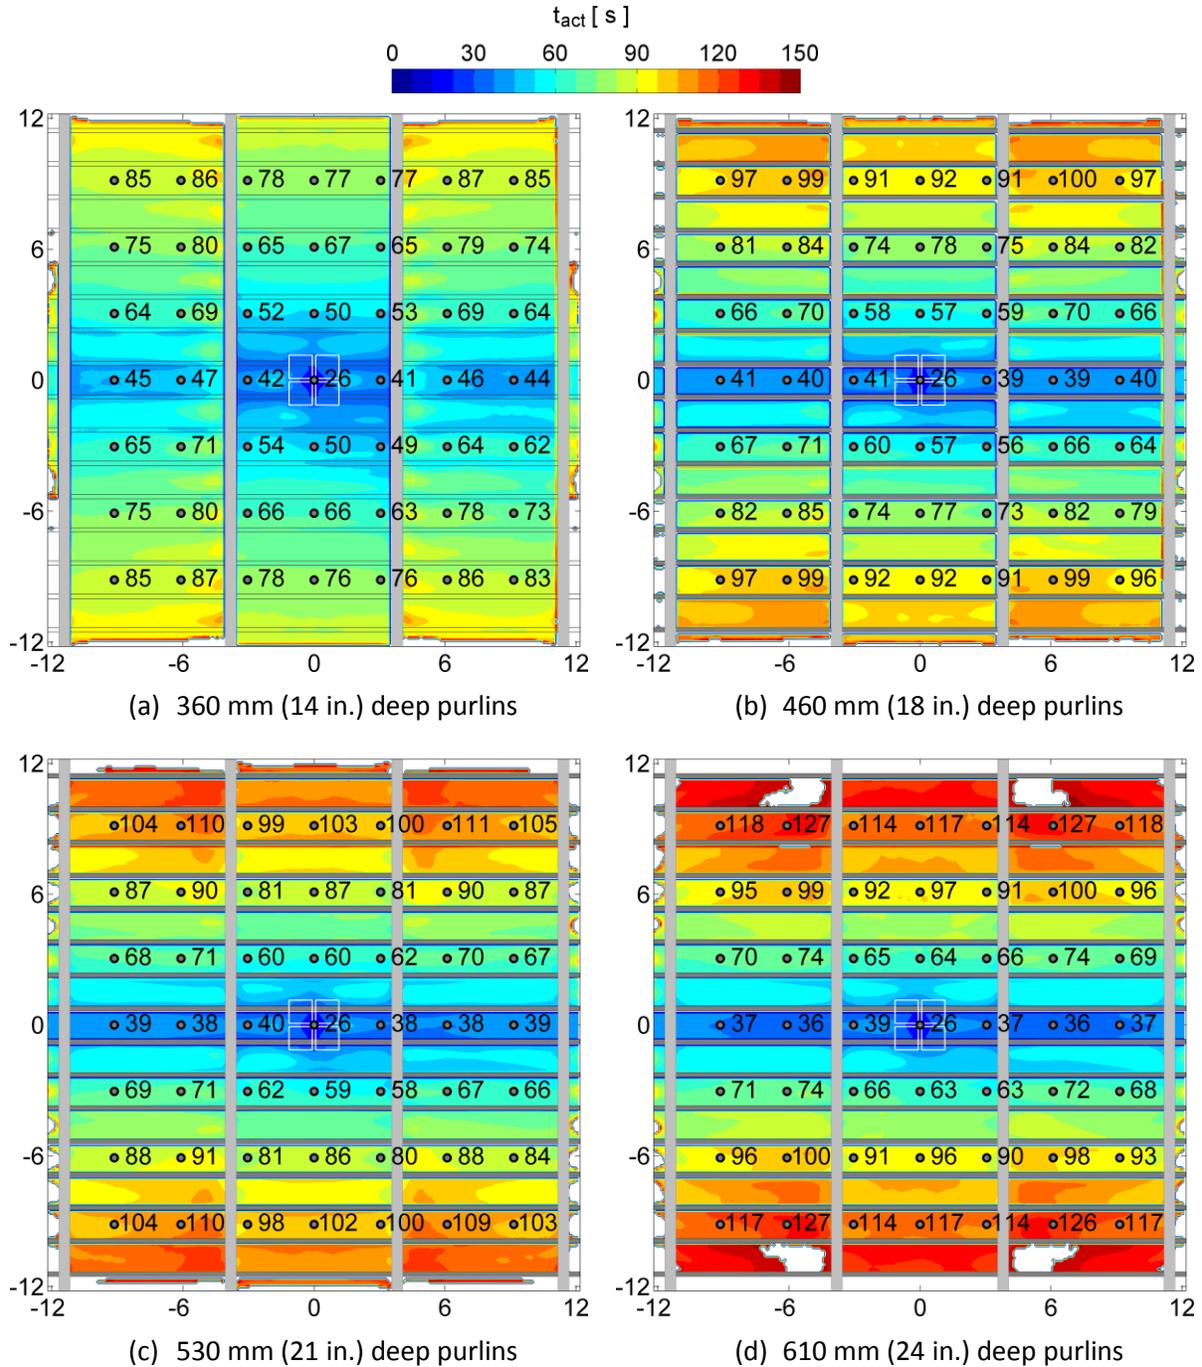
Figure 3-6: Activation time contours for QR/OT sprinkler links at 430 mm (17 in.) below a ceiling located 3.0 m (10 ft) above the CUP rack-storage array in the presence of 610 mm (24 in.) deep girders separated by 7.6 m (25 ft) and purlins with a separation distance of 1.5 m (5 ft) and depths of (a) 360 mm (14 in.), (b) 460 mm (18 in.), (c) 530 mm (21 in.), and (d) 610 mm (24 in.).

The activation times for deeper purlins, of a depth of 360–610 mm (14–24 in.), are shown in Figure 3-6. The average activation times for the first ring sprinklers are still significantly earlier compared to the case without obstructed ceiling construction. The initial decrease in the first ring average activation time (for purlin depths of 100–300 mm or 4–12 in.) and subsequent increase (for purlin depths ≥360 mm or 14 in.) indicates that the presence of purlins and girders can cause earlier sprinkler activations as discussed above. It should also be noted, as mentioned above, that the skewed activation pattern along the central purlin channel is of greater concern for purlin depths >300 mm (12 in.). The channeling effect for purlin depths ≤300 mm (12 in.) does not cause significant bias in the activation pattern, as can be observed in Table 3-1: the average activation time for the two central channel sprinklers remains almost identical to the average activation time for the rest of the six first ring sprinklers for purlin depths ≤300 mm (12 in.). For a purlin depth of 300 mm (12 in.), on average the two central channel sprinklers activate only ~9 s earlier than the remaining six first ring sprinklers. For purlin depths >300 mm (12 in.), the activation time difference between the central channel and the outer channel sprinklers increases significantly.

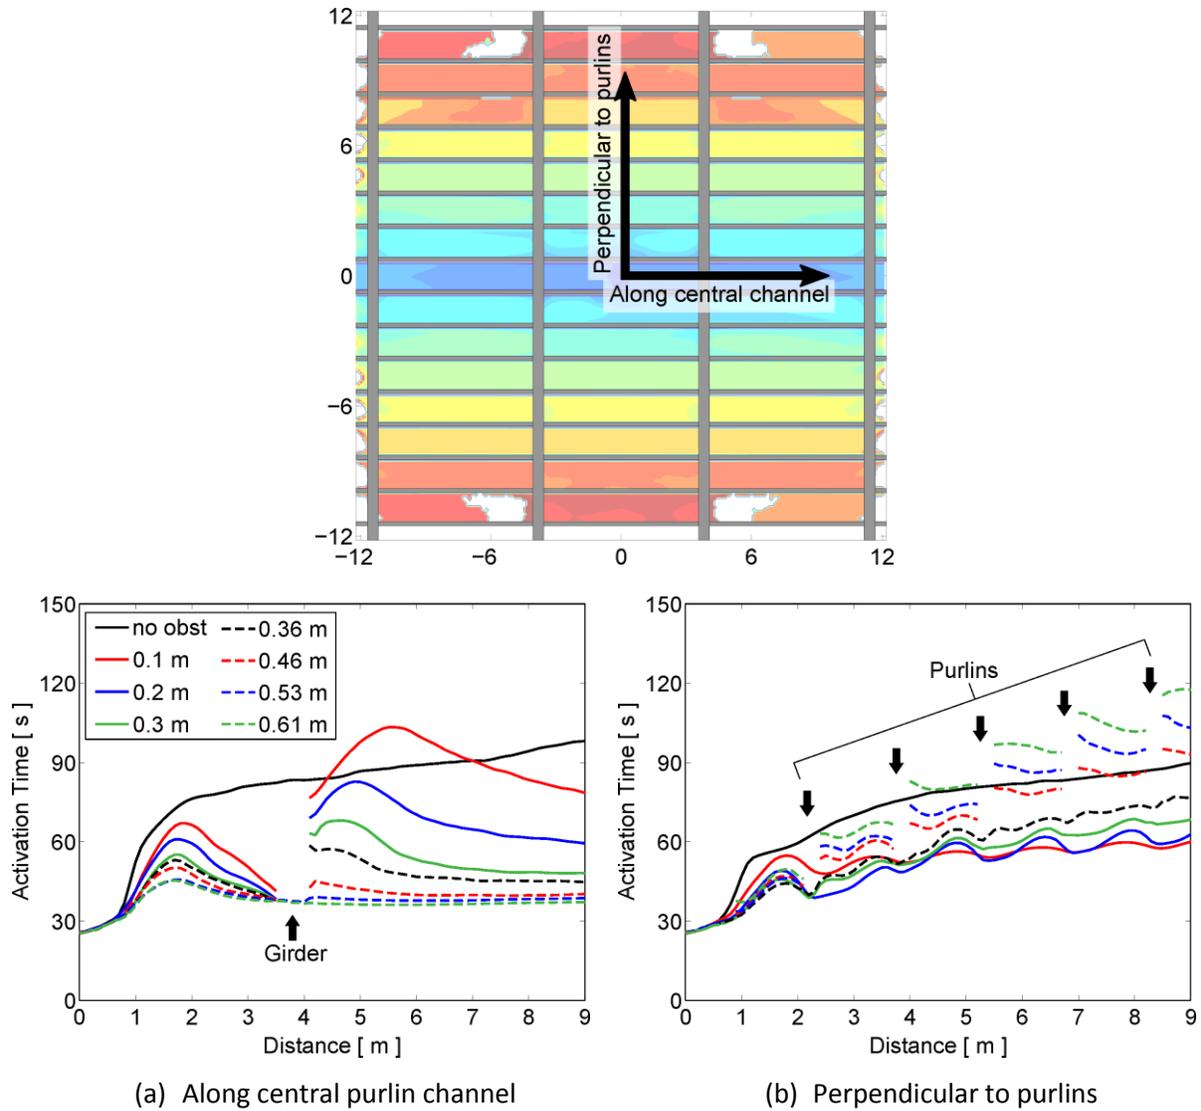
Figure 3-7: QR/OT sprinkler activation times at 430 mm (17 in.) below a ceiling located 3.0 m (10 ft) above the CUP rack-storage array as a function of purlin depth along (a) central purlins channel, and (b) in a perpendicular to the purlin direction. Purlins are separated by 1.5 m (5 ft) and girders by 7.6 m (25 ft).

The activation times probed along the two directions are plotted in Figure 3-7(a-b). In the absence of obstructed ceiling construction, the change of activation times in both directions shows a similar trend as indicated by the solid black curves (the small differences in the activation times are caused by non-symmetric fire growth due to the included two-way wood pallet design as discussed in Section 2.3.2 in Ref. [17]). In the presence of the purlins and girders, the activation times for distances ≤ 0.76 m (2.5 ft), i.e., in the plume impingement region, remain similar irrespective of the purlin depth. The presence of purlins and girders causes earlier activation times for distances >0.76 m (2.5 ft) and <3.0 m (10 ft). Along the central channel, the activation times initially increase (up to ~1.8 m or 6 ft) and then decrease as the hot ceiling jet gases tend to accumulate near the girder at 3.8 m (12.5 ft) from the ceiling mid-point causing earlier sprinkler activations. For deeper purlins (≥ 530 mm or 21 in.), activations along the central channel beyond the girder occur almost simultaneously. The activation times in the direction perpendicular to the purlins remain almost similar for purlin depths ≤ 360 mm (14 in.). For deeper purlins, the activation time delay increases with distance. A key observation from Figure 3-7 is that activation times in both directions remain similar up to a distance of ~1.8 m or 6 ft (typical maximum distance between the plume impingement location and the closest sprinkler found in warehouses). This is especially true for purlins with a depth ≥ 300 mm (12 in.). It should be emphasized that the presence of purlins and girders favorably affects sprinkler activation times: up to a distance of ~4 m (13 ft) activation times are earlier compared to when obstructed ceiling construction is absent.

For deeper purlins (depth >460 mm or 18 in.), as observed in Figure 3-7, due to the significant channeling of flow many simultaneous sprinkler activations could occur when the sprinkler links are located 430 mm (17 in.) below the ceiling. To evaluate the effect of the link distance, activation patterns and times are presented for links present at two planes: aligned with the bottom of the purlins and 150 mm (6 in.) below the bottom edge of the purlins. Activation time contours for two purlin depths, 530 mm (21 in.) and 610 mm (24 in.), are presented in Figure 3-8.

To evaluate the issue of water demand being exceeded due to an excessive number of activations in the purlin channels, as shown above in Figure 3-7, activation times along the central channel and perpendicular to the purlins are again compared. Figure 3-9 shows the activation time variation along the two directions. For distances ≤ 1.8 m (6 ft), the activation time variation with distance in the two directions remains almost identical when the sprinkler links are located on a plane passing through the bottom of the purlins. It can be concluded from this analysis that the sprinkler links can be lowered from the 430 mm (17 in.) depth to align them with a plane passing through the bottom of the purlins without significant effect on the activation times. This assessment is based on the convective HRR increase observed in the modeled 3-tier-high CUP fire applied in the current study. Also, compared to the unobstructed ceiling first ring average activation time, aligning the sprinkler links with the bottom of the purlins causes earlier average activation times. Lowering of the sprinklers beyond their maximum allowable vertical distance below the ceiling may become necessary to ensure spray impingement does not take place onto the deeper purlins.

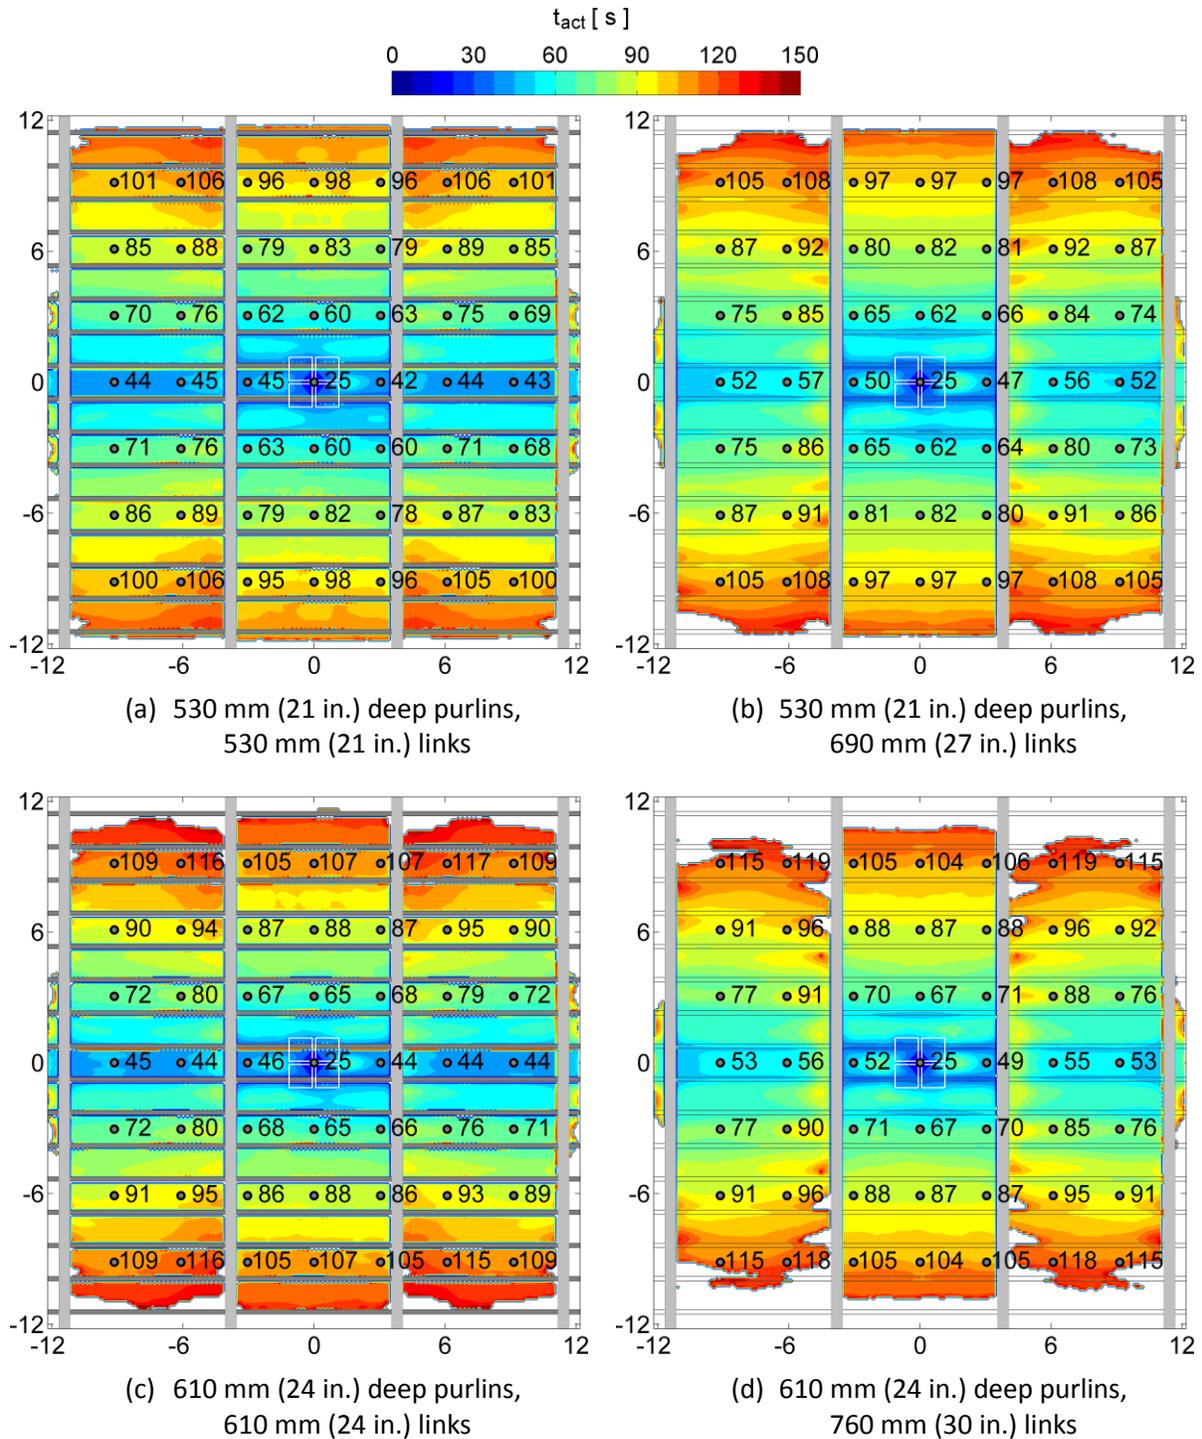
Figure 3-8: Activation time contours for QR/OT sprinkler links below a ceiling located 3.0 m (10 ft) above the CUP rack-storage array in the presence of 610 mm (24 in.) deep girders separated by 7.6 m (25 ft) and purlins with a separation distance of 1.5 m (5 ft) with a purlin depth of 530 mm (21 in.), sprinkler links at (a) 530 mm (21 in.), and (b) 690 mm (27 in.) below the ceiling, and with a purlin depth of 610 mm (24 in.), sprinkler links at (c) 610 mm (24 in.), and (d) 760 mm (30 in.) below the ceiling.

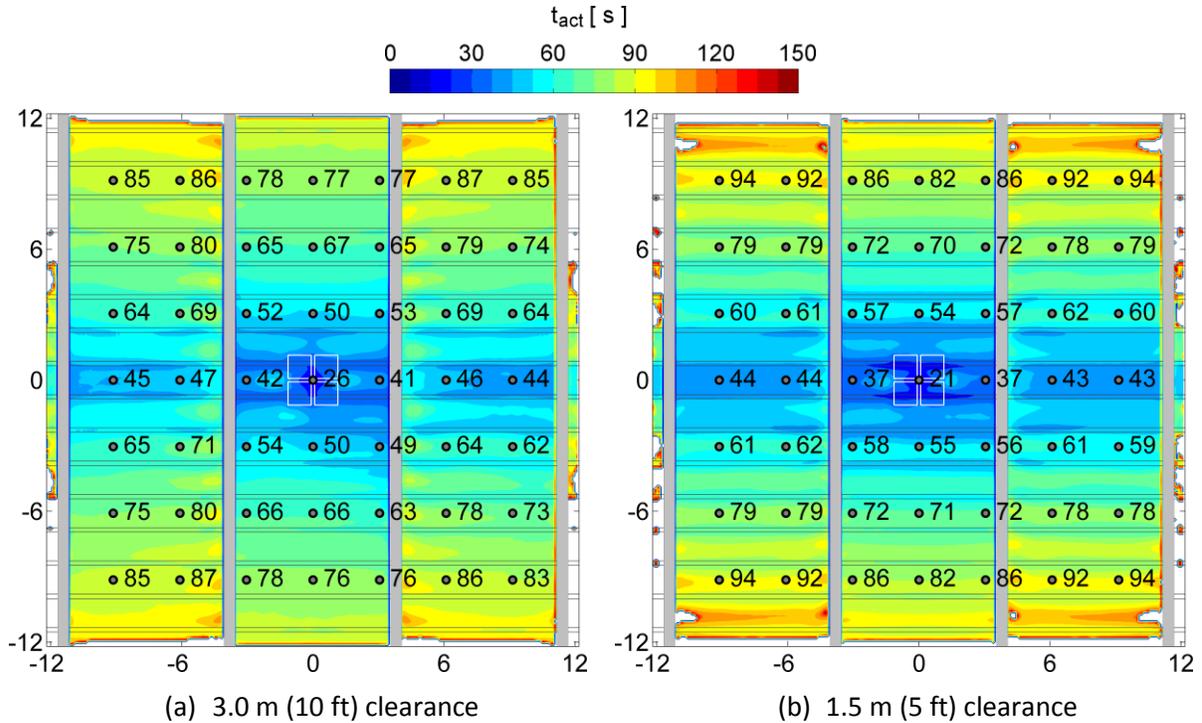
Figure 3-10: Activation time contours for QR/OT sprinkler links in the presence of 610 mm (24 in.) deep girders separated by 7.6 m (25 ft), purlins with a separation distance of 1.5 m (5 ft) and a depth of 360 mm (14 in.), and sprinkler links 430 mm (17 in.) below the ceiling with a ceiling clearance of (a) 3.0 m (10 ft), and (b) 1.5 m (5 ft).

The effect of ceiling clearance on the activation times and patterns is next evaluated. The ceiling clearance is halved from 3.0 m (10 ft) to 1.5 m (5 ft). Figure 3-10(a) shows the activation pattern and times for the case with a ceiling clearance of 3.0 m (10 ft) and Figure 3-10(b) is when the ceiling clearance is 1.5 m (5 ft). Comparisons are shown for purlin depth and separation distances of 360 mm (14 in.) and 1.5 m (5 ft), respectively. The average time of activation for the first ring sprinklers is found to increase marginally by ~2 s compared to when the ceiling clearance was 3.0 m (10 ft). This could be attributed to the greater channeling effect observed in the three central purlin channels (the central channel and the two on its sides) for the 1.5 m (5 ft) ceiling clearance. The greater channeling of the ceiling jet occurs due to the smaller plume width at the impingement region. The smaller plume width results from reduced entrainment rate for the shorter distance the plume travels (1.5 m or 5 ft instead of 3.0 m or 10 ft) and the higher plume temperatures encountered at the ceiling level. The smaller plume width and higher temperatures result in the development of a narrower ceiling jet. Even though the maximum activation delay along the central channel for the 3.0 m (10 ft) case is ~10 s for distances ≤ 1.8 m (6 ft), as seen in Figure 3-11, the average activation time difference perpendicular to the purlins remains within ~3–4 s. In summary, for lower ceiling clearance, a greater channeling effect is observed, and lower ceiling clearance can therefore be viewed as a worst-case scenario when obstructed ceiling construction is present.

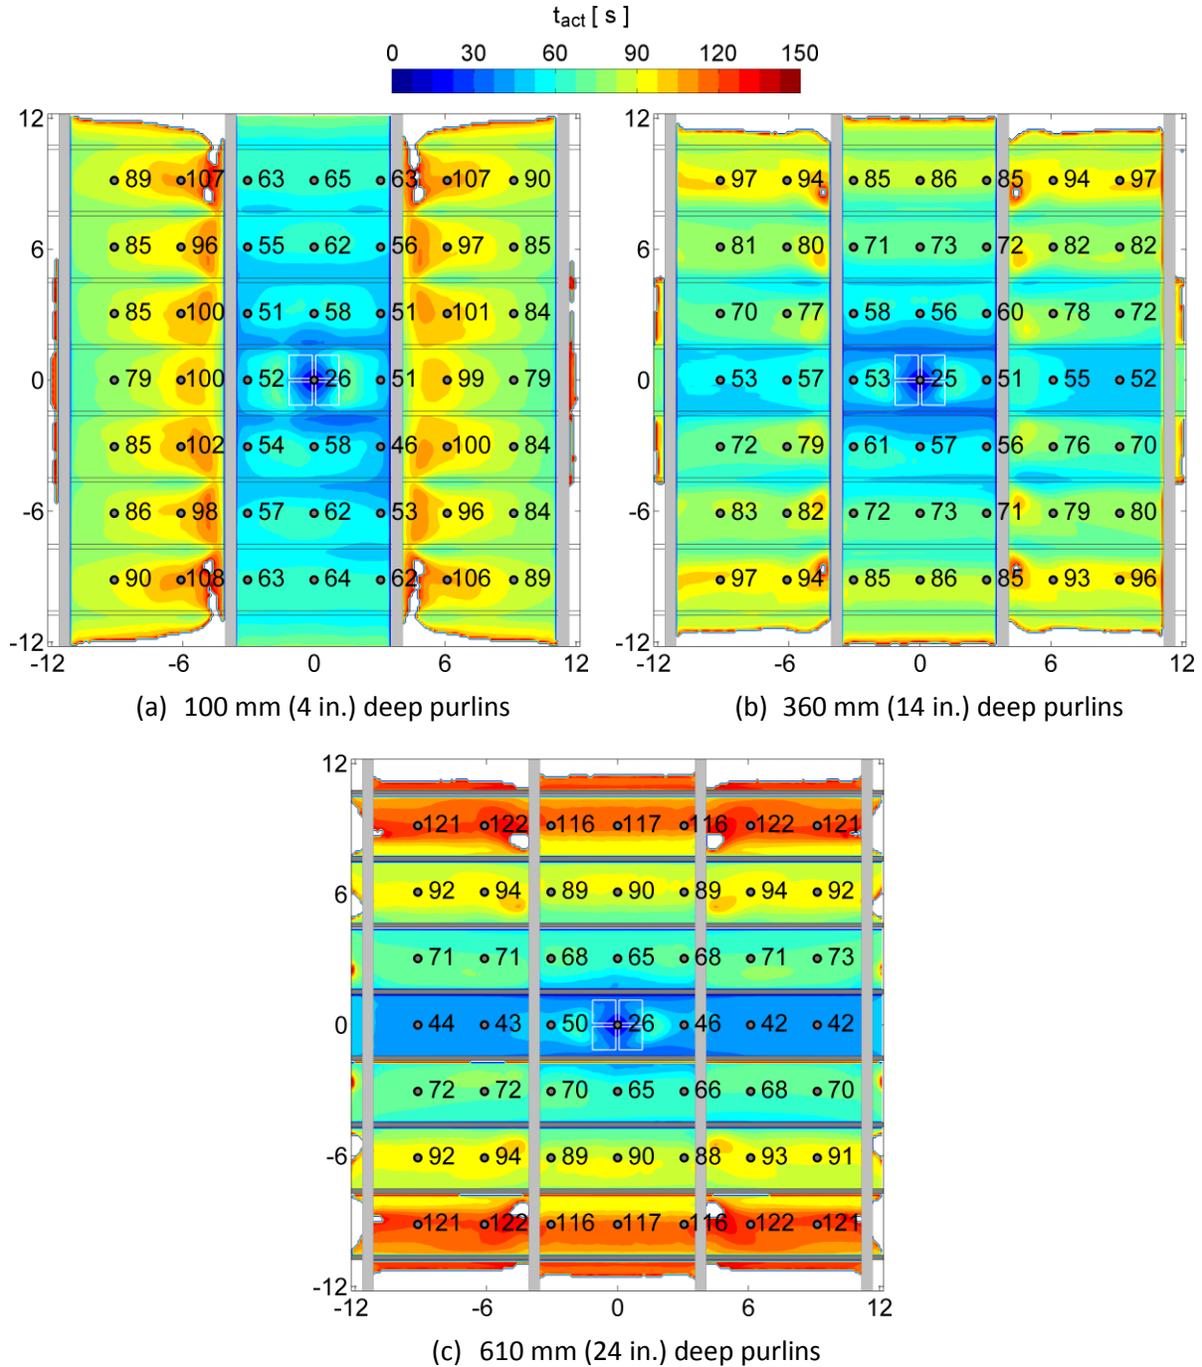
Figure 3-12: Activation time contours for QR/OT sprinkler links below a ceiling located 3.0 m (10 ft) above the CUP rack-storage array in the presence of 610 mm (24 in.) deep girders separated by 7.6 m (25 ft) and purlins with a separation distance of 3.0 m (10 ft) and a depth of (a) 100 mm (4 in.), (b) 360 mm (14 in.), and (c) 610 mm (24 in.). Sprinkler links are 430 mm (17 in) below the ceiling.
