RESEARCH TECHNICAL REPORT
*Sprinkler Performance under
Non-Sloped Obstructed
Ceiling Construction*

Prateep Chatterjee

FM Global

December 2018

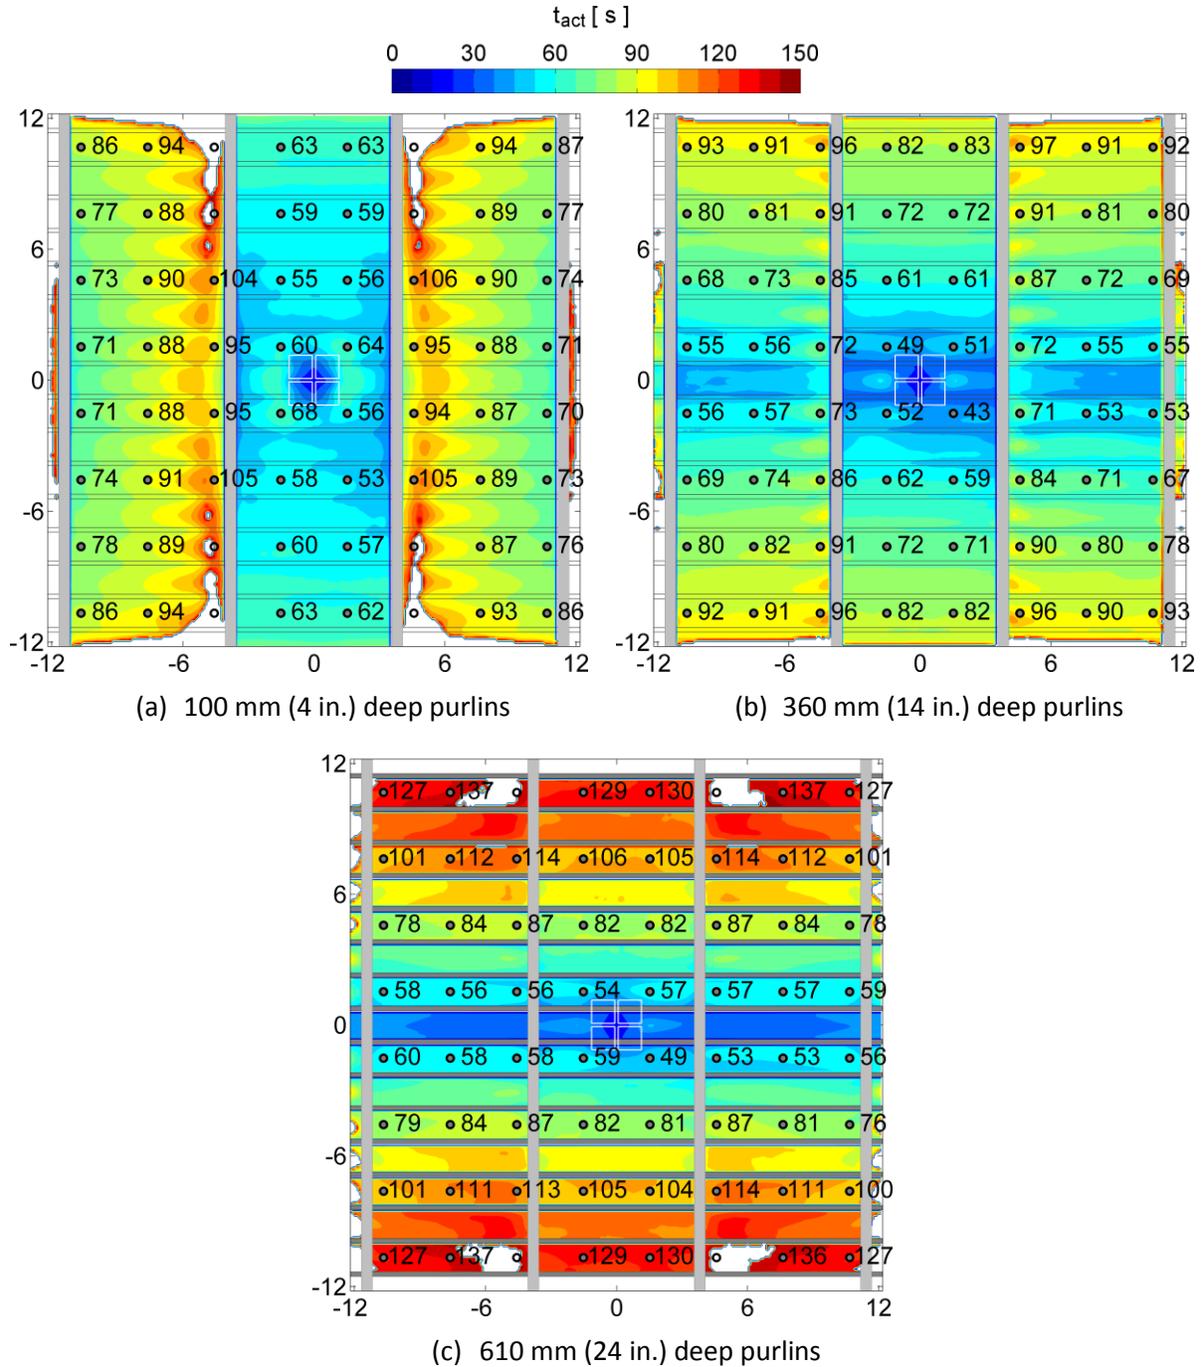
Figure 3-16: Activation time contours for QR/OT sprinkler links below a ceiling located 3.0 m (10 ft) above the CUP rack-storage array in the presence of 610 mm (24 in.) deep girders separated by 7.6 m (25 ft) and purlins with a separation distance of 1.5 m (5 ft) and a depth of (a) 300 mm (12 in.), (b) 460 mm (18 in.), and (c) 610 mm (24 in.). Sprinkler links are 430 mm (17 in.) below the ceiling. Discrete sprinkler locations correspond to an offset sprinkler arrangement with 3.0 m \times 3.0 m (10 ft \times 10 ft) spacing.

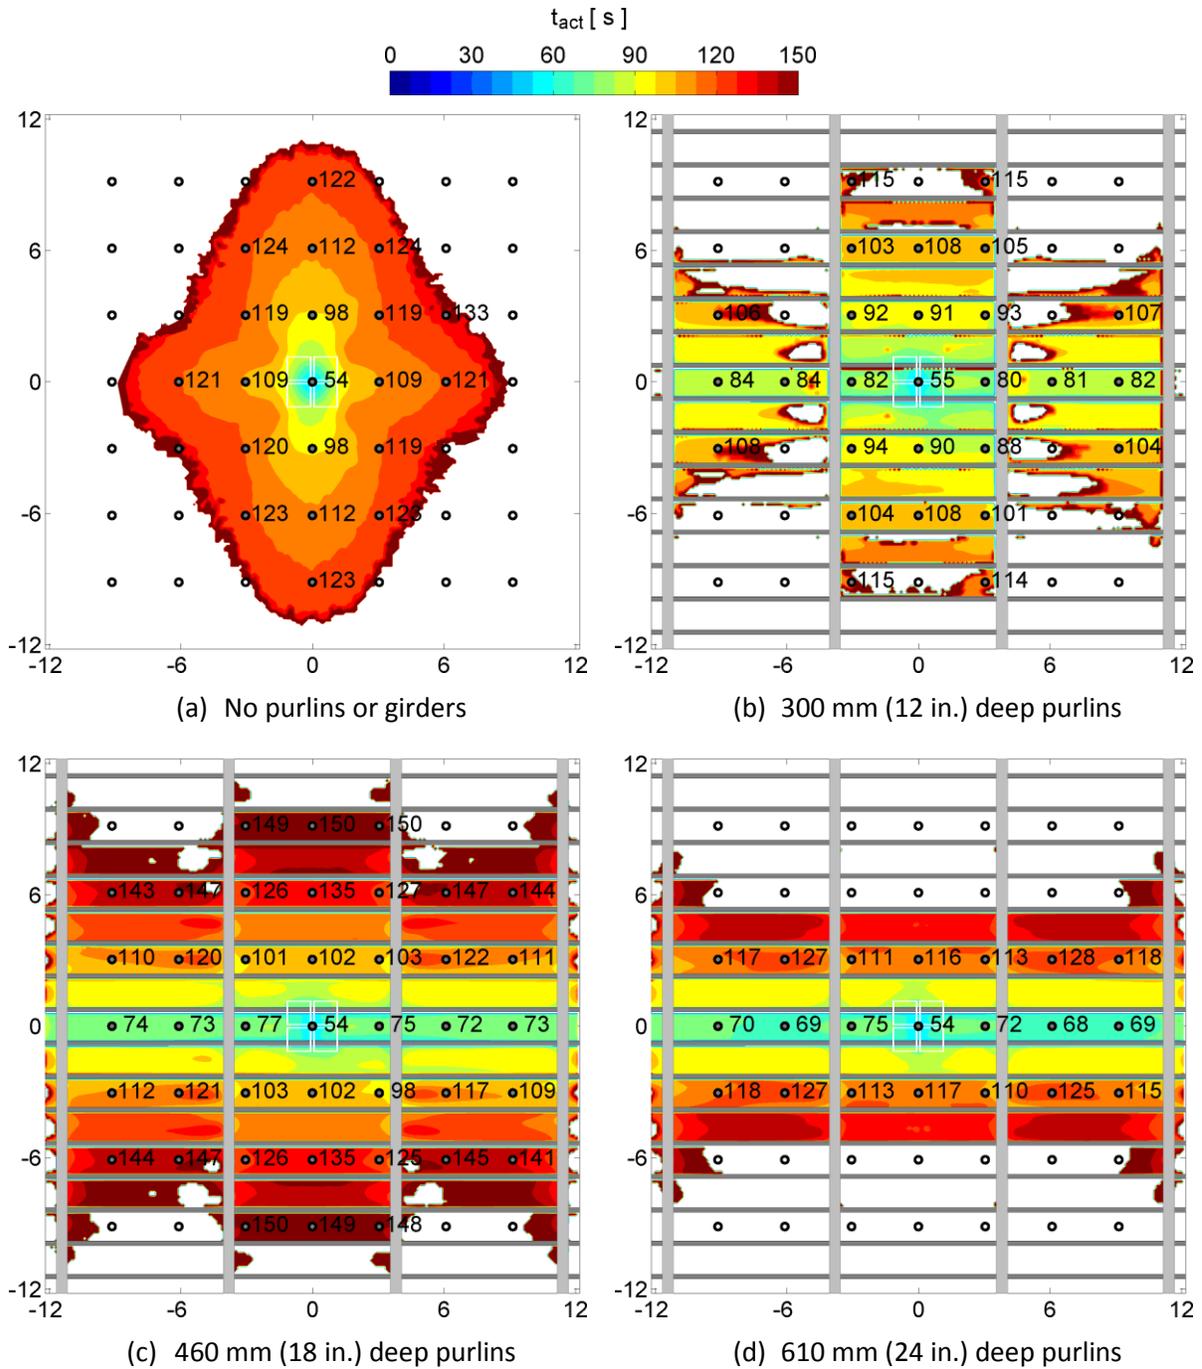
Figure 3-17: Activation time contours for SR/HT sprinkler links at 330 mm (13 in.) below a ceiling located 3.0 m (10 ft) above the CUP rack-storage array in (a) the absence of obstructed ceiling construction, and in the presence of 610 mm (24 in.) deep girders separated by 7.6 m (25 ft) and purlins with a separation distance of 1.5 m (5 ft) and a depth of (b) 300 mm (12 in.), (c) 460 mm (18 in.), and (d) 610 mm (24 in.).

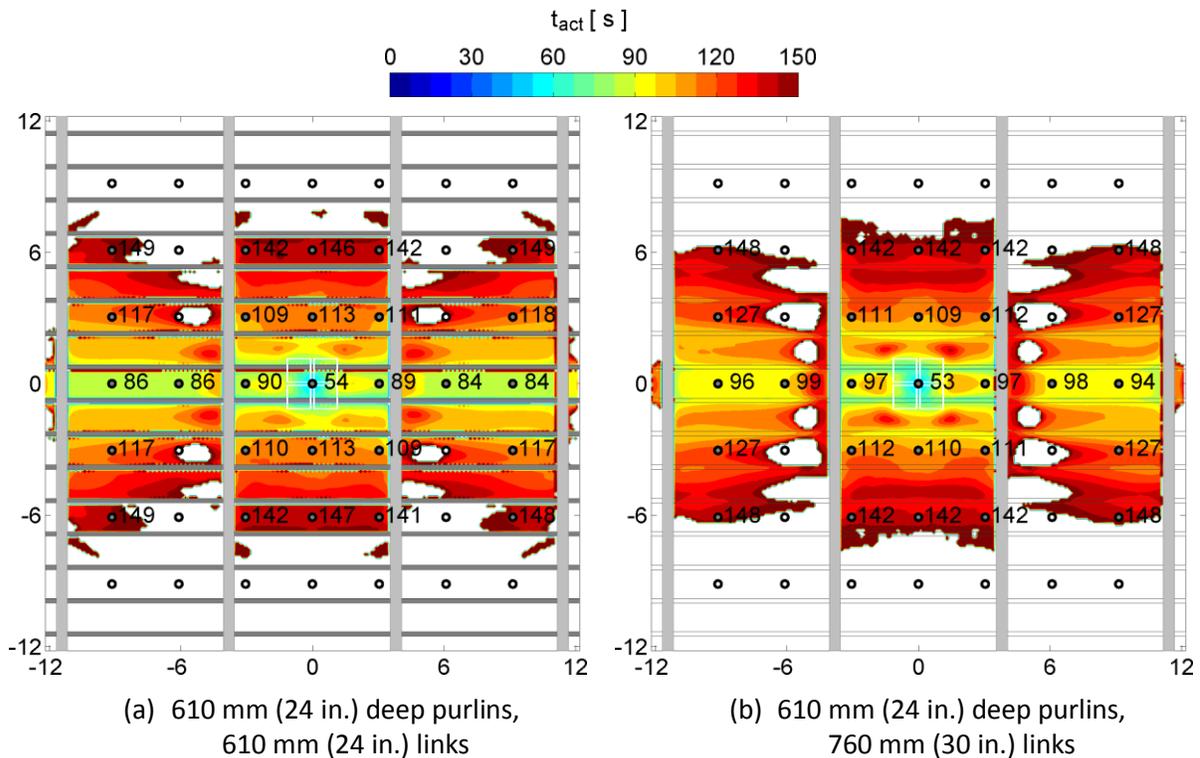
Figure 3-18: Activation time contours for SR/HT sprinkler links below a ceiling located 3.0 m (10 ft) above the CUP rack-storage array in the presence of 610 mm (24 in.) deep girders separated by 7.6 m (25 ft) and purlins with a separation distance of 1.5 m (5 ft) with a purlin depth of 610 mm (24 in.). The sprinkler links are (a) 610 mm (24 in.), and (b) 760 mm (30 in.) below the ceiling.

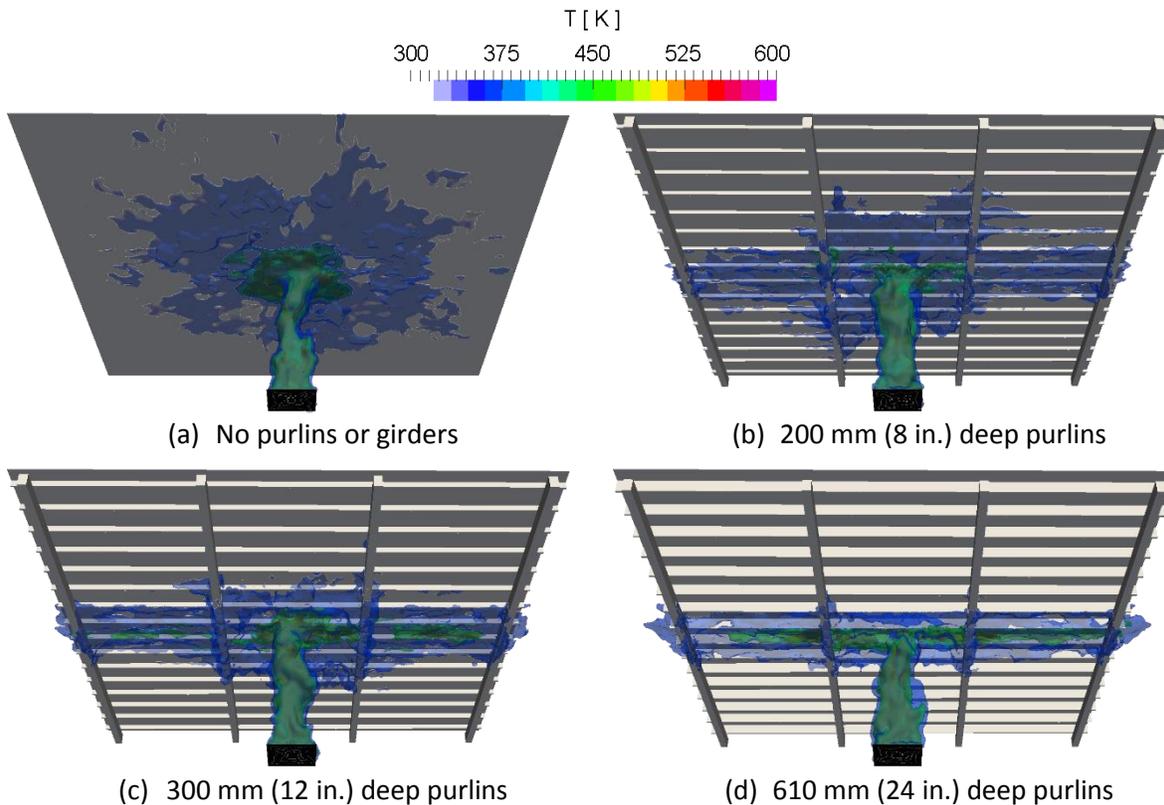
Figure 3-19: Ceiling jet at 375 s depicted by CO₂ contours ($Y_{CO_2} = 0.02-0.04$) under a ceiling located 7.6 m (25 ft) above the UUP fire source in (a) the absence of obstructed ceiling construction, and in the presence of 610 mm (24 in.) deep girders separated by 7.6 m (25 ft) and purlins with a separation distance of 1.5 m (5 ft) and a depth of (b) 200 mm (8 in.), (c) 300 mm (12 in.), and (d) 610 mm (24 in.).

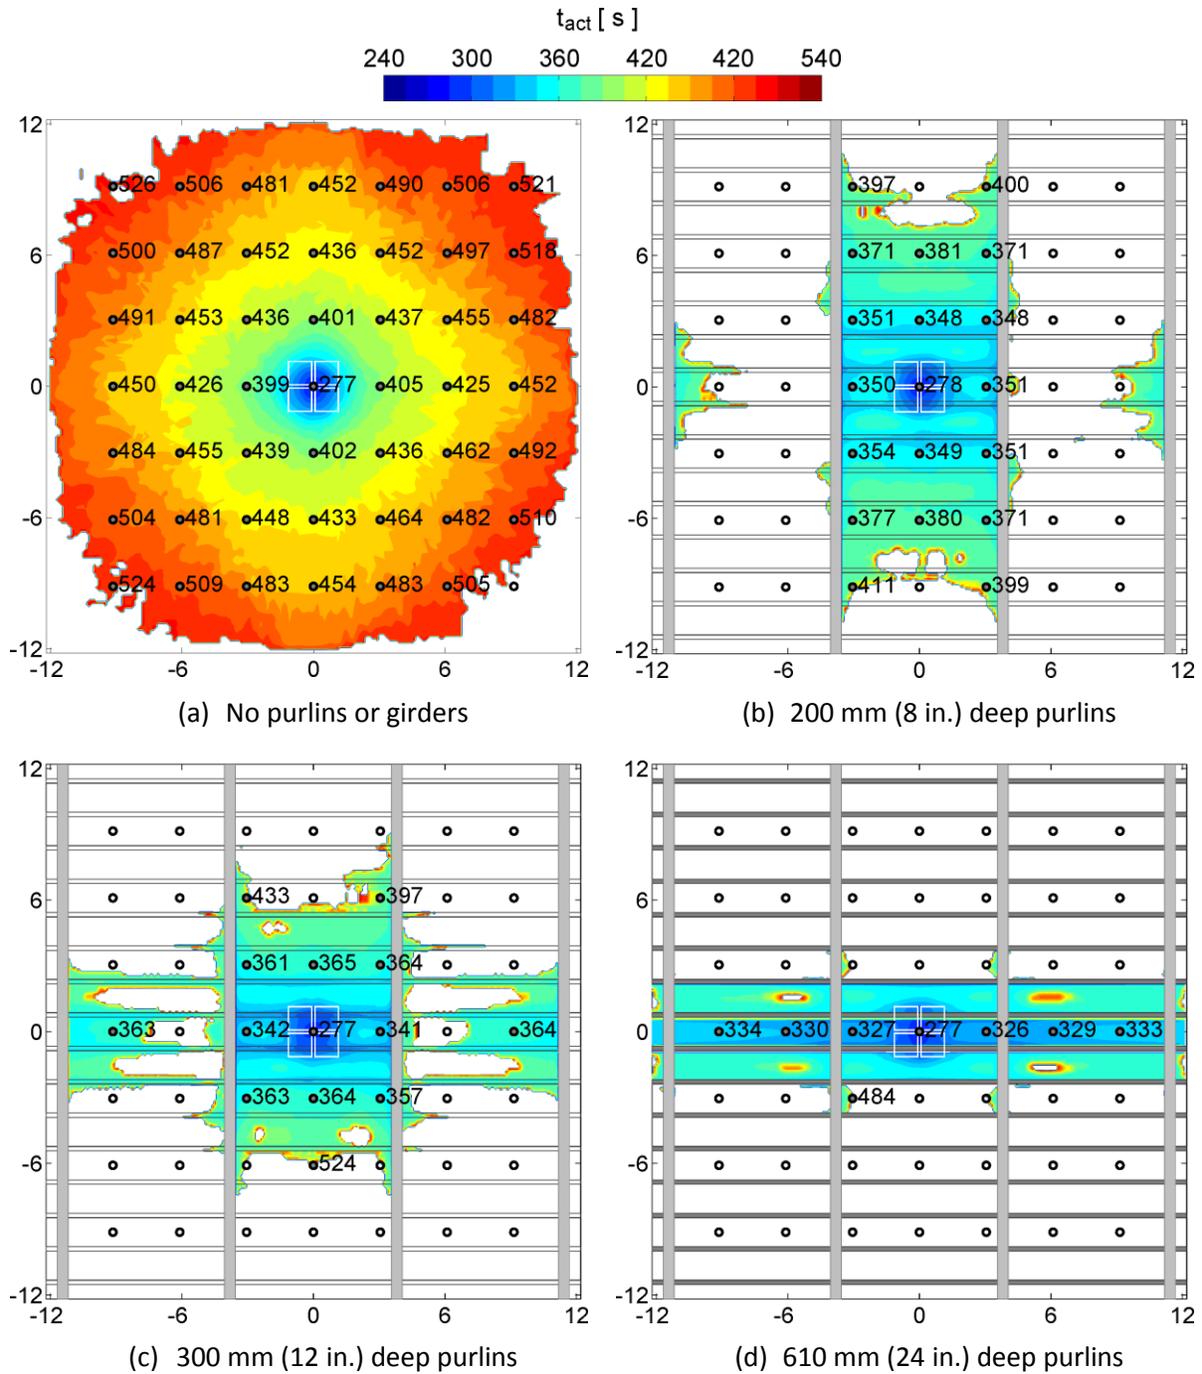
Figure 3-20: Activation time contours for QR/OT sprinkler links at 430 mm (17 in.) below a ceiling located 3.0 m (10 ft) above a UUP fire source in (a) the absence of obstructed ceiling construction, and in the presence of 610 mm (24 in.) deep girders separated by 7.6 m (25 ft) and purlins with a separation distance of 1.5 m (5 ft) and a depth of (b) 200 mm (8 in.), (c) 300 mm (12 in.), and (d) 610 mm (24 in.). Discrete locations of sprinkler links arranged in a 3.0 m × 3.0 m (10 ft × 10 ft) spacing are also shown with the corresponding activation times.

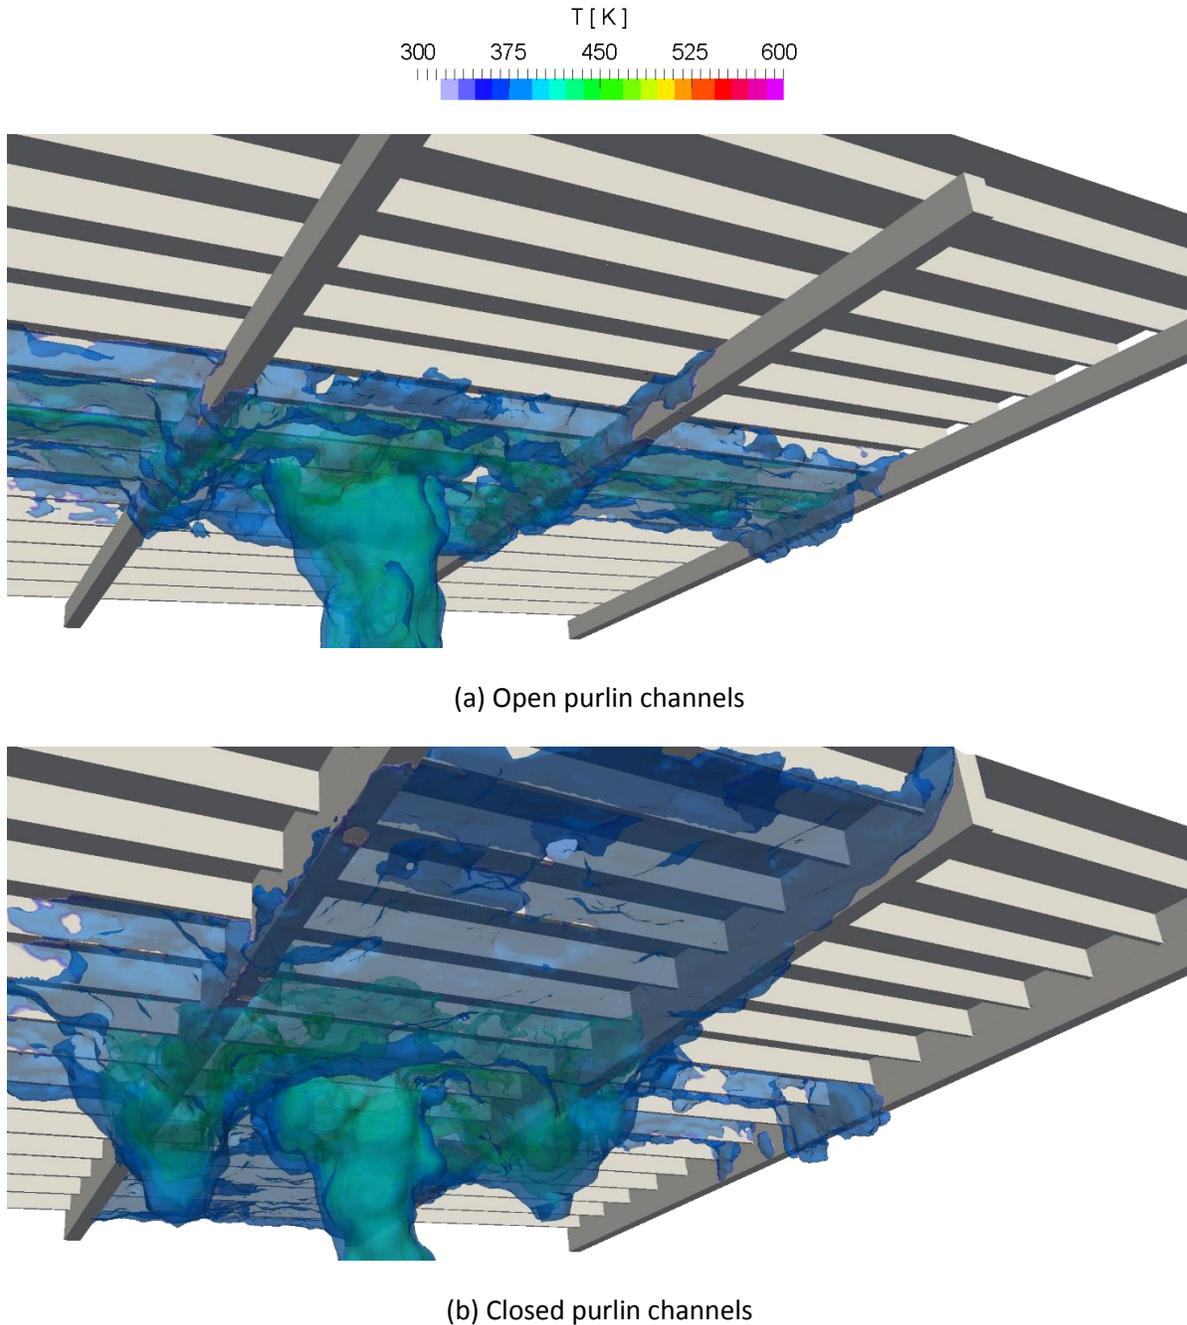
Figure 3-21: Ceiling jet at 395 s depicted by CO₂ contours ($Y_{CO_2} = 0.01-0.04$) under a ceiling located 3.0 m (10 ft) above the UUP fire source with 610 mm (24 in.) deep purlins separated by 1.5 m (5 ft) and girders separated by 7.6 m (25 ft). The purlin channels are (a) open with 610 mm (24 in.) deep girders located below the purlins, and (b) closed by obstructing the top of the 610 mm (24 in.) girders.

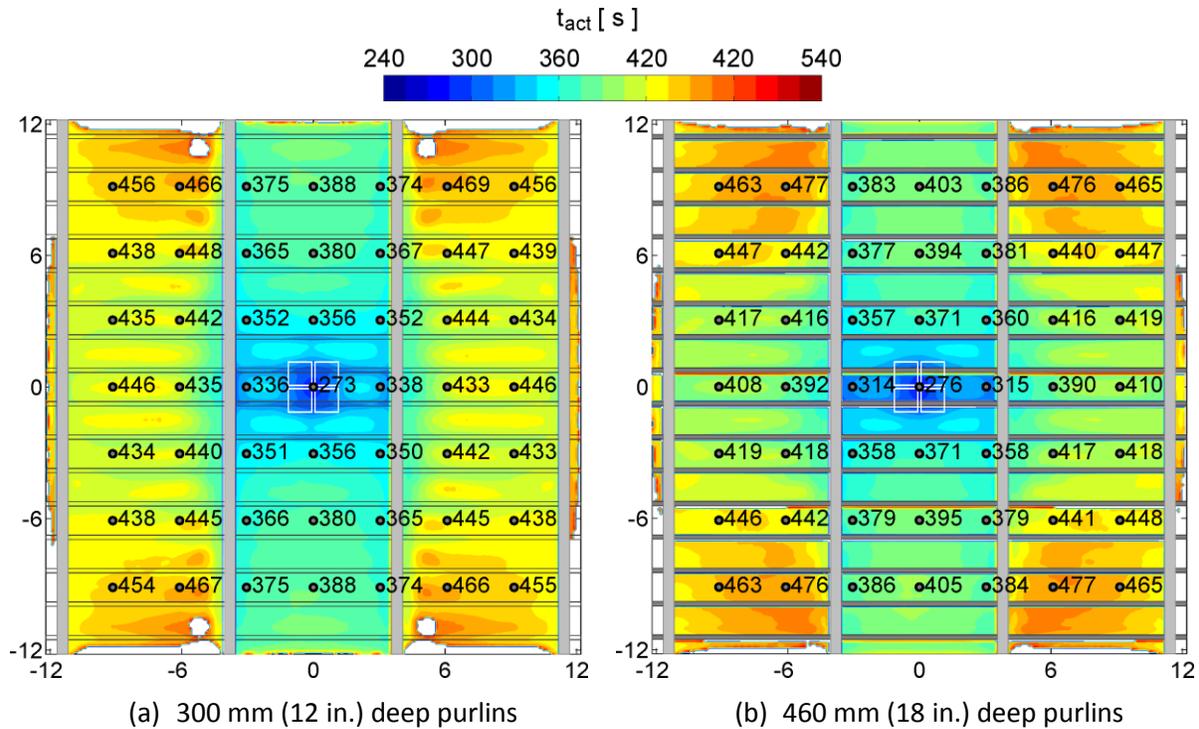
Figure 3-22: Activation time contours for QR/OT sprinkler links at 430 mm (17 in.) below a ceiling located 3.0 m (10 ft) above a UUP fire source. Purlins are separated by 1.5 m (5 ft) and girders by 7.6 m (25 ft) with (a) 300 mm (12 in.), and (b) 460 mm (18 in.) deep purlins. Purlin channels are closed at the girder locations.

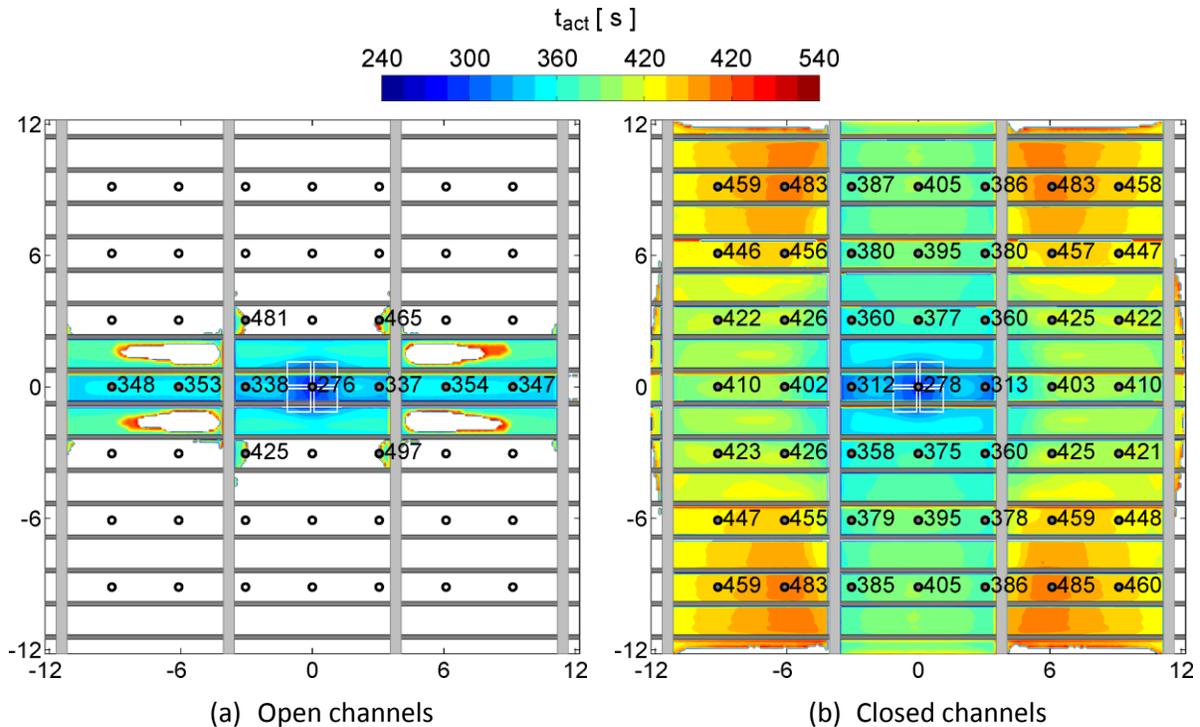
Figure 3-23: Activation time contours for QR/OT sprinkler links below a ceiling located 3.0 m (10 ft) above a UUP fire source in the presence of girders separated by 7.6 m (25 ft). Purlins with a separation distance of 1.5 m (5 ft) and a depth of 610 mm (24 in.) form (a) open channels, and (b) channels closed at the girder locations. Sprinkler links are located 610 mm (24 in.) below the ceiling.

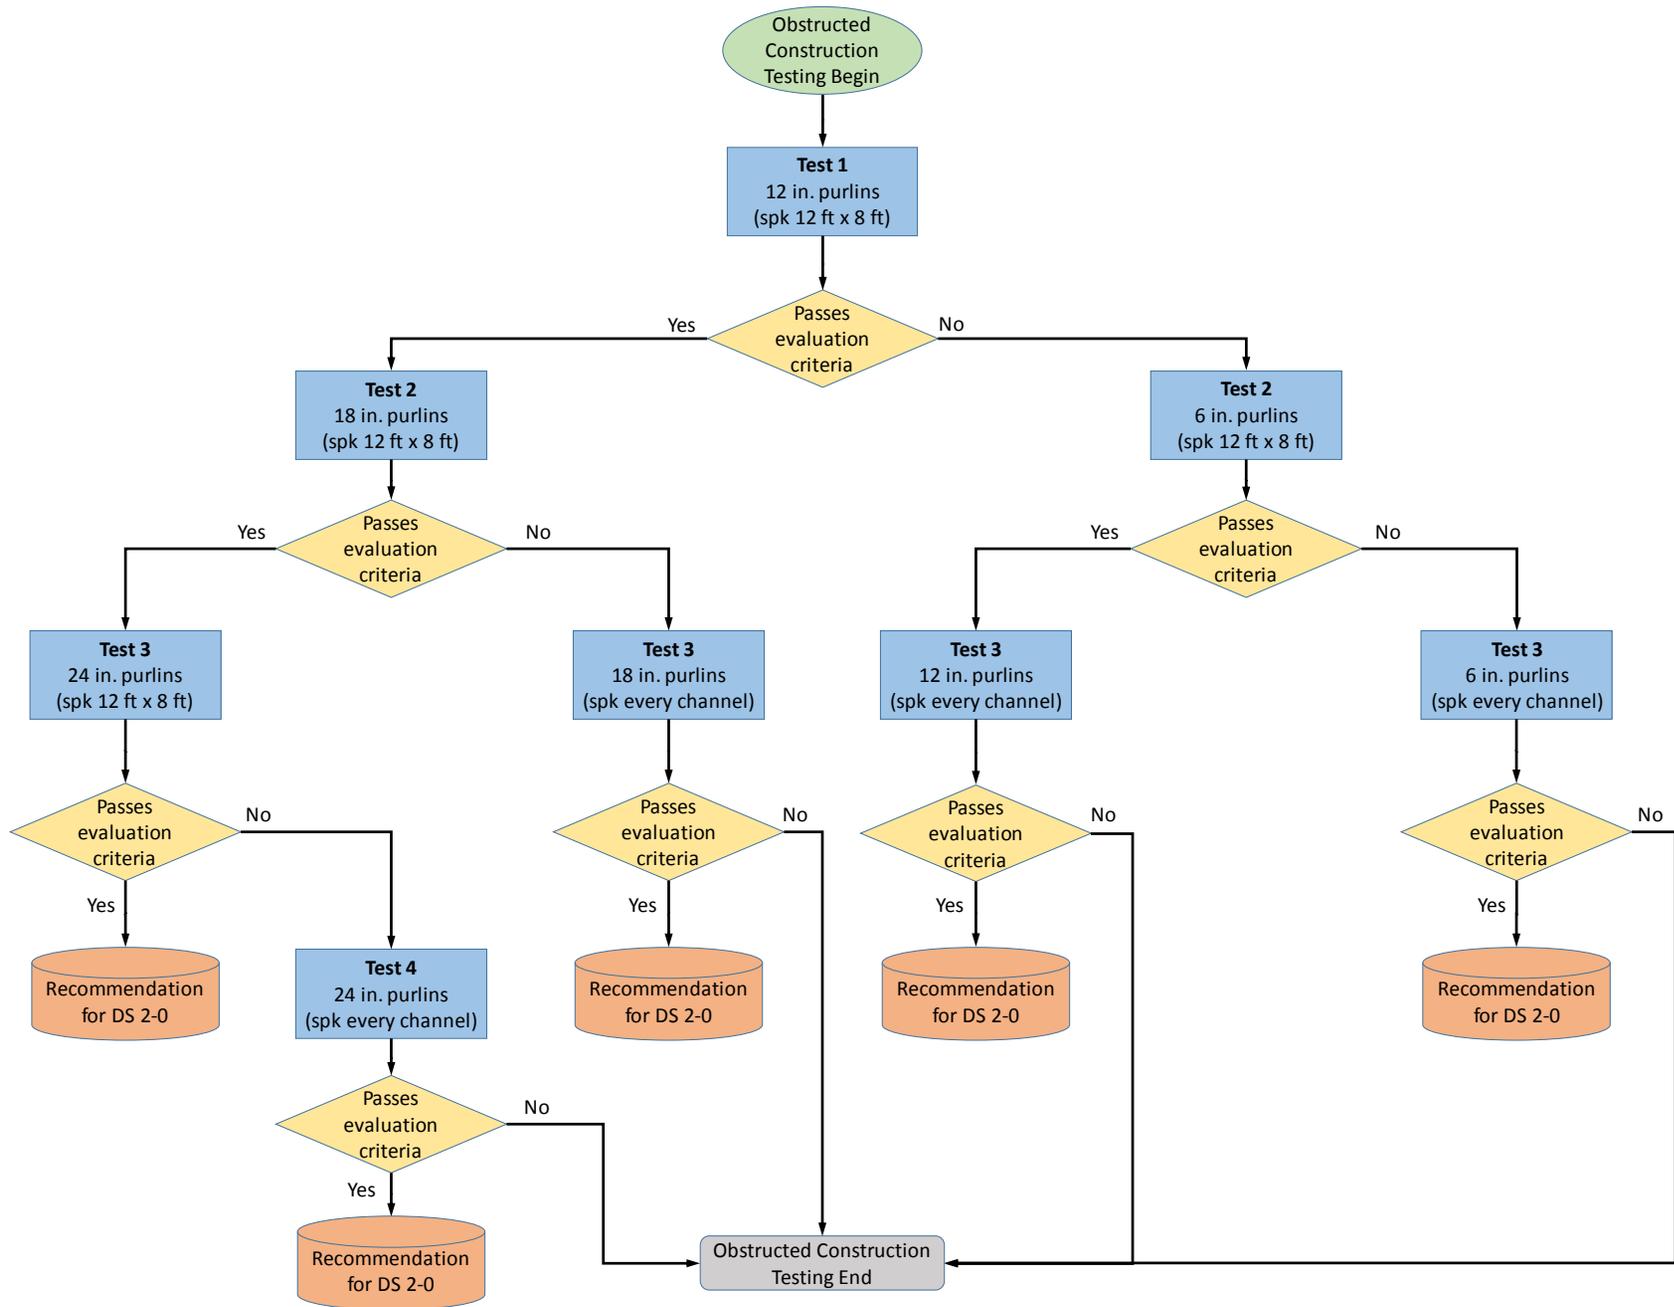
Figure 3-24: Flowchart for determining the sequence of the CUP large-scale tests.

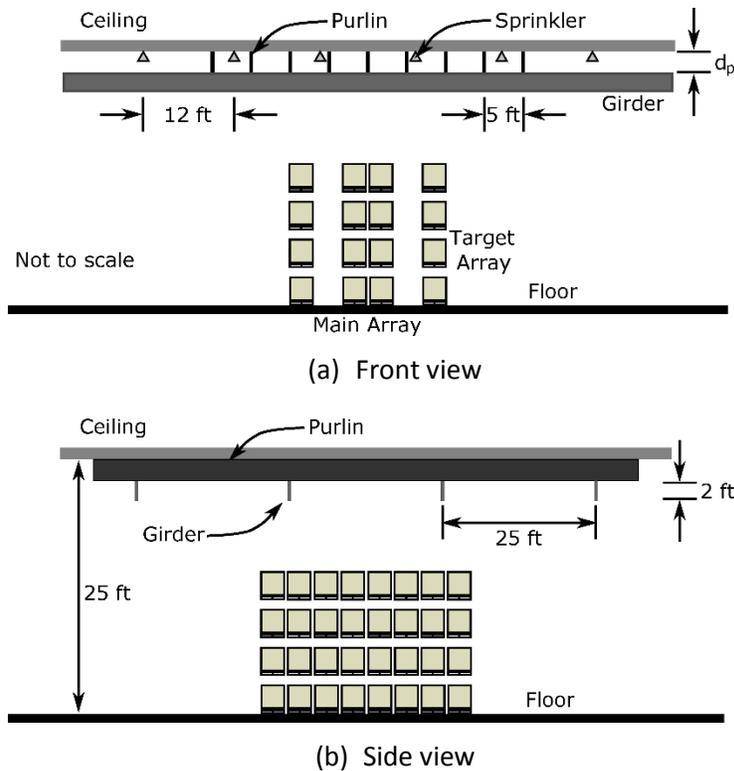
Figure 4-1: Testing setup (not to scale) showing a 4-tier-high CUP rack storage array as a fire source with two target arrays (separated by 1.2 m or 4 ft), 610 mm (24 in.) tall girders spaced 7.6 m (25 ft) apart, and purlins of depth d_p separated by 1.5 m (5 ft): (a) front view showing purlins, and (b) side view showing girders present below the purlins.

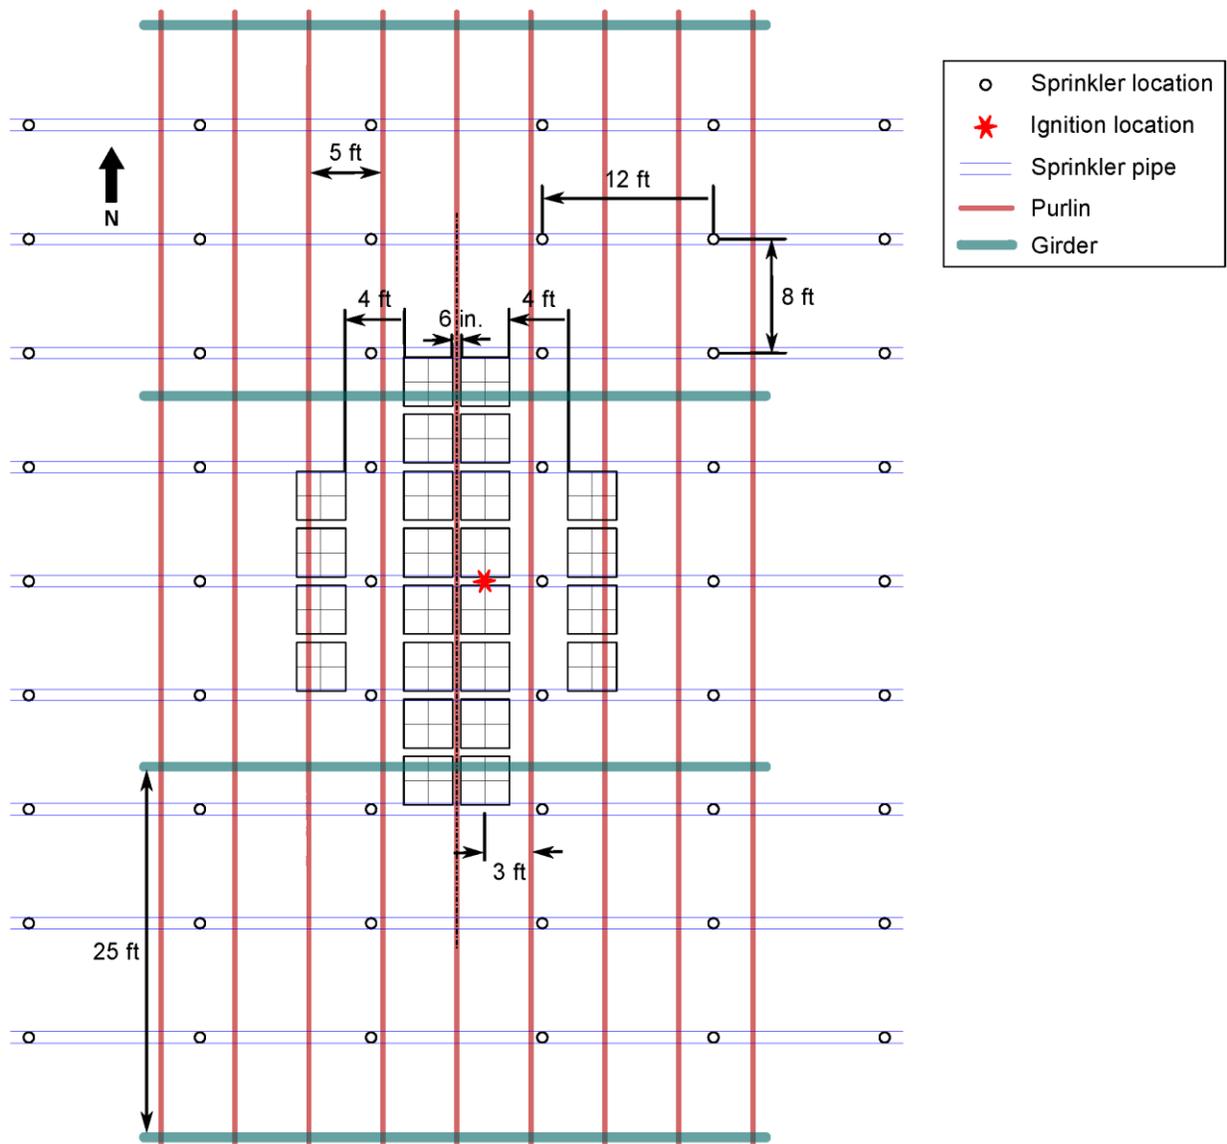
Figure 4-3: Plan view of the test array (CUP commodity) with ignition placed between two sprinklers. The sprinklers, piping, purlin, and girder distances relative to the test array are shown.

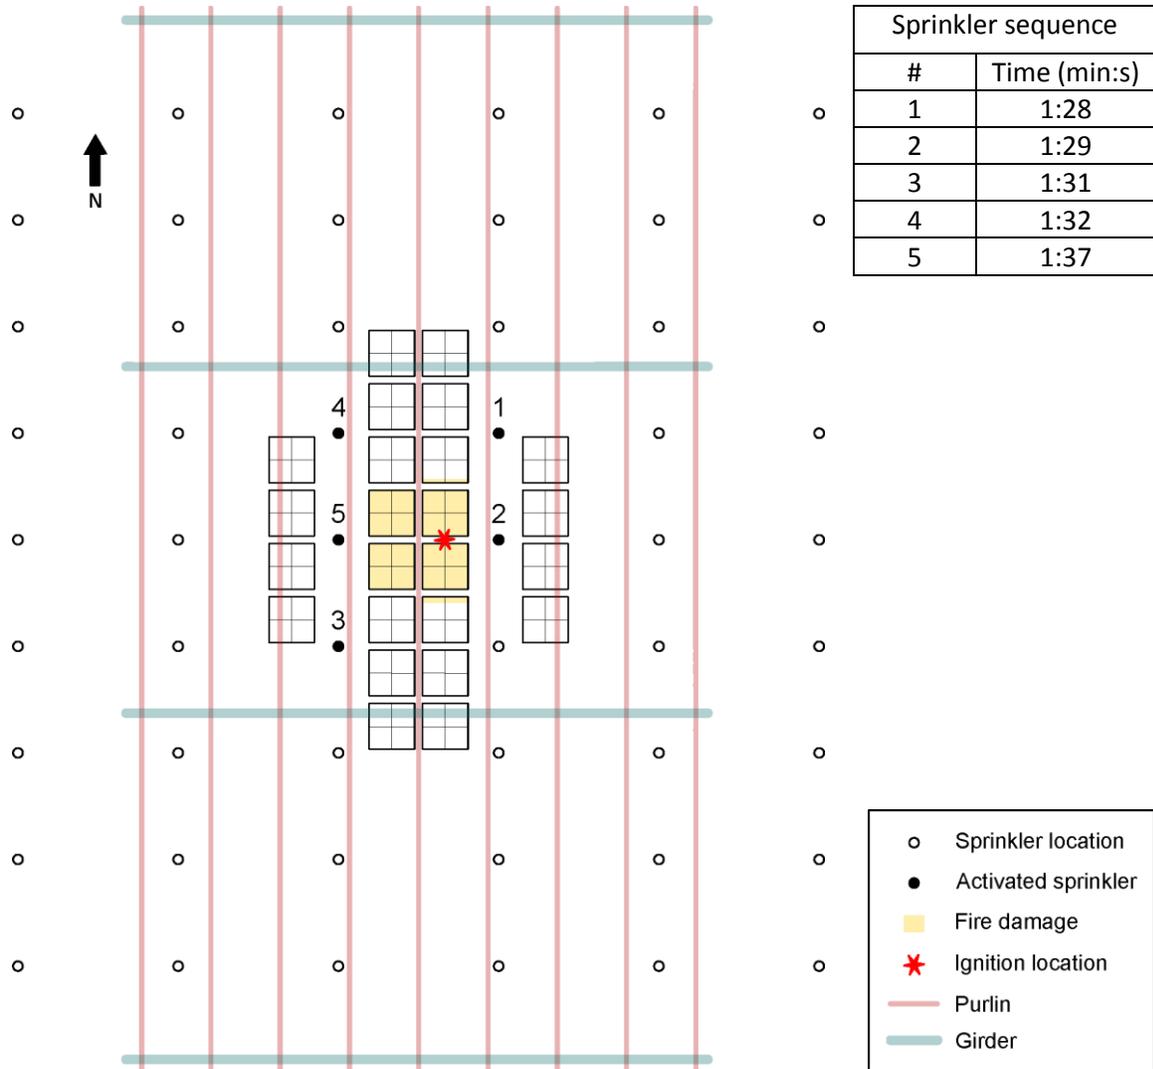
Figure 4-6: Sprinkler operation pattern and top view of damage assessment for Test #1.

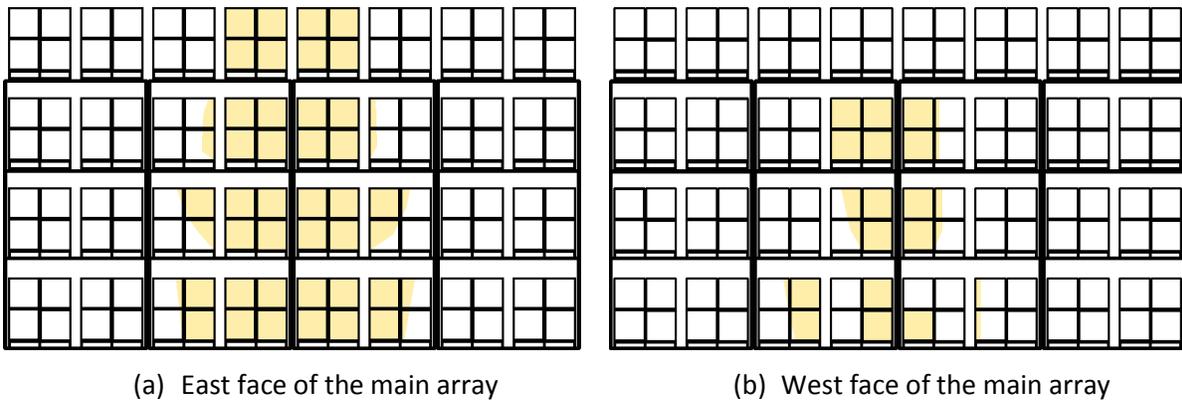
Figure 4-7: Damage assessment on the main array for Test #1.

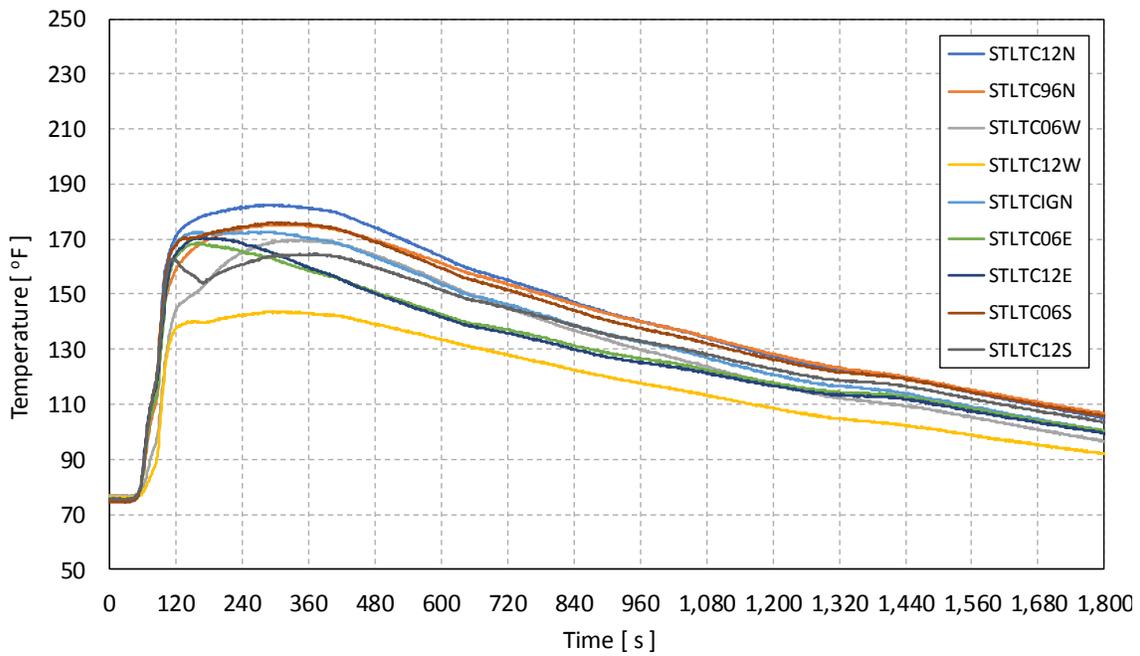
Figure 4-8: Temperatures of the ceiling steel angle for Test #1. The thermocouples on the steel angle are named with a prefix of STLTC (Steel Thermocouple), followed by their placement relative to the ignition location (e.g., IGN stands for thermocouple above the ignition location, 06E means the thermocouple was offset by 6 in. toward the east, etc.)

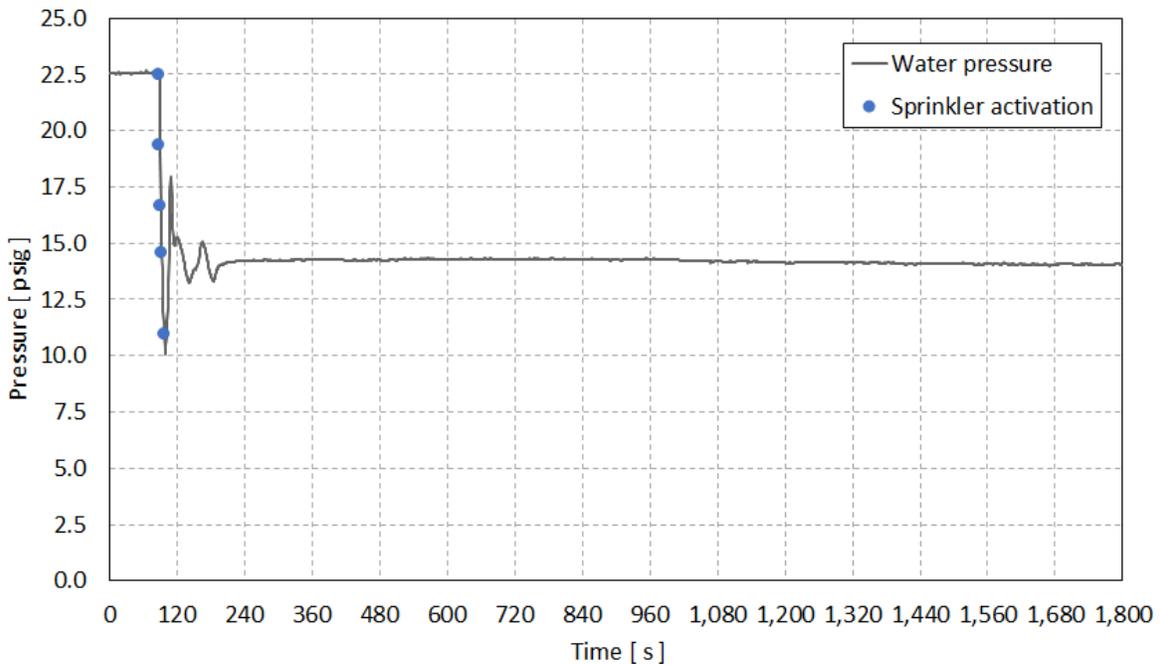
Figure 4-9: Water pressure measured at the main water supply header duct for Test #1.

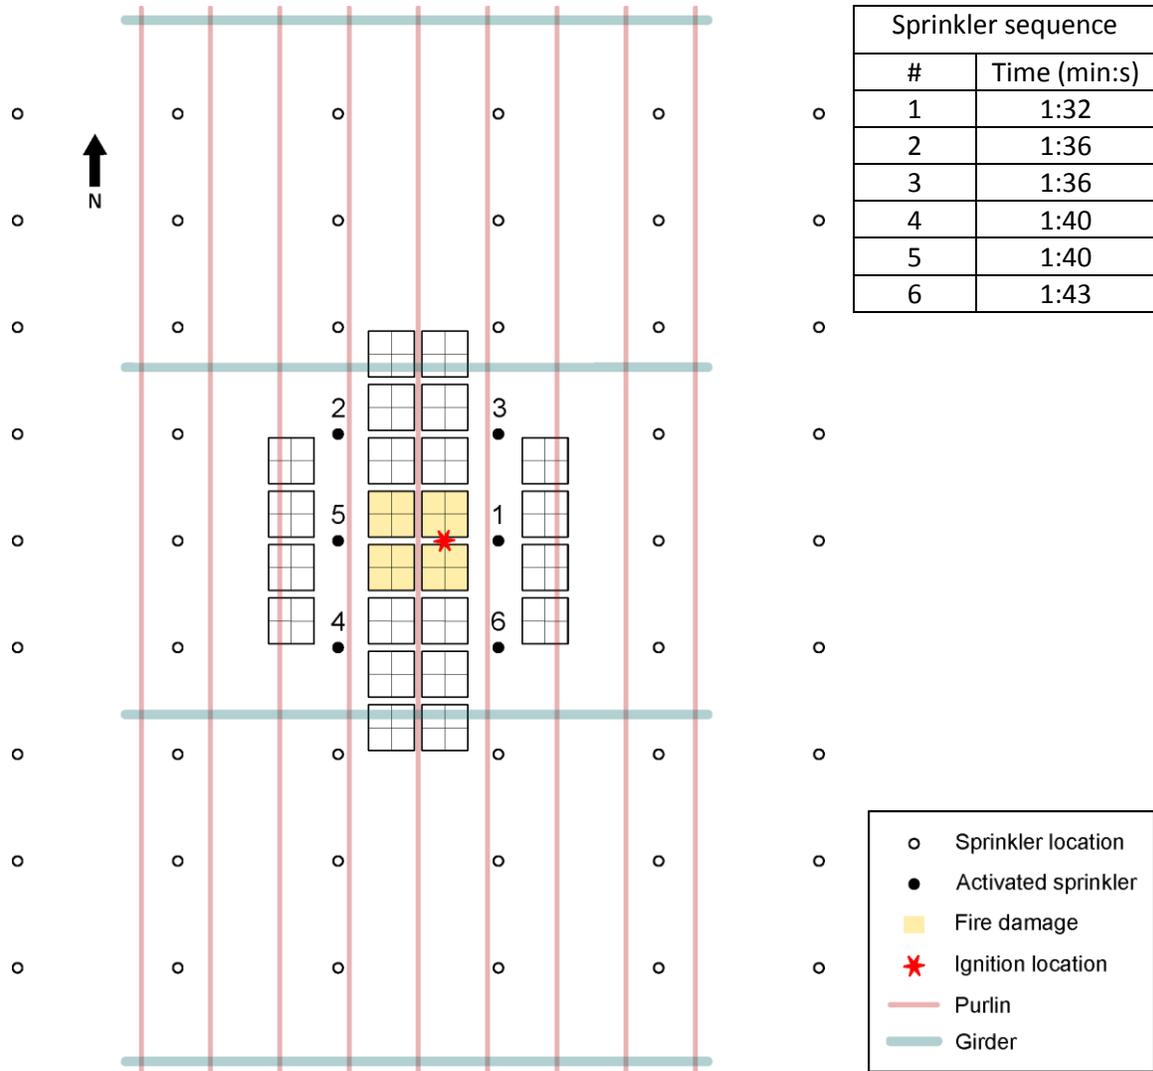
Figure 4-10: Sprinkler operation pattern and top view of damage assessment for test #2.

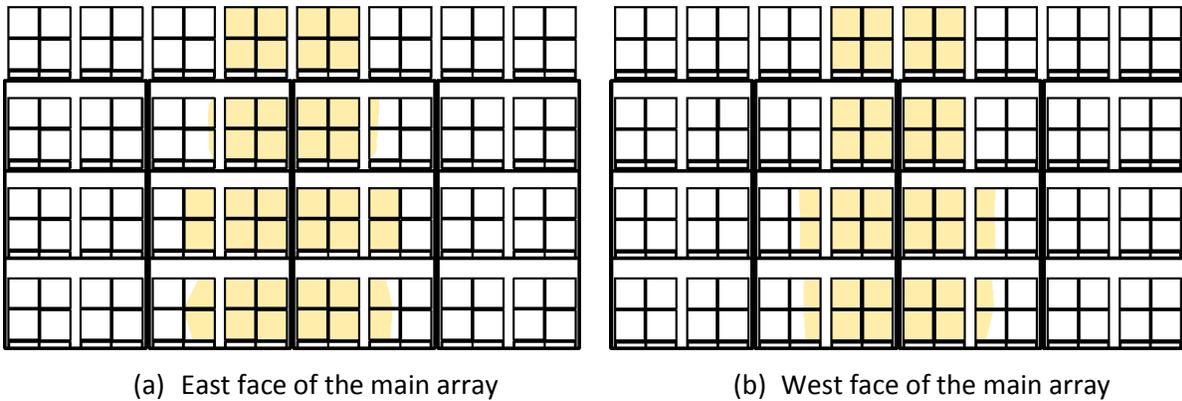
Figure 4-11: Damage assessment on the main array for Test #2.

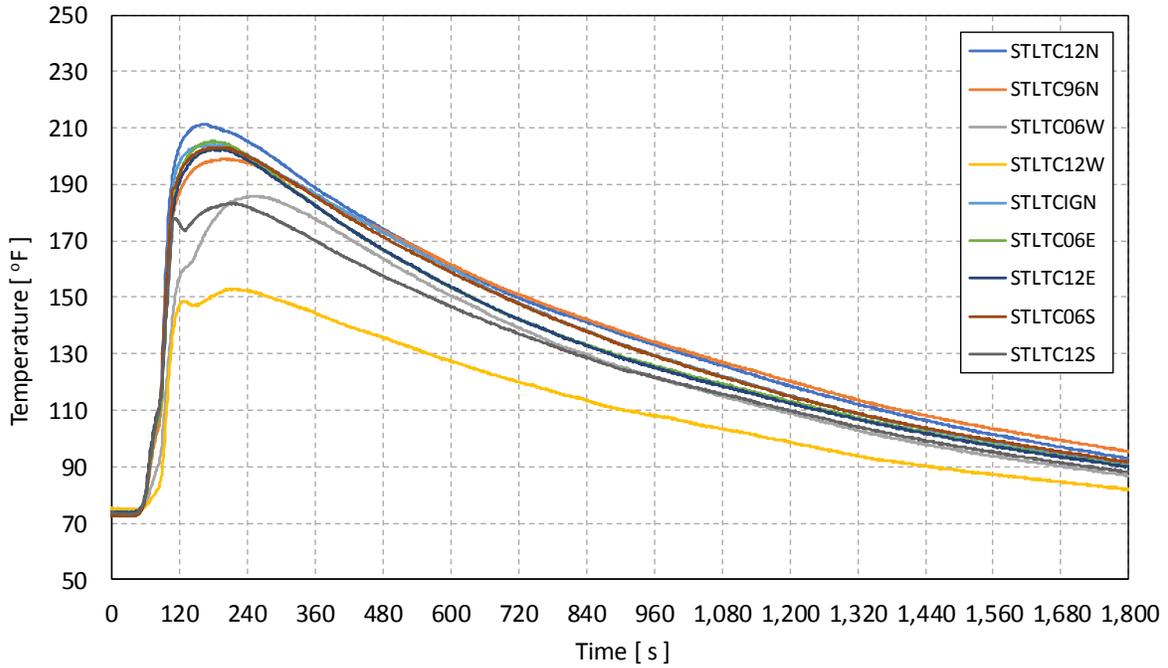
Figure 4-12: Temperatures of the ceiling steel angle for Test #2.

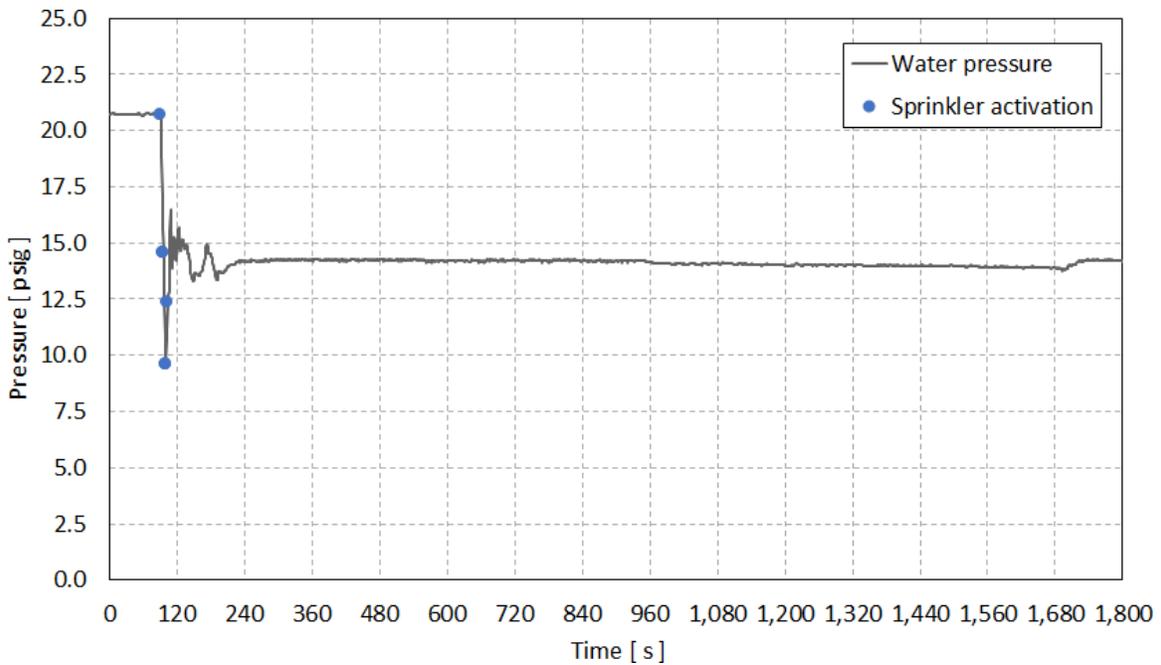
Figure 4-13: Water pressure for Test #2.
