RESEARCH TECHNICAL REPORT
*Sprinkler Performance under
Non-Sloped Obstructed
Ceiling Construction*

Prateep Chatterjee

FM Global

December 2018

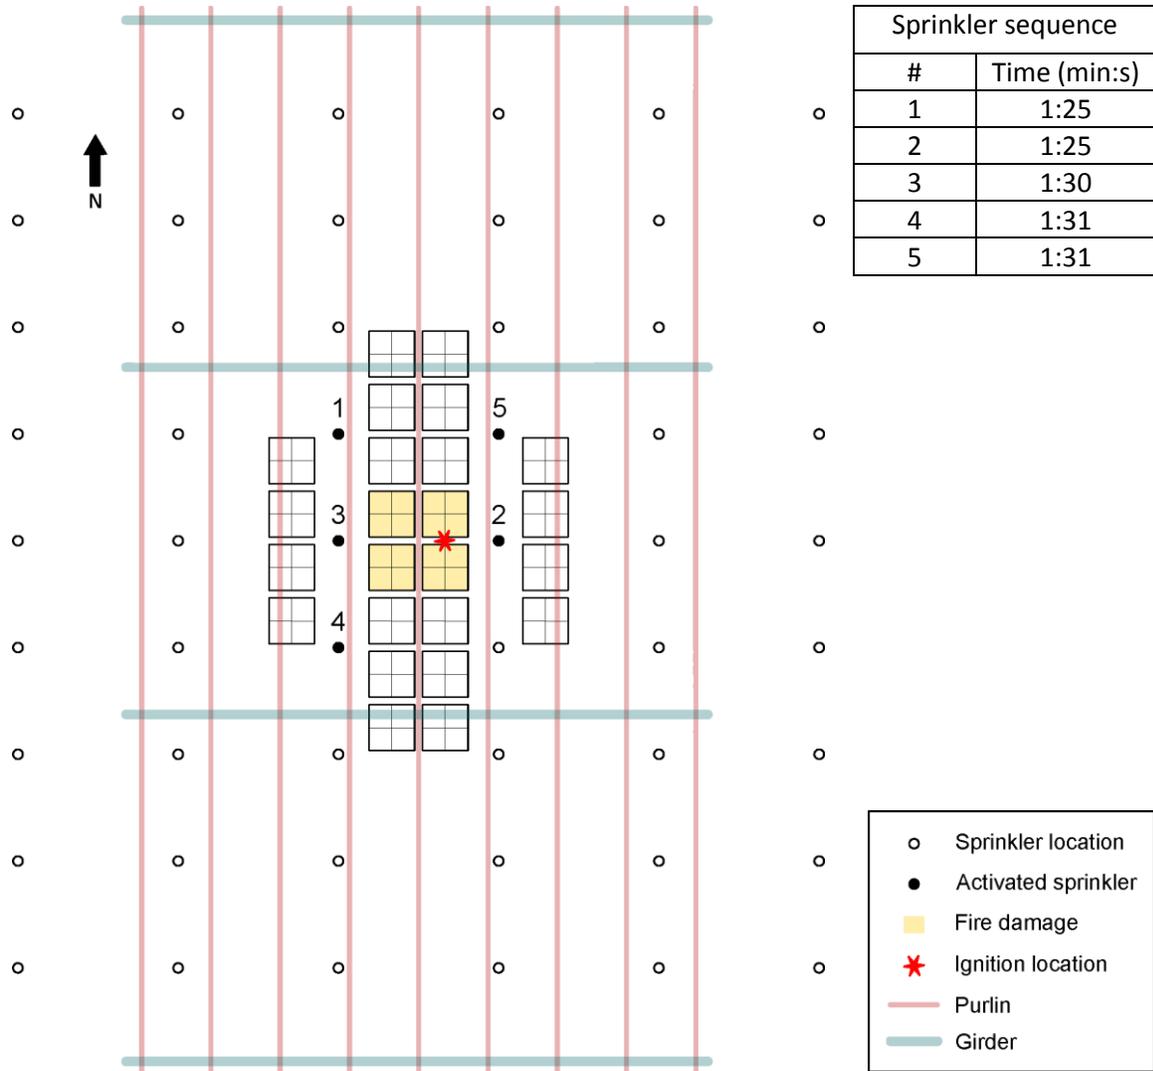
Figure 4-14: Sprinkler operation pattern and top view of damage assessment for Test #3.

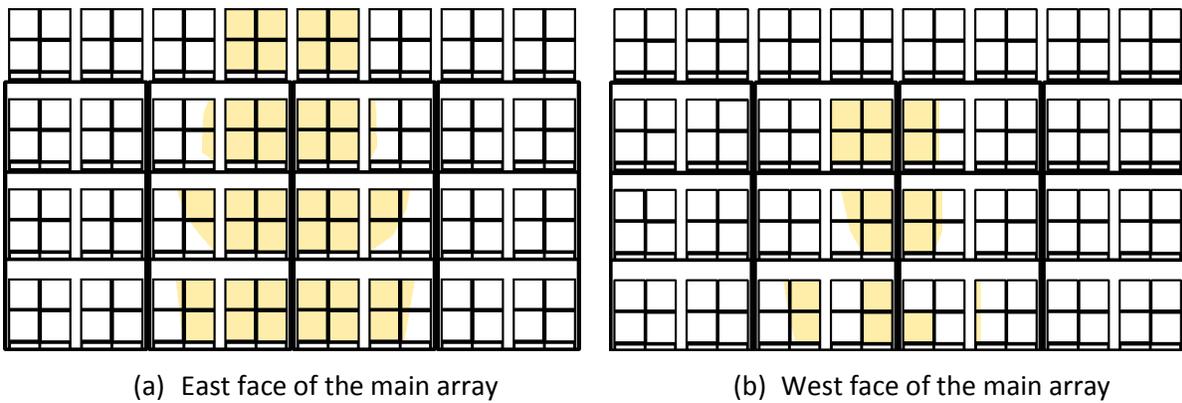
Figure 4-15: Damage assessment on the main array for Test #3.

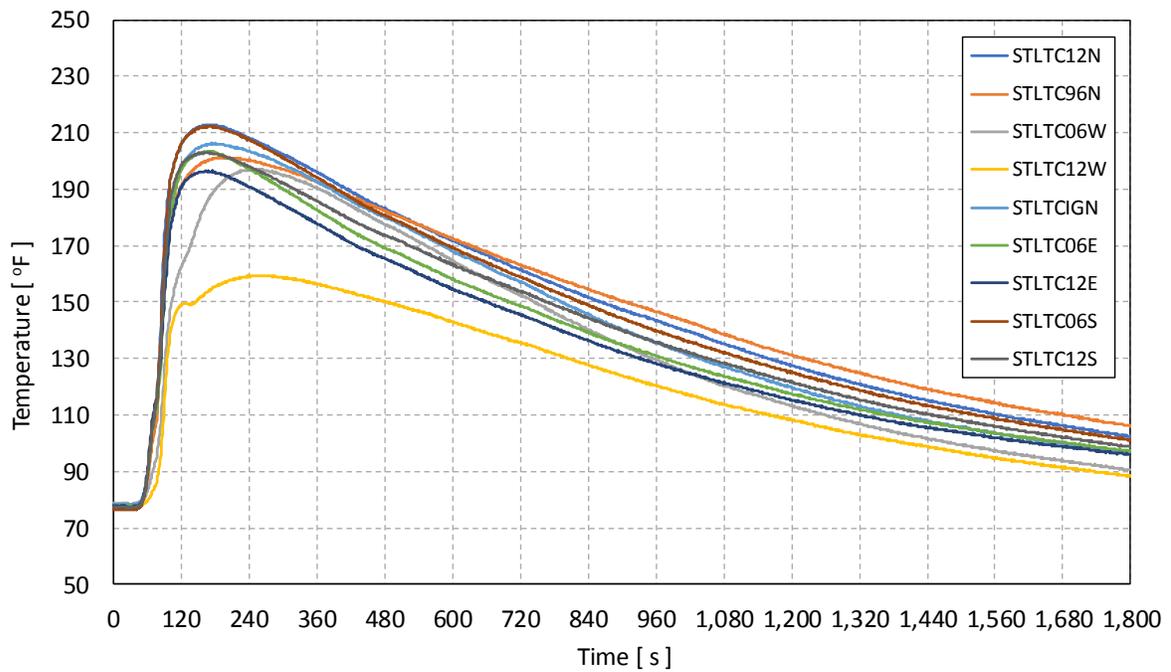
Figure 4-16: Temperatures of the ceiling steel angle for Test #3.

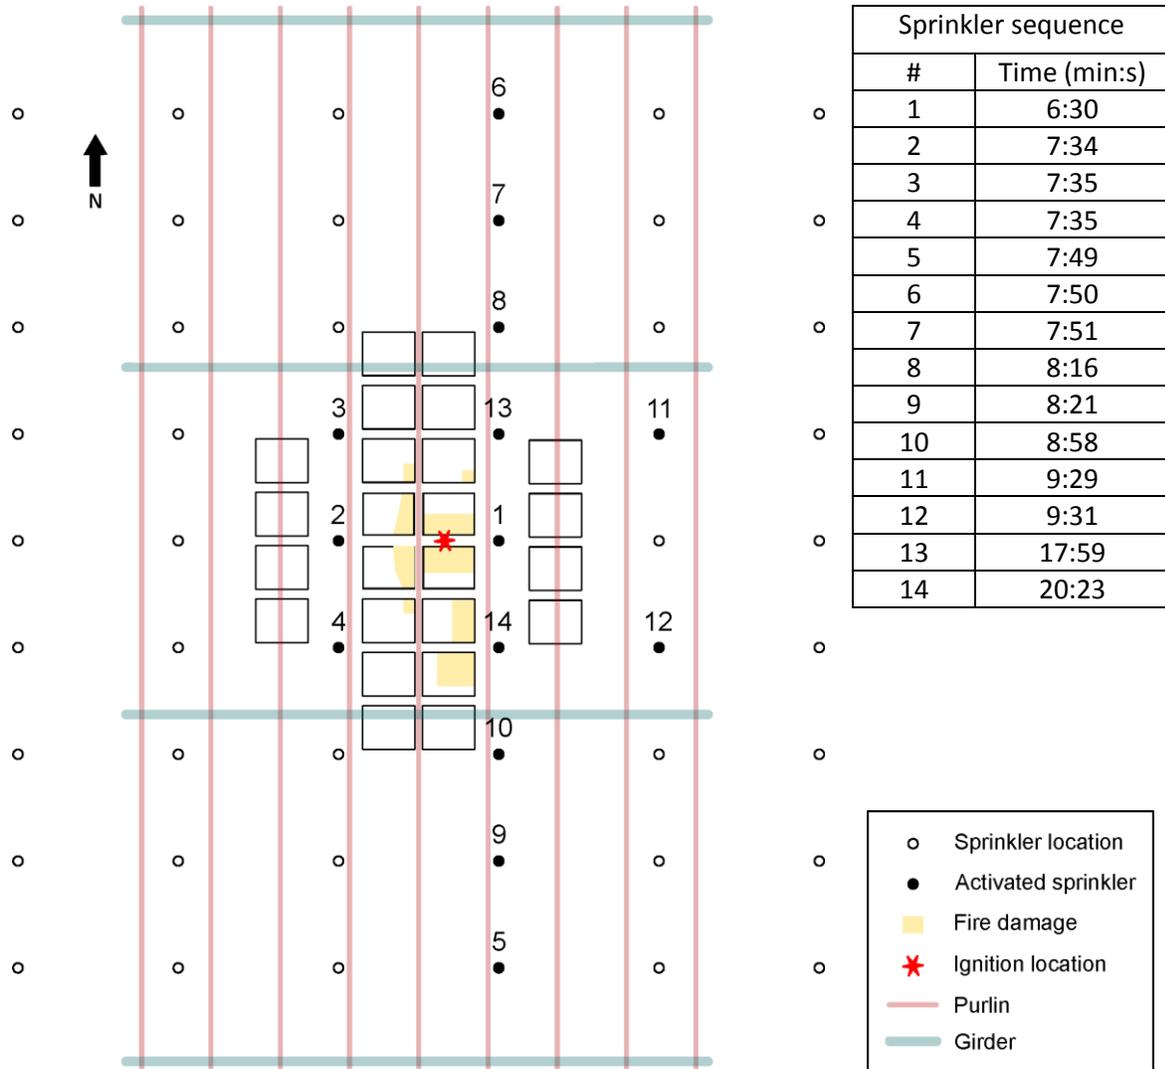
Figure 4-18: Sprinkler operation pattern and top view of damage assessment for Test #4.

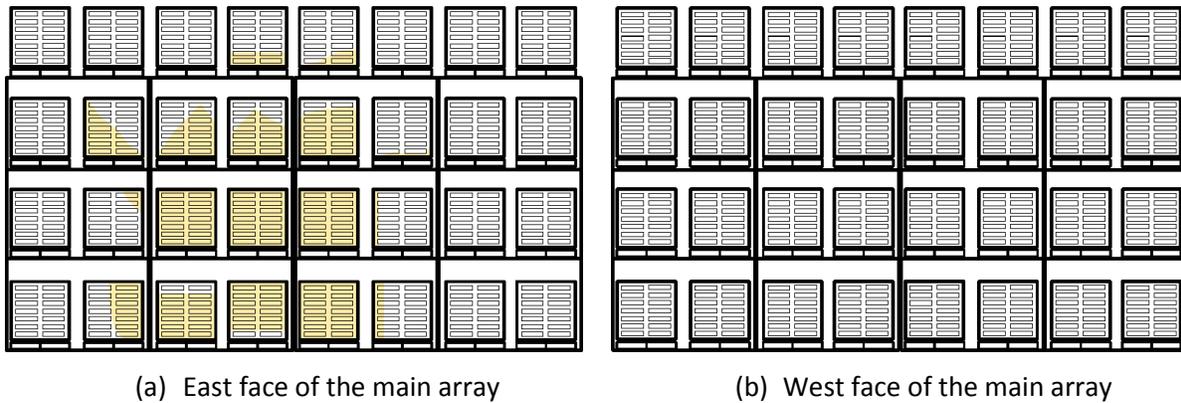
Figure 4-19: Damage assessment on the main array for Test #4.

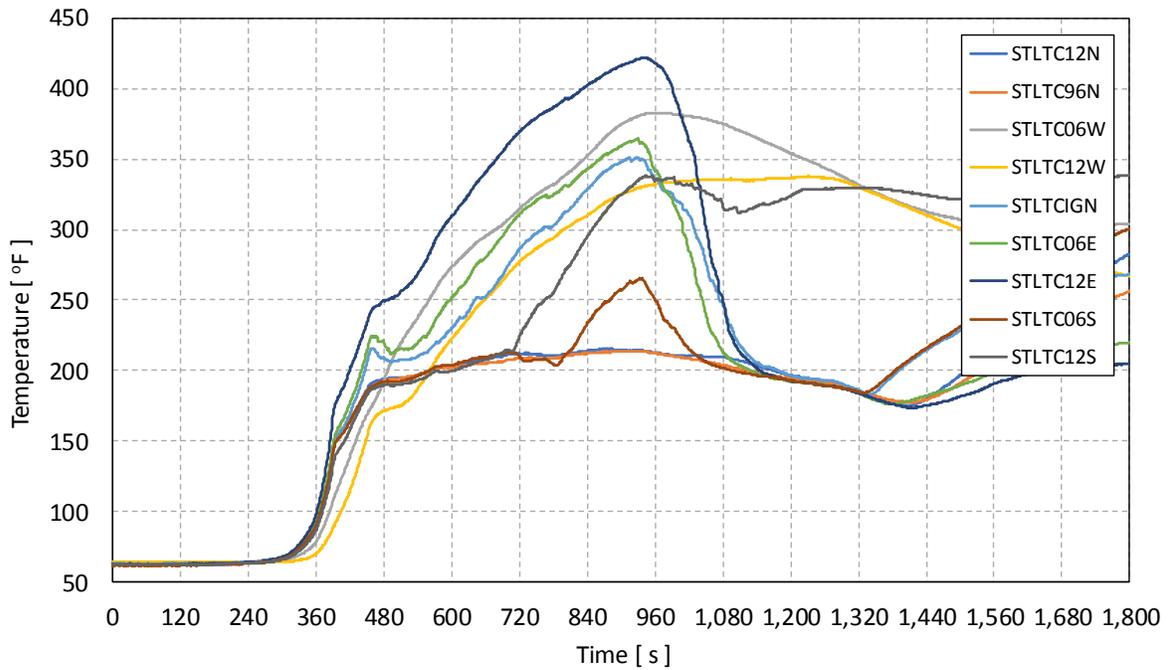
Figure 4-20: Temperatures of the ceiling steel angle for Test #4.

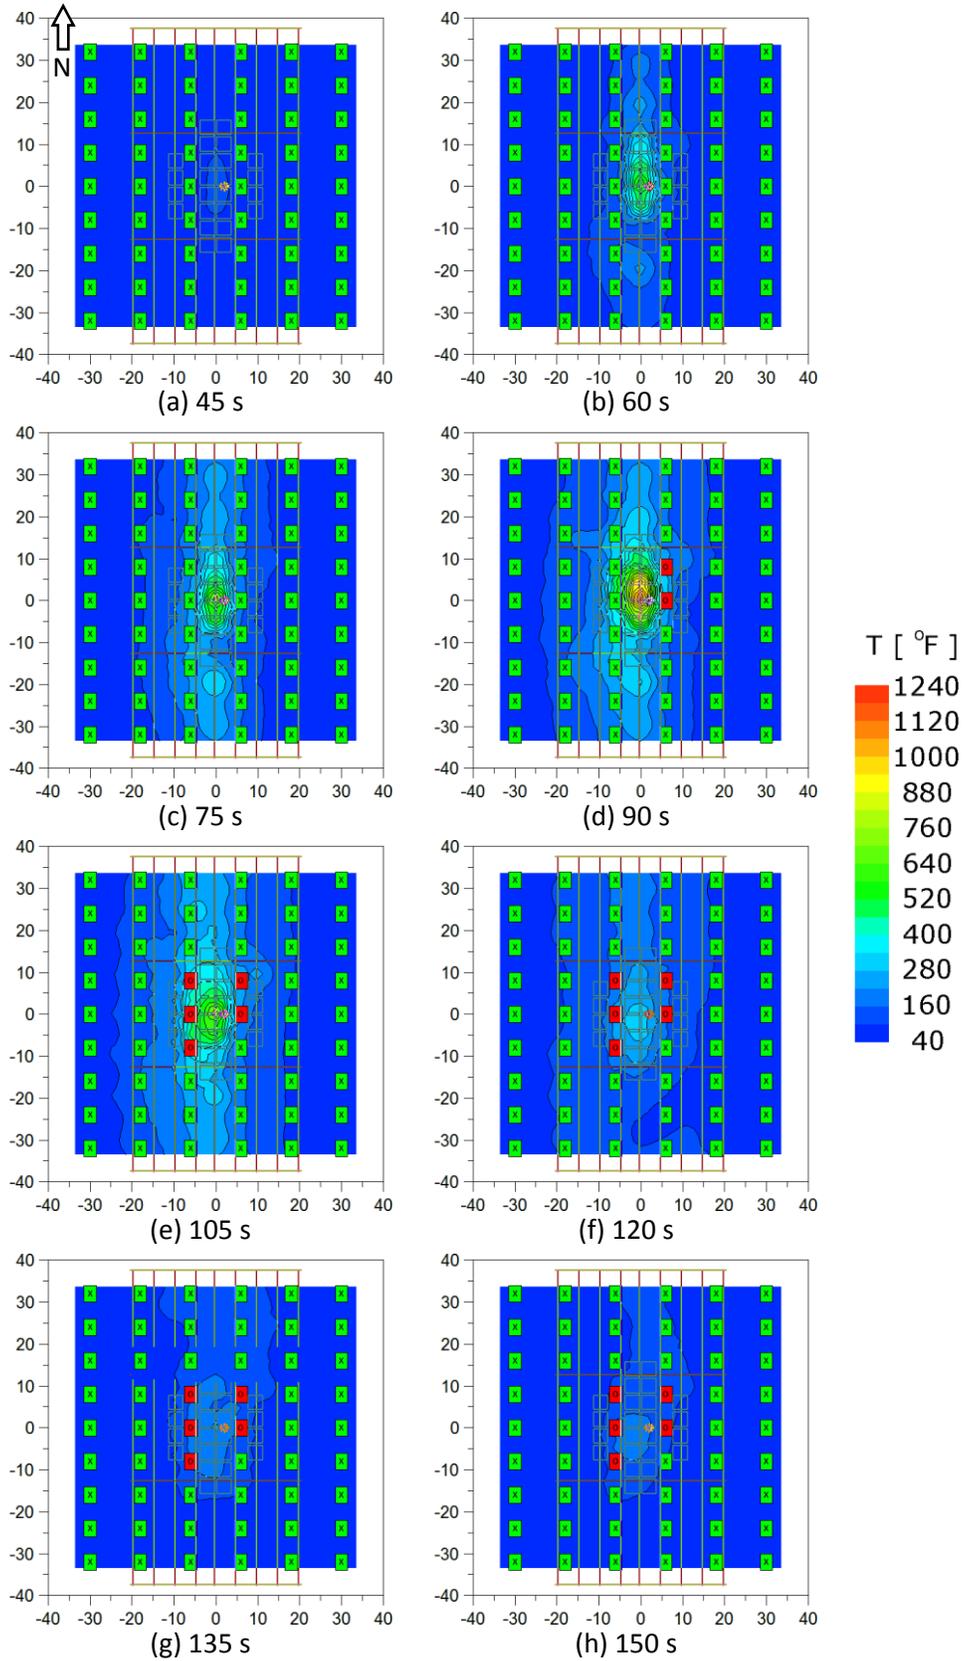
Figure 4-22: Test #1 ceiling temperature contours shown in 15 s increments.

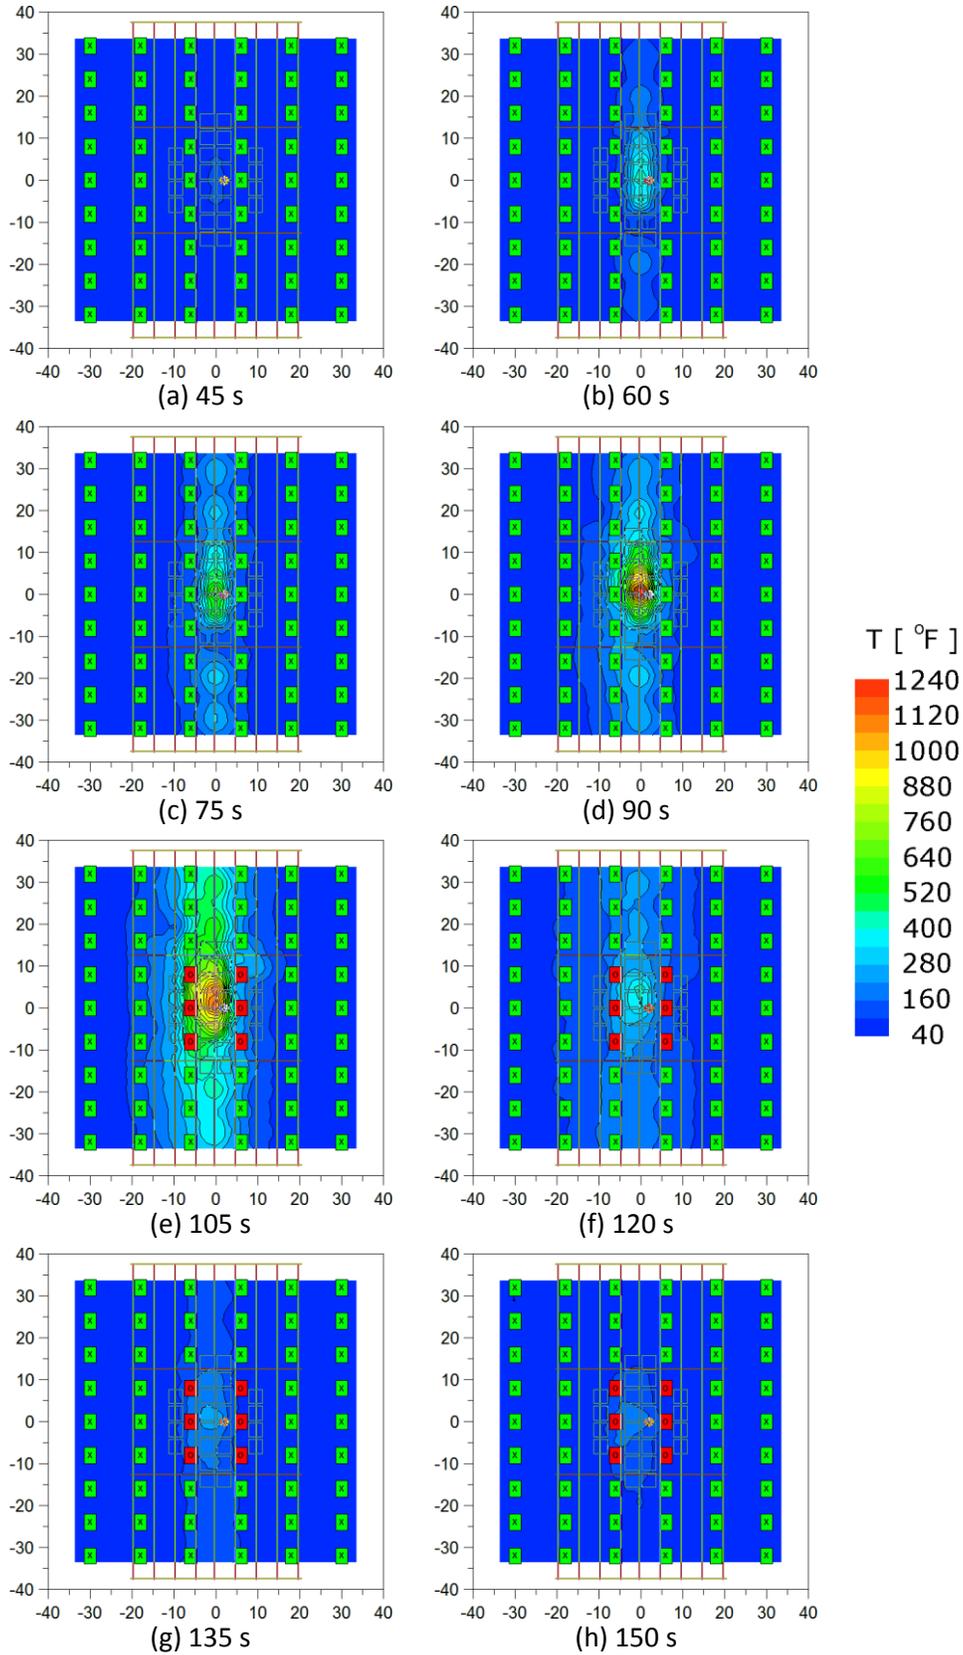
Figure 4-23: Test #2 ceiling temperature contours shown in 15 s increments.

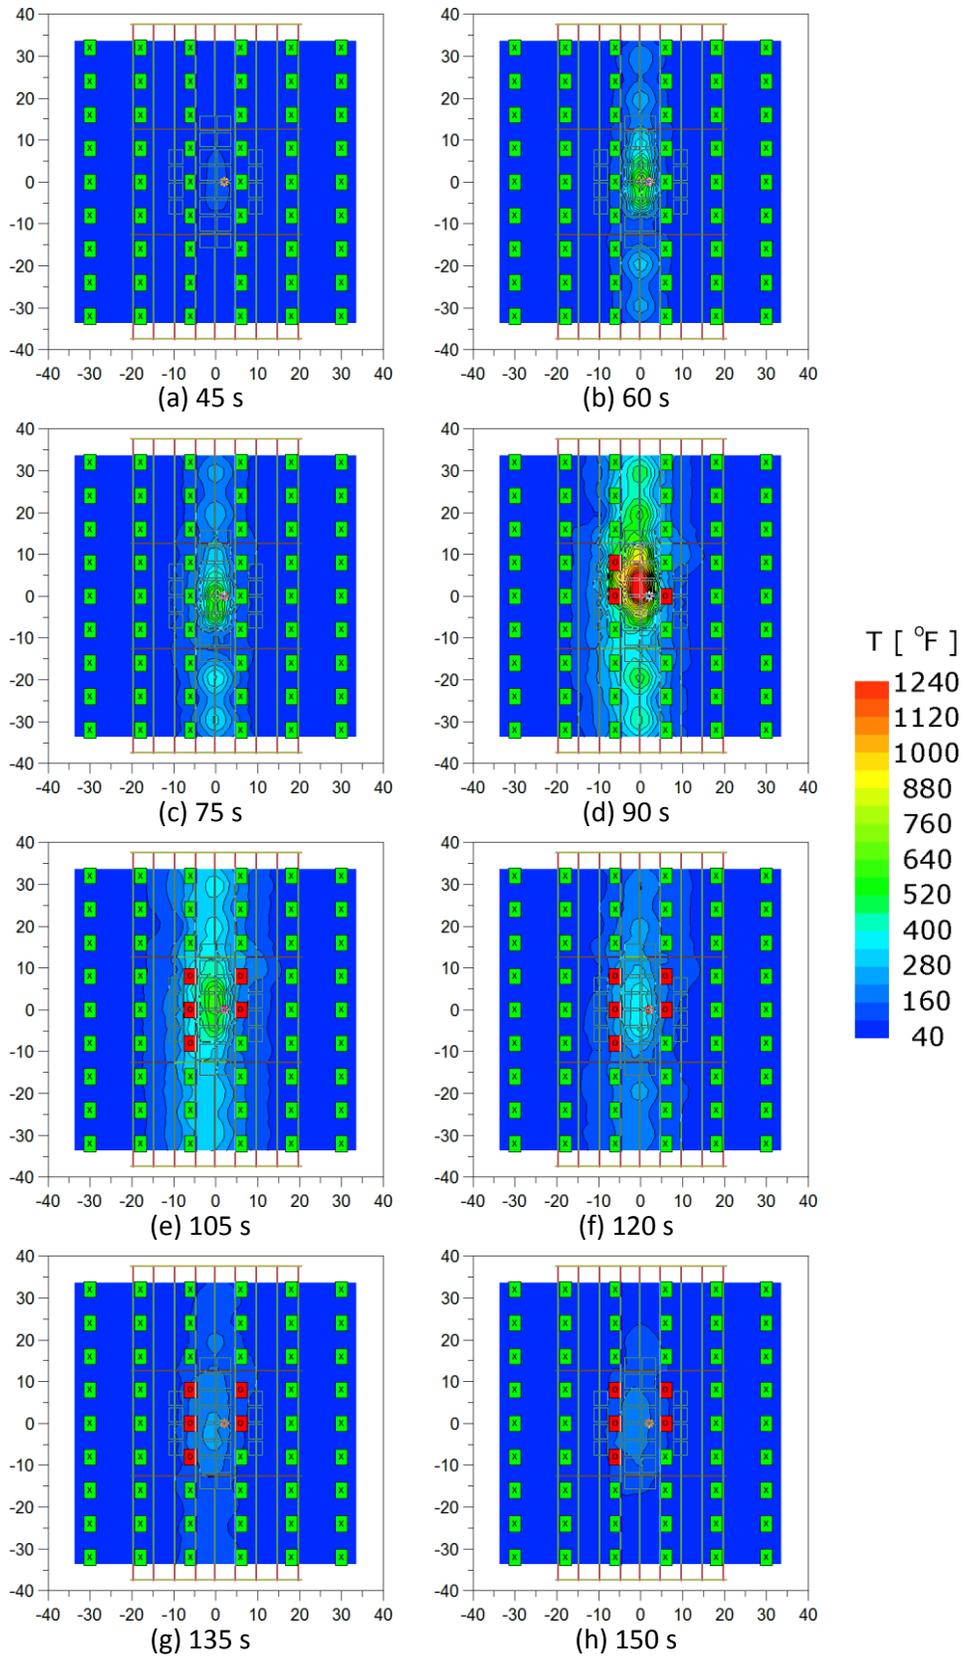
Figure 4-24: Test #3 ceiling temperature contours shown in 15 s increments.

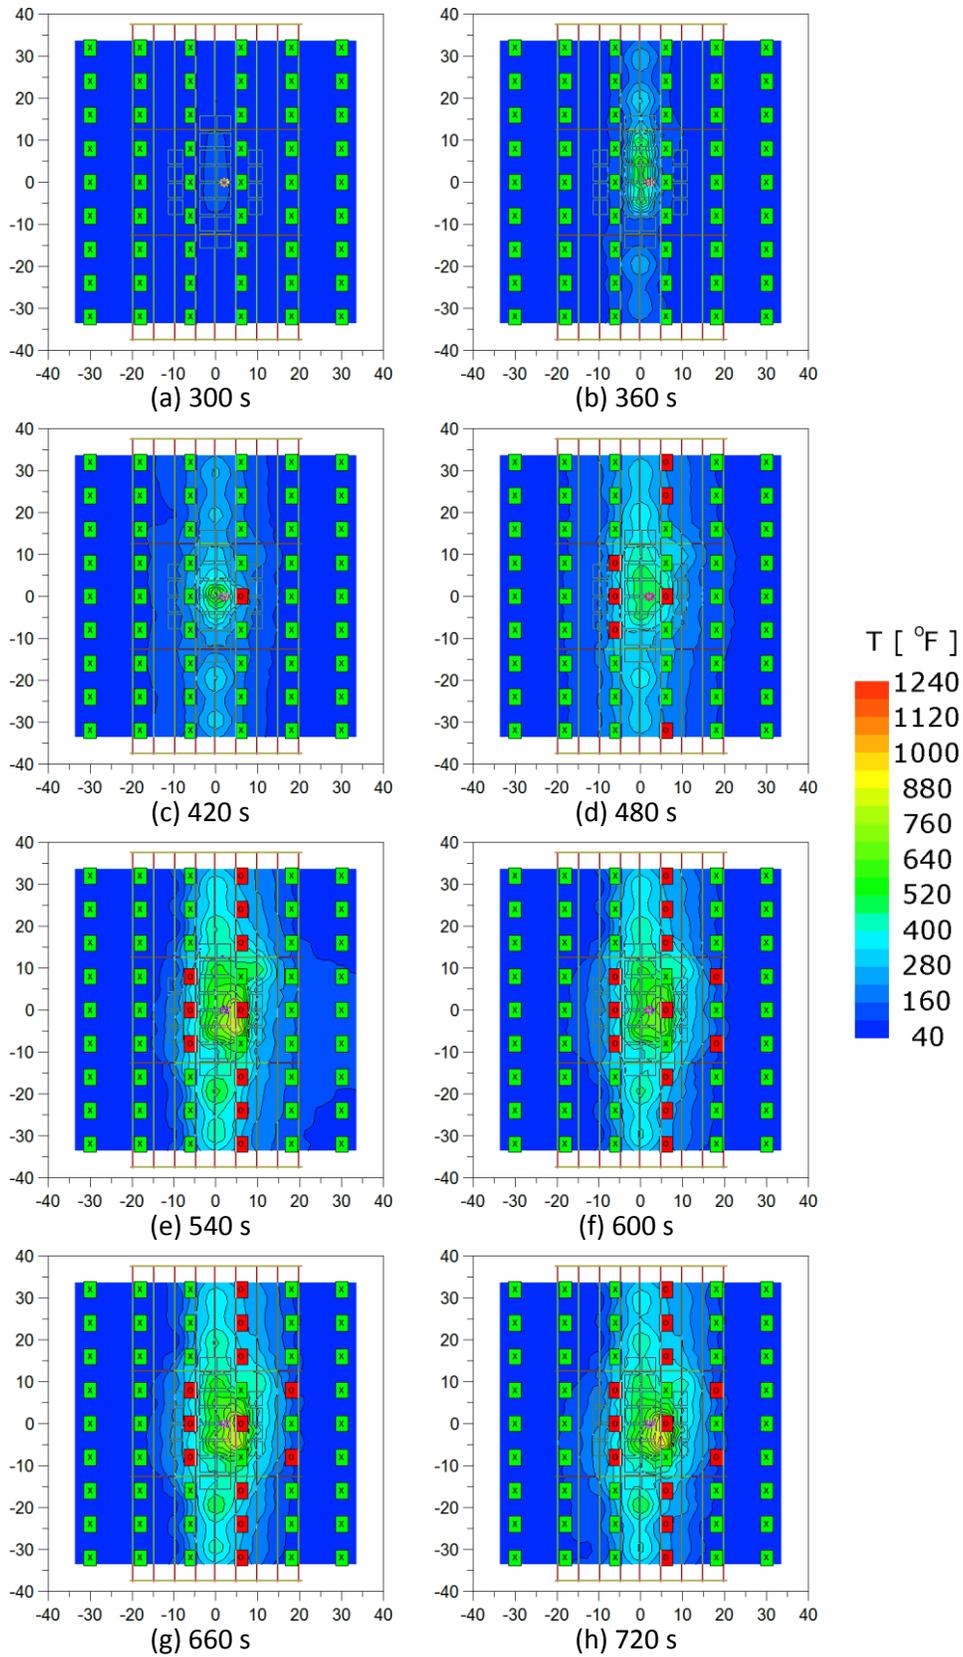
Figure 4-25: Test #4 ceiling temperature contours shown in 60 s increments.

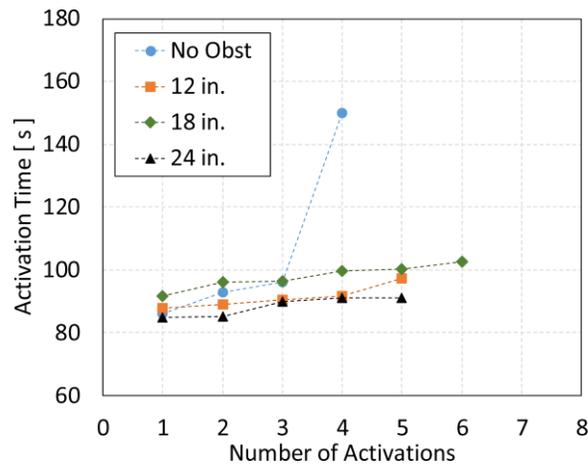
Figure 4-26: Activation times plotted as functions of number of activations for tests with and without obstructed ceiling construction for the CUP tests.

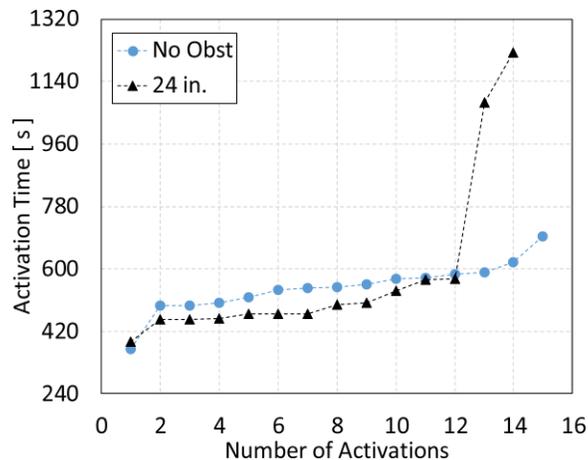
Figure 4-28: Activation times plotted as functions of number of activations for tests with and without obstructed ceiling construction for the UUP tests.

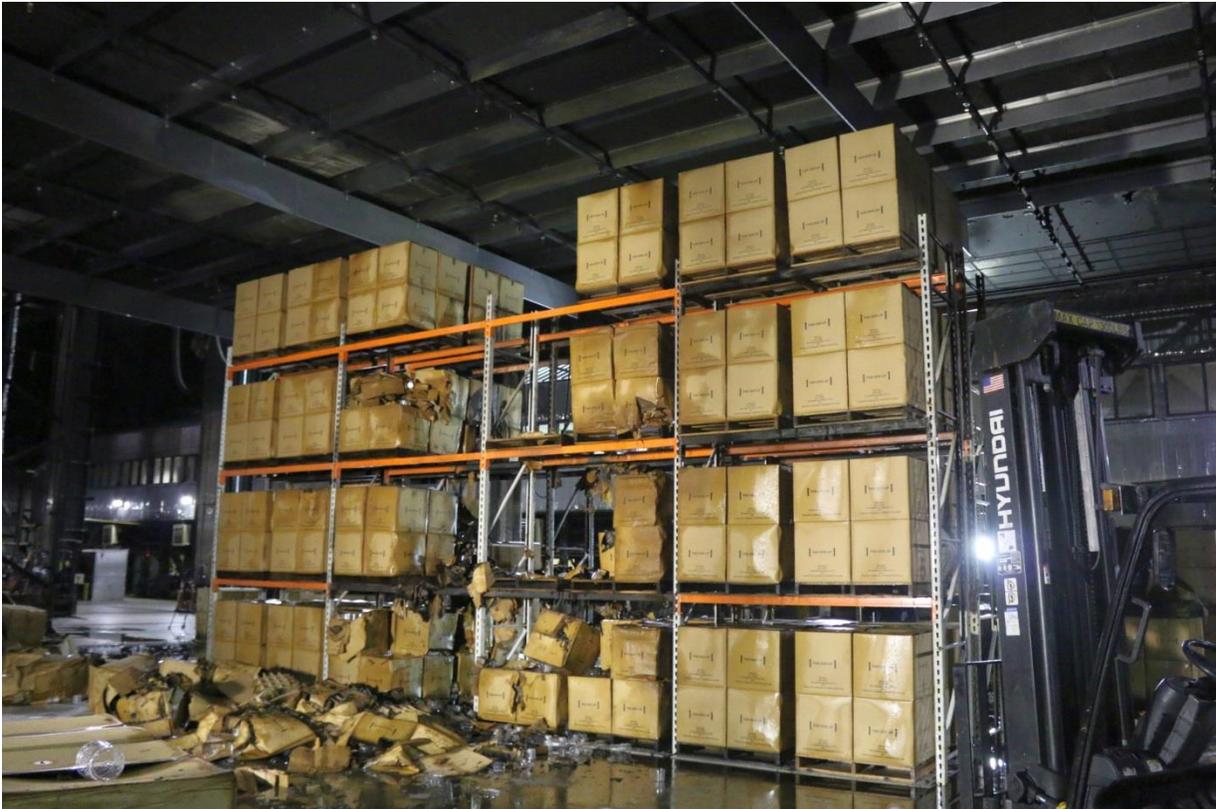
Figure B-5: Test #1 post-test photograph of the east face of the main array showing fire damage.

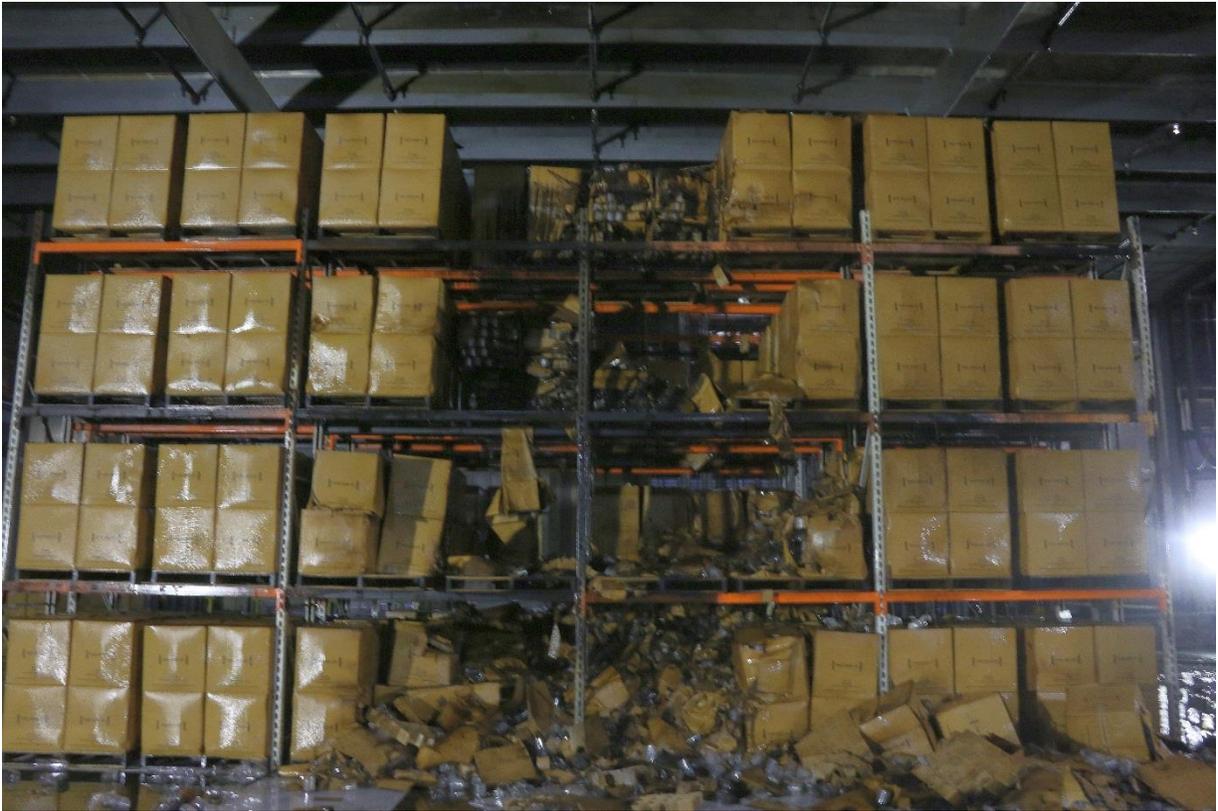
Figure B-10: Test #2 post-test photograph of the east face of the main array showing fire damage.

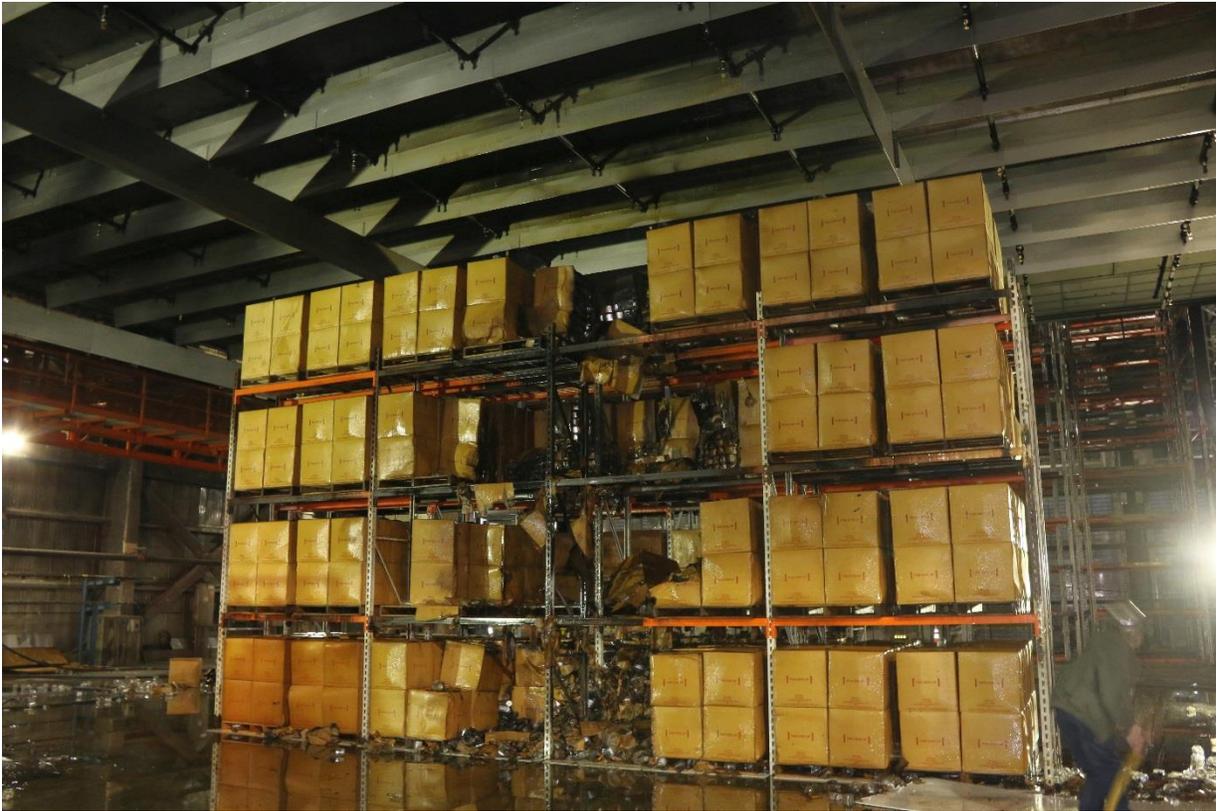
Figure B-15: Test #3 post-test photograph of the east face of the main array showing fire damage.

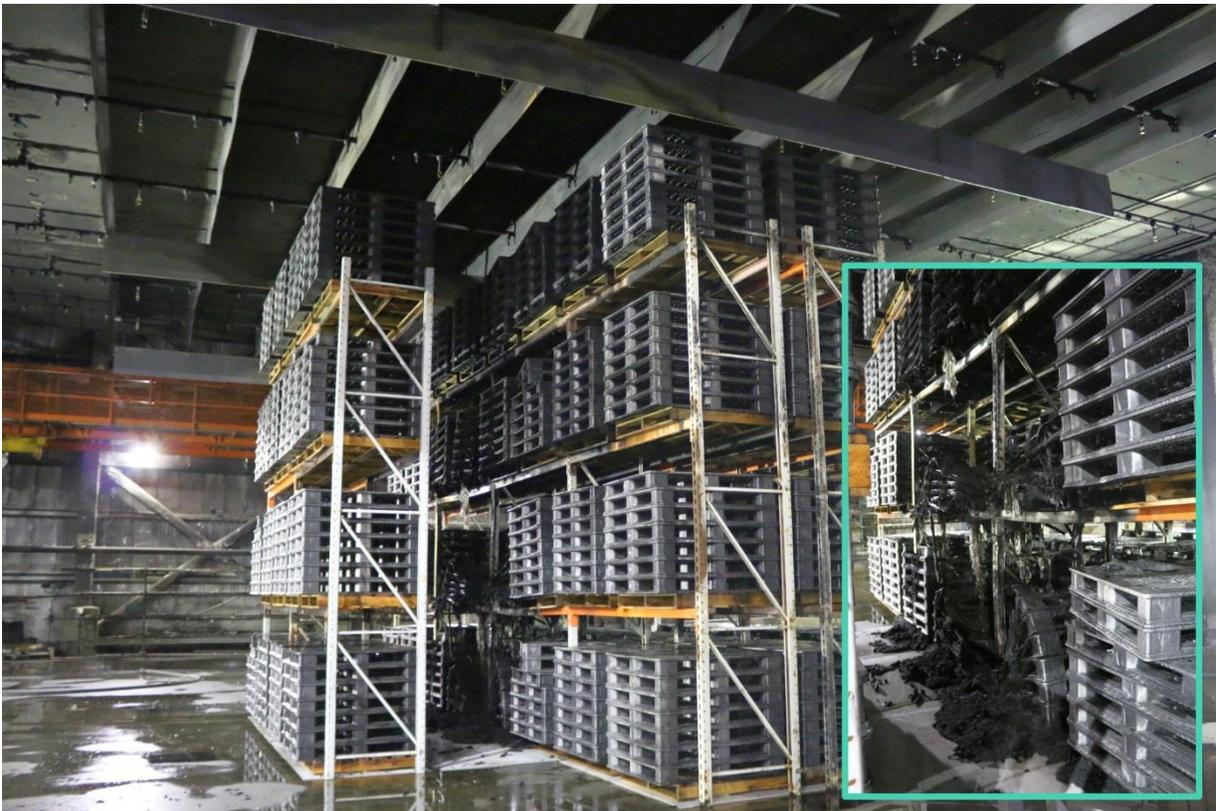
Figure B-20: Test #4 post-test photograph of the east face of the main array showing fire damage. Close-up of the damage area is shown in the inset.
