TECHNICAL REPORT FOR NFPA 13

**Large-Scale Validation of:**

**(1) In-Rack Automatic Sprinkler Designs for Open-Frame Rack Storage Using Quick-Response, Pendent K200 lpm/bar<sup>1/2</sup> (K14.0 gpm/psi<sup>1/2</sup>) and Larger Sprinklers, and**

**(2) Protection of Uncartoned Unexpanded Plastics in Open-Frame Double-Row Racks Using Two Different In-Rack Sprinkler Protection Arrangements**

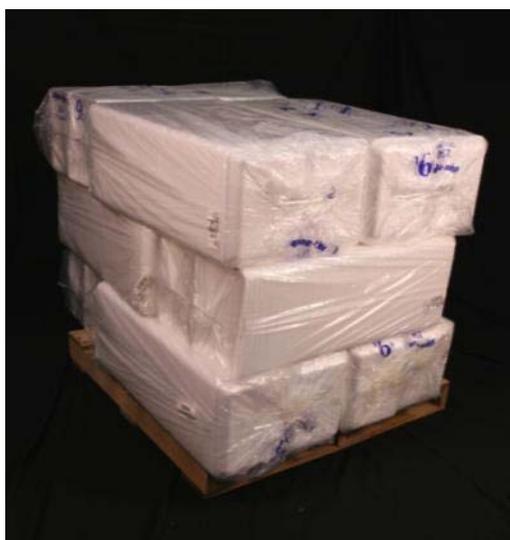
Figure 3.1.2.2.1-1: FM Global Standard Uncartoned Expanded Plastic (UEP) Commodity.

The FM Global Standard UEP test commodity, consists of expanded polystyrene meat trays packed in a plastic bag. Eight bags are then stacked onto an ordinary, two-way, slatted deck, hardwood pallet. The overall dimension of the commodity is 1.07 m x 1.18 m x 1.09 m (42 in. x 46 in. x 43 in.). The total combustible weight of one pallet load is approximately 52.3 kg (115.3 lb); the expanded plastic weighs approximately 29.9 kg (65.9 lb), and the hardwood pallet that supports the commodity weighs approximately 22.4 kg (49.4 lb). A photo of a representative pallet load of UEP commodity (note that this is not the actual pallet arrangement for the UEP test commodity) is provided in Figure 3.1.2.2.1-1.

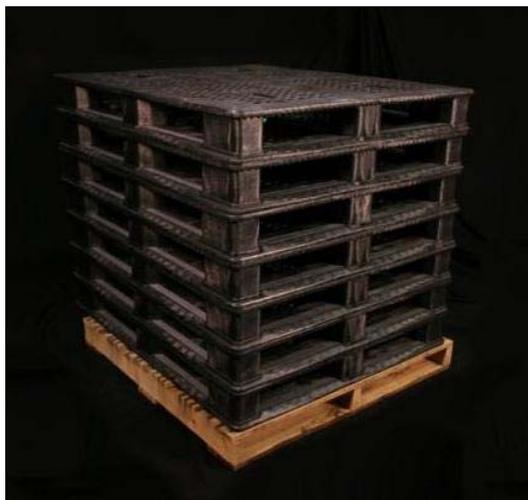
Figure 3.1.2.2.3-1: FM Global Standard Uncartoned Unexpanded Plastic (UUP) Commodity.

The rack storage UUP test commodity consists of seven plastic pallets stacked on top of an ordinary, two-way, slatted deck, hardwood pallet resulting in an overall dimension of 1.07 m x 1.22 m x 1.11 m (42 in. x 48 in. x 44 in.). The standard plastic pallets used by FM Global are high-density polyethylene plastic pallets. The four-way entry plastic pallets are not FM Approved and do not contain fire retardant materials. The pallets have dimensions of 1.02 m (40 in.) long by 1.22 m (48 in.) wide by 14 cm (5.6 in.) high and weigh about 25.4 kg [56 lb] each. The total combustible weight of one standard rack storage UUP pallet load is 200.3 kg (441.6 lb); the plastic pallets weigh approximately 177.9 kg (392.2 lb), and the hardwood pallet that supports the commodity weighs approximately 22.4 kg (49.4 lb). A photo of the standard rack storage UUP commodity is provided in Figure 3.1.2.2.3-1.

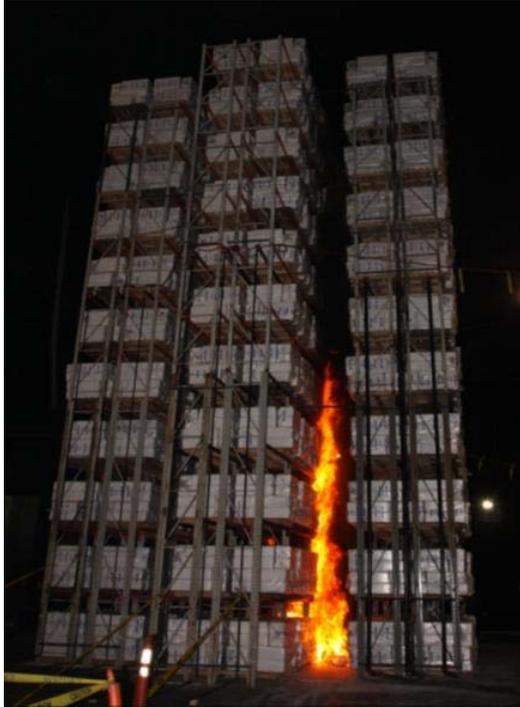
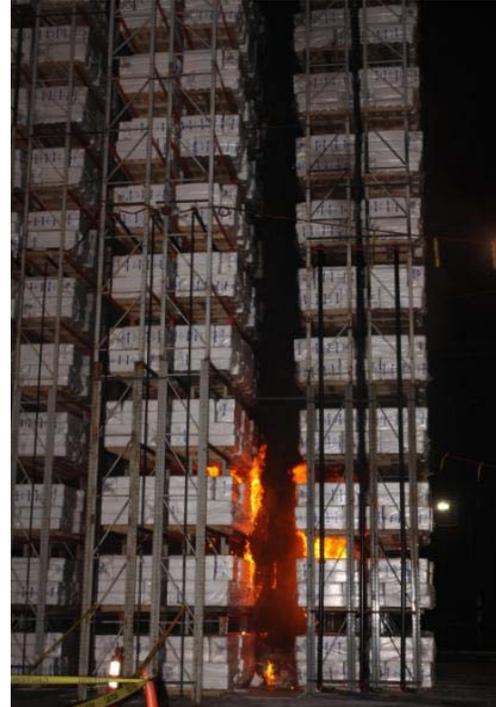
Figure 3.1.3.1.1-11: Test 1 (a) at 01:04, (b) at 02:14.

Ignition occurred at 00:00. Flame tips reached the top of the 1<sup>st</sup> tier commodity at 00:16, the top of the 2<sup>nd</sup> tier commodity at 00:38, and the top of the 4<sup>th</sup> tier commodity at 00:48. A burning piece of commodity became airborne by the fire plume and caused ignition of the east target at 00:55. As flames reached the top of the 5<sup>th</sup> tier commodity in the main array at 01:00 the 1<sup>st</sup> IRAS activation occurred in the transverse flue north of ignition. Following the IRAS activation, the vertical fire growth in the main array ceased; however, the fire remained in tiers 1-5 and the fire in the east target array was intensifying (Figure 3.1.3.1.1-1a). At 01:34 the 2<sup>nd</sup> IRAS activation occurred in the longitudinal flue of the main array south of ignition. The fire began to subside in the main array and intensify in the east target array to involve tiers 1-4. At 02:18 the 3<sup>rd</sup> IRAS activated in the southern most transverse flue in the east target array; Figure 3.1.3.1.1-1b shows the state of the fire 4 seconds prior to this IRAS activation. The 4<sup>th</sup> IRAS activation occurred seconds later at 02:21 in the longitudinal flue of the east target array. By 02:40 the fire in the east target array was confined to the west face and appeared to be stable and was of greater intensity than the fire in the main array, which remained confined to the east face. However, at 03:13 (Figure 3.1.3.1.1-2a shows the fire at 03:16) flames became visible in the longitudinal flue of the main array and two subsequent IRAS activated at 03:21 and 03:26 bringing the final IRAS count to six. By 03:55 the fire intensity had greatly diminished; Figure 3.1.3.1.1-2b shows the state of the fire at 04:12. At 06:30 small localized fires were observed in the 2<sup>nd</sup> and 4<sup>th</sup> tiers of the main array and the 3<sup>rd</sup> tier of the east target array. At no point during the test did fire ignite the commodity above the IRAS. The fire remained small in size until the test was terminated at 30:00.

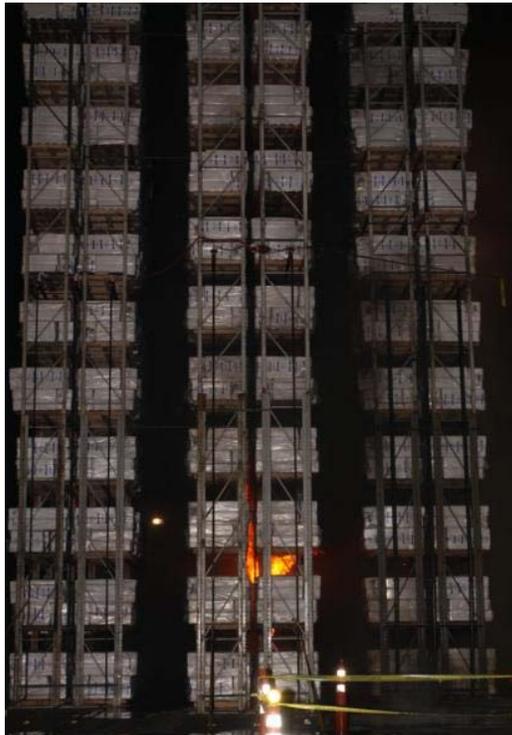
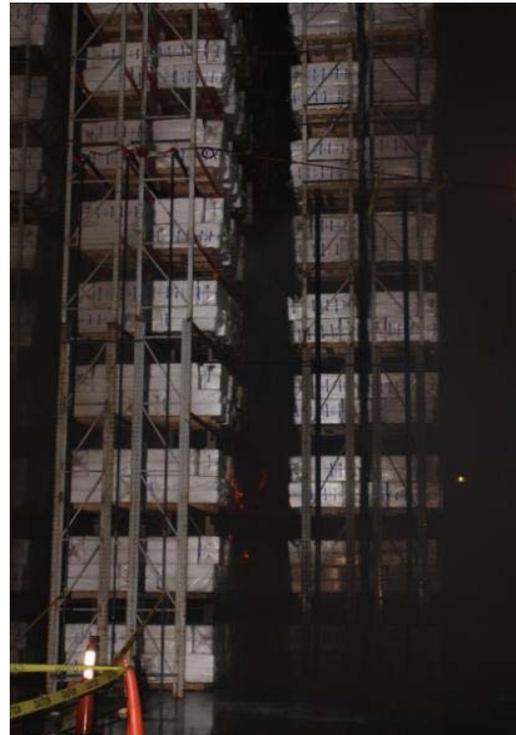
Figure 3.1.3.1.1-2: Test 1 (a) at 03:16, (b) at 04:12.

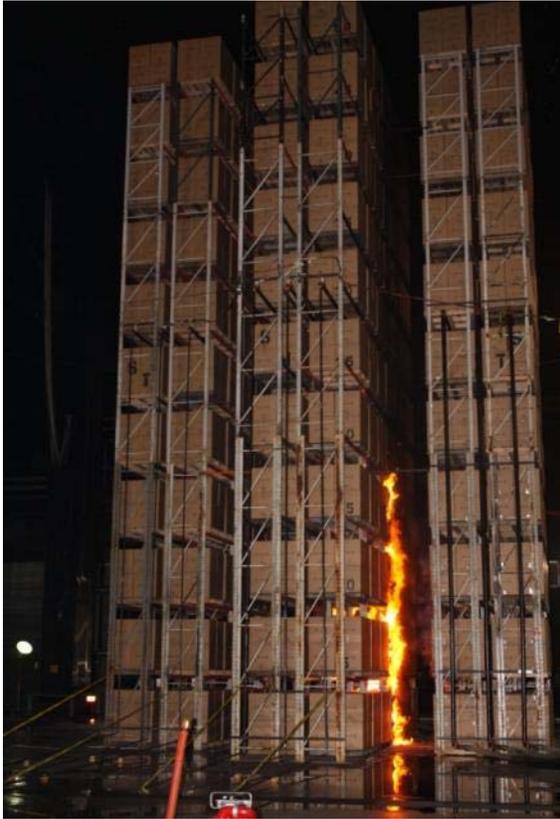
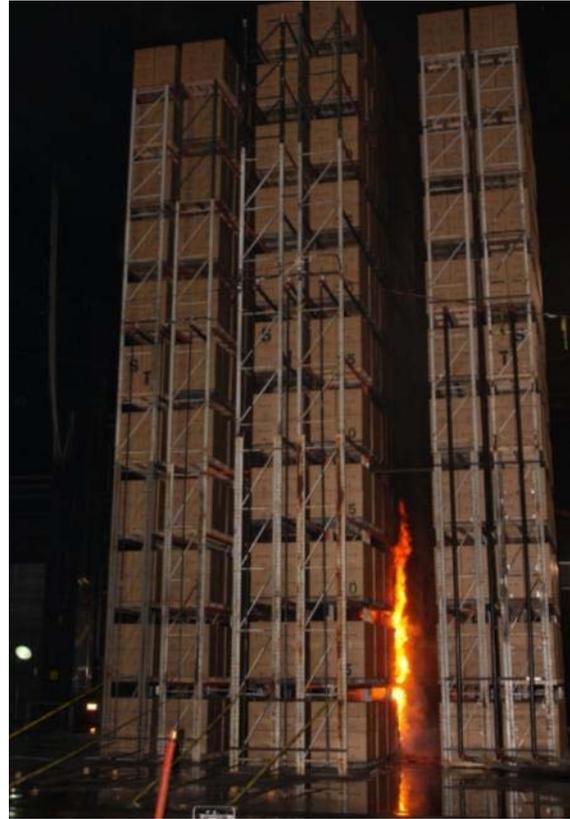
Figure 3.1.3.2.1-1: Test 2 (a) at 03:32, (b) at 4:46.

Ignition occurred at 00:00. Flame tips reached the top of the 1<sup>st</sup> tier commodity at 00:30. Flames periodically flashed above the top of the 2<sup>nd</sup> tier commodity at 02:20 and involved commodity in tiers 1-3 at 02:55. Flames were at the top of the 4<sup>th</sup> tier commodity at 03:18 and the 1<sup>st</sup> IRAS activation occurred at 03:32 (Figure 3.1.3.2.1-1a) in the main array within the transverse flue north of ignition. The 2<sup>nd</sup> and final IRAS activation occurred at 03:37 within the longitudinal flue of the main array south of ignition. Following sprinkler activation the vertical fire growth ceased and the fire remained contained to tiers 1-4 on the east

side of the main array. The fire intensity remained fairly constant for the next couple of minutes (Figure 3.1.3.2.1-1b) but began to show a noticeable decrease in severity by 06:15. Figure 3.1.3.2.1-2a shows the state of the fire at 06:32. The fire severity continued to decrease and at 09:00 flames were only visible in tiers 2 and 3 on the east side of the main array. For the remainder of the test the fire remained very small in size with localized burning in tiers 1-3 on the east side of the main array (Figure 3.1.3.2.1-2b). The test was terminated at 30:00.

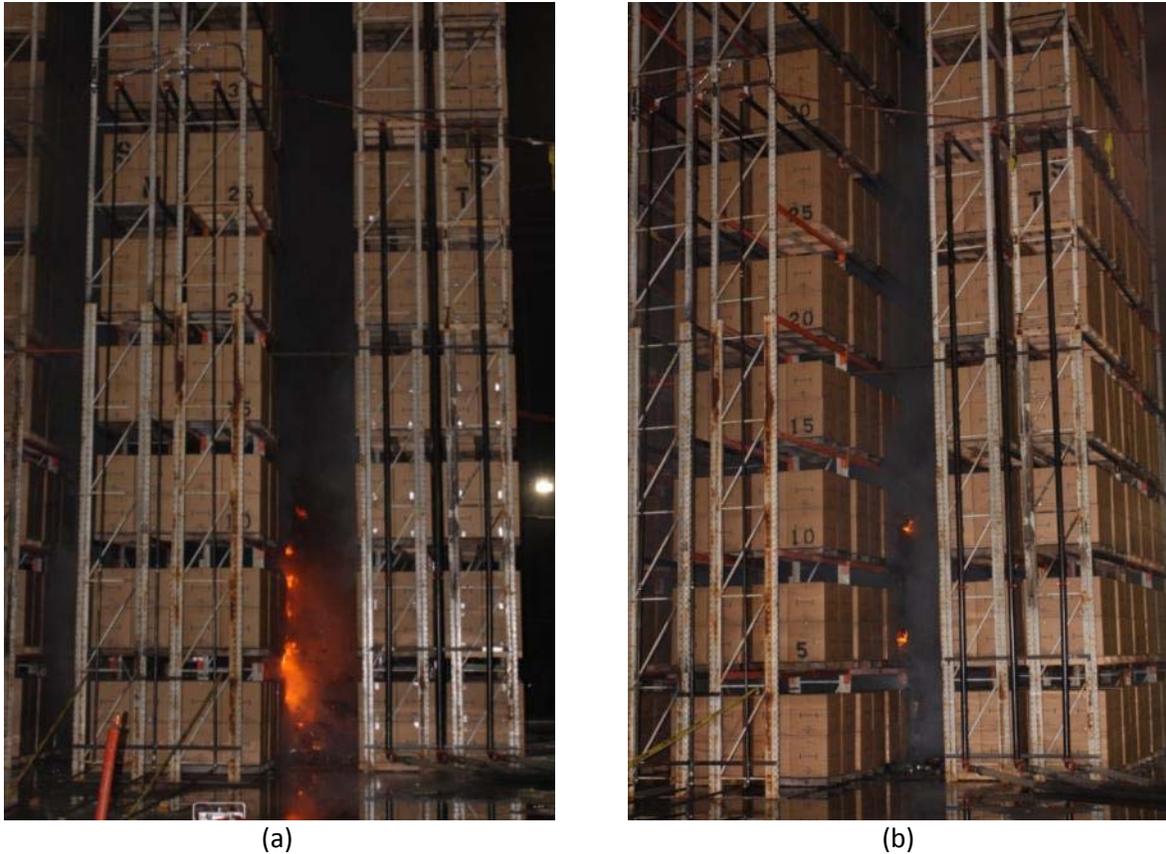
Figure 3.1.3.2.1-2: Test 2 (a) at 06:32, (b) at 24:24.

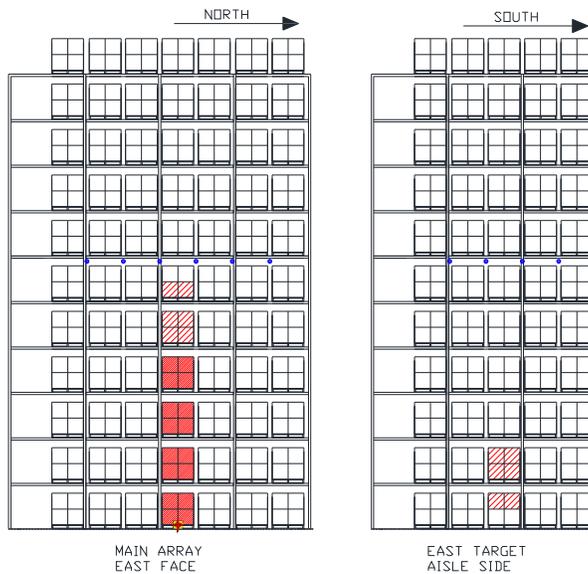
Figure 3.1.3.2.3-1: Test 2 Post Test Damage: (Left) Ignition Face of Main Array, (Right) Target Facing Ignition.

Test 2 post-test damage is shown in Figure 3.1.3.2.3-1 and Figure 3.1.3.2.3-2. The fire remained exclusively on the east side (ignition side) of the main array. Heat from the ignition region cause discoloration of the commodity directly across the aisle in the east target; however, that commodity did not ignite. The fire and all fire damage remained below the IRAS.

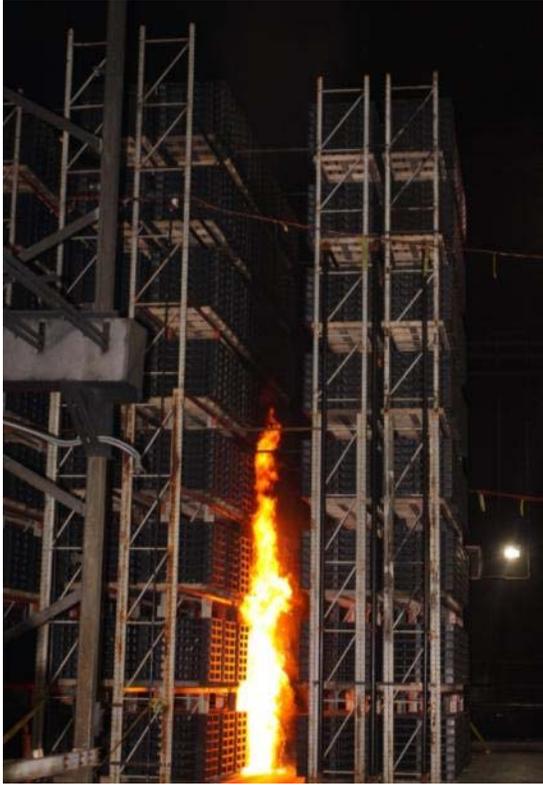
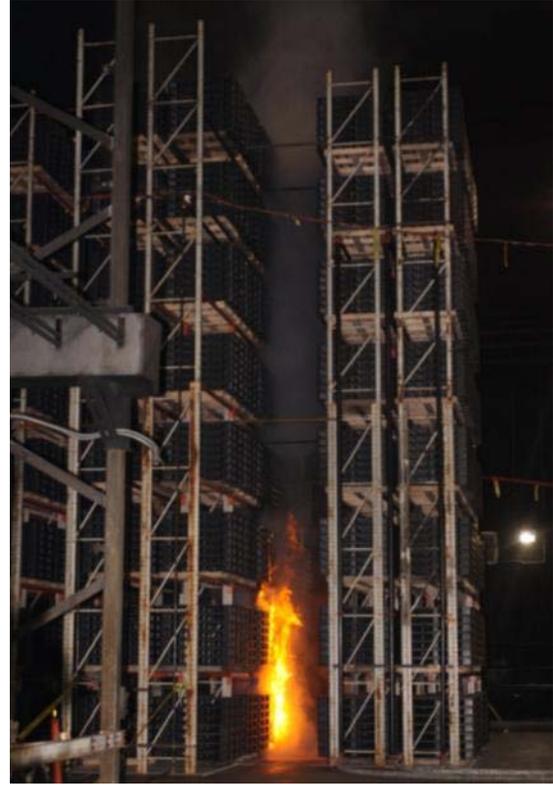
Figure 3.1.3.4.1-1: Test 4 (a) at 07:14, (b) at 07:52.

Ignition occurred at 00:00. At 03:05 flame tips reached the top of the 1<sup>st</sup> tier commodity and periodically extended to the bottom of the 3<sup>rd</sup> tier commodity at 06:00. At 07:14 flame tips were periodically extending to the top of the 5<sup>th</sup> tier commodity (Figure 3.1.3.4.1-1a). The 1<sup>st</sup> IRAS activation occurred at 07:22 immediately followed by the 2<sup>nd</sup> and final IRAS activation at 07:25. The activations occurred within the transverse flue spaces directly north and south of ignition. At 07:47 flames had been driven down to below the 5<sup>th</sup> tier level. At 07:52 the fire was confined to tiers 1-3 (Figure 3.1.3.4.1-1b). By 08:01 flames were below the 3<sup>rd</sup> tier level and by 08:14 the fire was confined to the 1<sup>st</sup> tier commodity. No flames were visible in the main array at 08:52 (Figure 3.1.3.4.1-2). At 12:47 firefighters confirmed that the fire was extinguished and the test was terminated at 13:00.

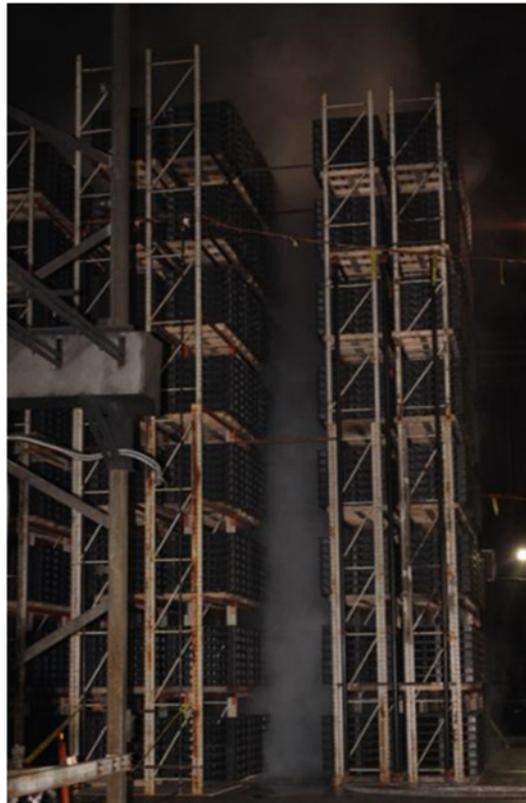
Figure 3.1.3.4.1-2: Test 4 at 08:52.

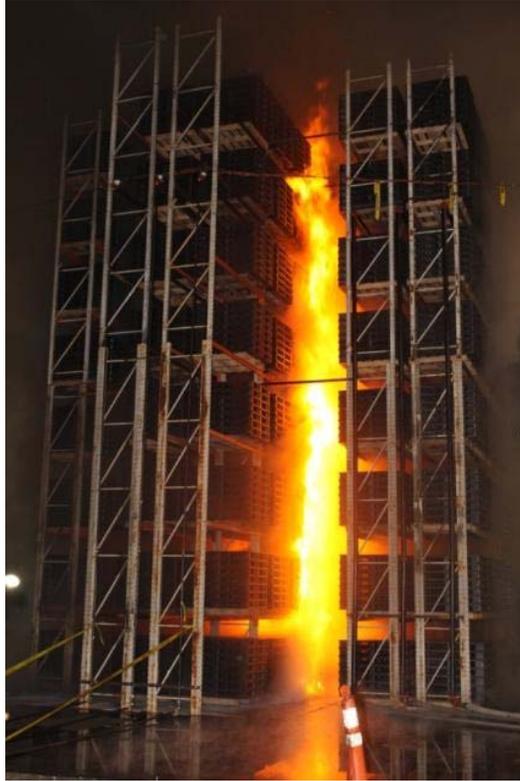
Figure 3.1.3.5.1-2: Test 5 at 15:42.

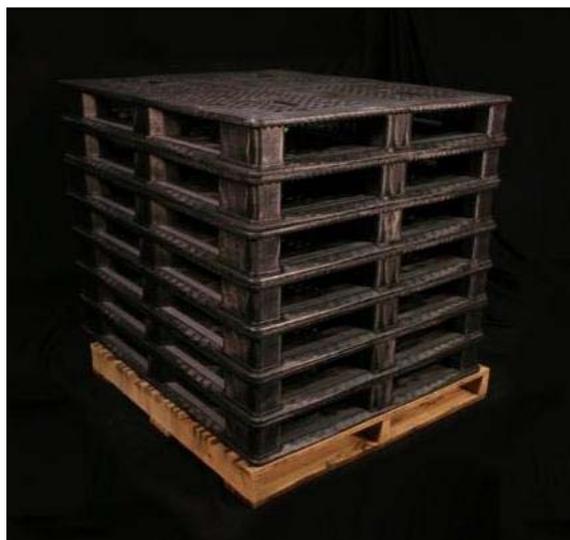
Figure 3.2.2.2-1: FM Global Standard Uncartoned Unexpanded Plastic (UUP) Commodity.

The rack storage UUP test commodity consists of seven plastic pallets stacked on top of an ordinary, two-way, slatted deck, hardwood pallet resulting in an overall dimension of 1.07 m x 1.22 m x 1.11 m (42 in. x 48 in. x 44 in.). The standard plastic pallets used by FM Global are high-density polyethylene plastic pallets. The four-way entry plastic pallets are not FM Approved and do not contain fire retardant materials. The pallets have dimensions of 1.02 m (40 in.) long by 1.22 m (48 in.) wide by 14 cm (5.6 in.) high and weigh about 25.4 kg [56 lb] each. The total combustible weight of one standard rack storage UUP pallet load is 200.3 kg (441.6 lb); the plastic pallets weigh approximately 177.9 kg (392.2 lb), and the hardwood pallet that supports the commodity weighs approximately 22.4 kg (49.4 lb). A photo of the standard rack storage UUP commodity is provided in Figure 3.2.2.2-1.
