*Summary Report of Fire Testing Involving
Small Plastic Containers of Low Flash Point
Liquids in Rack Storage – for NFPA 30*

(Document prepared in support of code changes)

Jill Norcott
Chief Engineer's Group
FM

NFPA 30 Flammable and Combustible Liquids Code

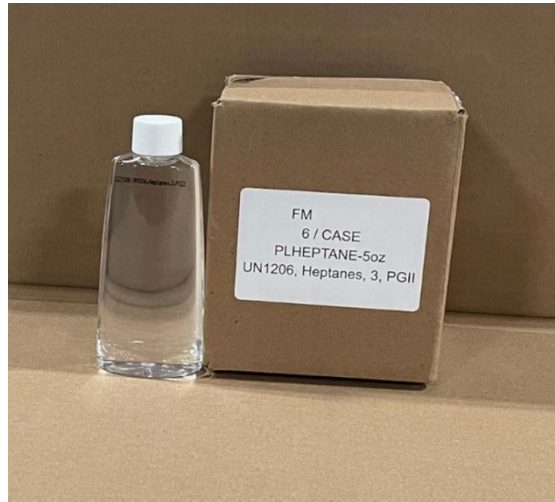
Figure 3-1: Photograph showing typical heptane bottle and carton.

Commodity for both tests included 5 oz. (150 mL) polyethylene terephthalate (PET) plastic bottles filled with heptane, as shown in Fig. 3-1. The heptane bottles were loosely packaged as a single layer, two bottles wide by three bottles long (six bottles per carton) inside corrugated cardboard cartons measuring 4.25 in. (10.8 cm) wide by 5 in. (12.7 cm) long by 6 in. (15.2 cm) tall (see Fig. 3-1). The cartons were stacked on hardwood pallets, 80 cartons per layer by 7 layers tall (560 cartons per pallet) as shown in Fig. 3-2. Each pallet load of heptane commodity nominally measured 42.5 in. (108 cm) wide by 42.5 in. (108 cm) long by 47 in. (119 cm) tall.

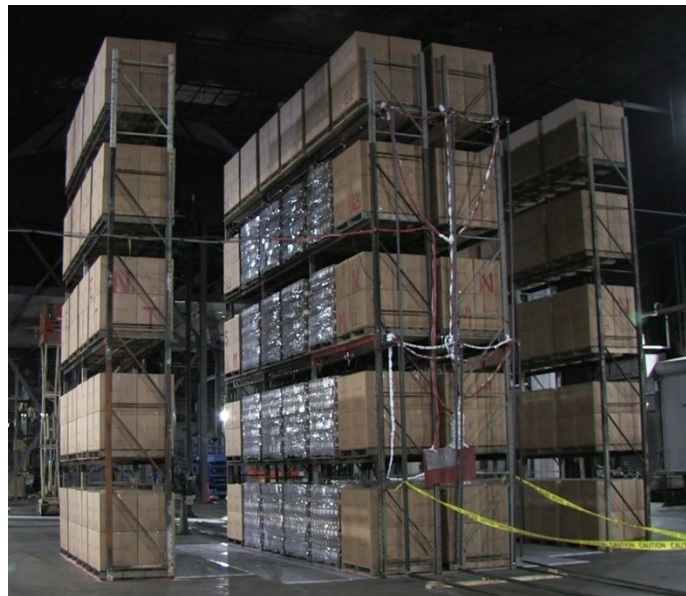
Figure 3-6: Photograph viewing Test 1 array from the northeast.

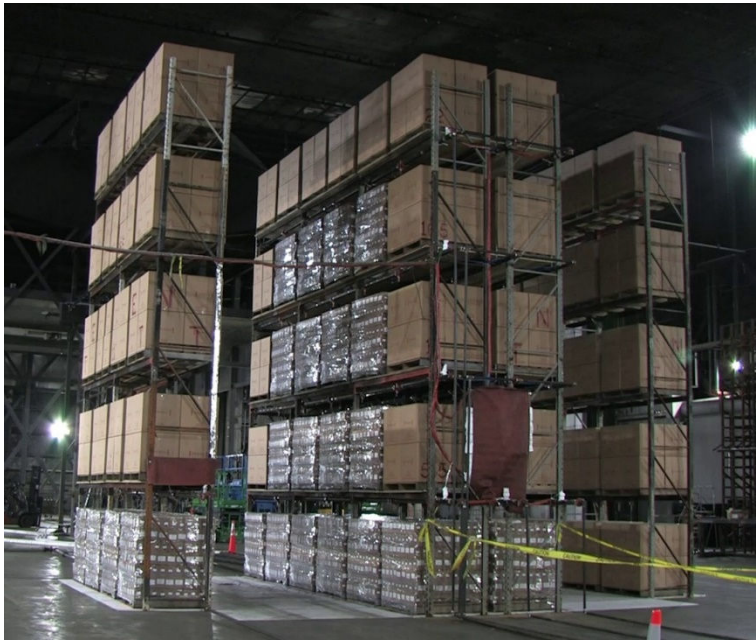
Figure 3-11: Photograph viewing Test 2 array from the northeast.
