# UPS Battery Safety: Fire and Explosion Hazard Assessment and Mitigation

TECHNICAL REPORT

April 2026

Project ID: RW000938

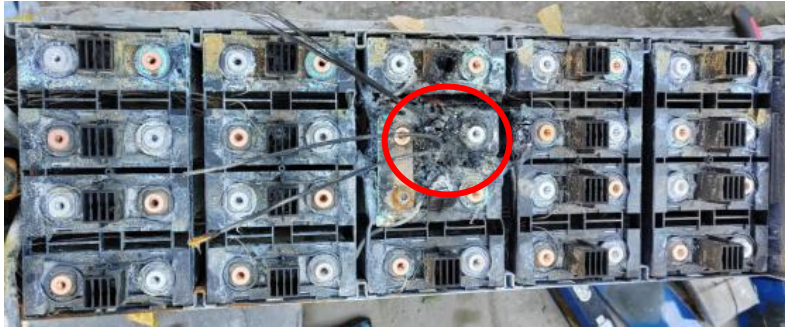
In the UL 9540A unit-level test, all modules were charged to a 100% state-of-charge (SOC) and one module was designated as the initiating module. A single cell within this module was thermally abused to initiate TR. Within the initiating module, a cell located at the center of the module (highlighted by the red circle in the post-test image in Figure 2-2), was heated at a rate of 5.5 °C/min via electrical heaters. TR occurred after approximately 21 minutes, releasing a substantial amount of gas that enveloped the unit. TR did not propagate to adjacent cells, likely due to reduced heat transfer caused by the separation between cells. The post-test image of the initiating module (Figure 2-2) indicated that the damage was largely confined to the cell of origin, while neighboring cells exhibited minimal damage.

Figure 2-2: Post-test image of the initiating module [3].

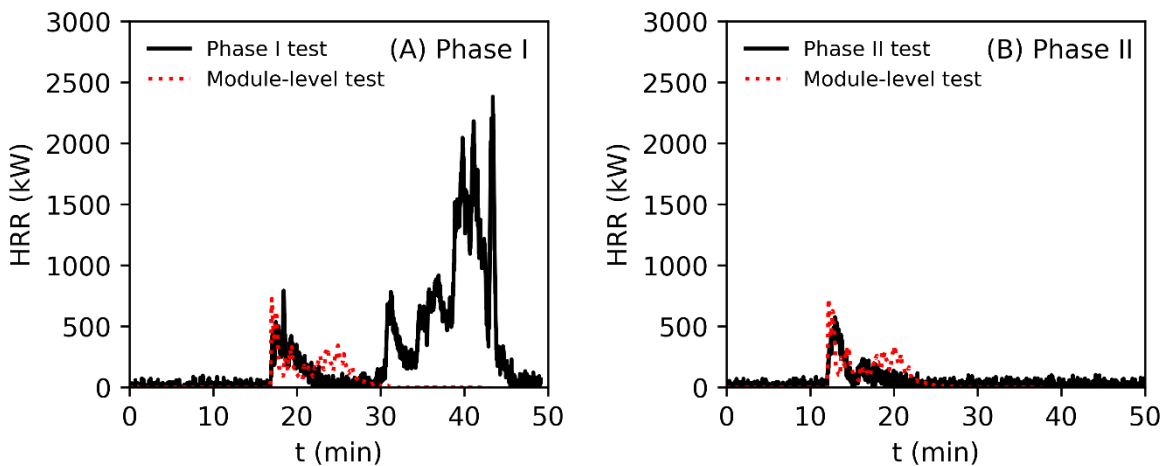
Figure 3-5 shows the fire growth histories for both Phase I and Phase II tests. In the Phase I test, the HRR rapidly increased, reaching a peak of about 800 kW at around 17 minutes. This was followed by a decline to a low value at 22 minutes and remained low until the 30-minute mark. The Phase II test exhibited a similar fire growth pattern during the first 30 minutes. In both cases, the HRR trend closely resembles the HRR profile observed in the module-level test (shown as red dotted line with time-shifting to match the onset), confirming the dominant role of Module 23 in early fire development.

Figure 3-5: Heat release rate (HRR) of the three-unit fire tests, with module-level result shown as red dotted lines.

Despite displaying similar initial fire growth, the two tests diverged significantly after 30 minutes. In the Phase I test, the HRR rose again at around 30 minutes, reaching another local peak of about 800 kW. This was followed by a number of local peaks, suggesting the involvement of additional modules and TR propagation within the unit of origin. At around 38 minutes, the surface temperatures of Modules 2 and 29 in the target units exceeded the cell venting temperature of 500 °F (260 °C), as

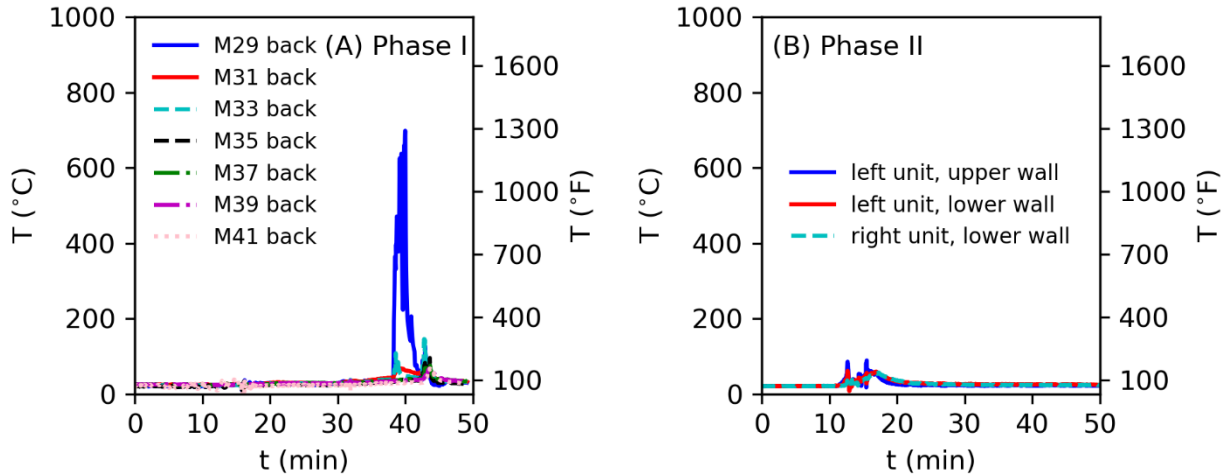
shown for Phase I in Figure 3-6; thereby meeting the test failure criteria. Although the automatic sprinklers activated at approximately 24 minutes, they were ineffective in suppressing the TR propagation process. This is likely caused by the unit enclosure obstructing water access to the modules. The HRR ultimately reached a maximum value of 2400 kW before manual suppression was initiated and the test was concluded. Post-test monitoring over a 24-hour period confirmed that no further reignition or TR events occurred.

In contrast to Phase I, the Phase II test showed no visible flames after 24 minutes, and the HRR remained consistently low throughout the remainder of the test. Thermocouples mounted on the target unit walls (see Appendix C for detailed sensor locations) recorded maximum temperatures below 212 °F (100 °C) (see Figure 3-6), indicating no TR propagation potential to neighboring units in the Phase II test.

Figure 3-6: Temperature history in the target units for Phase I and Phase II tests.

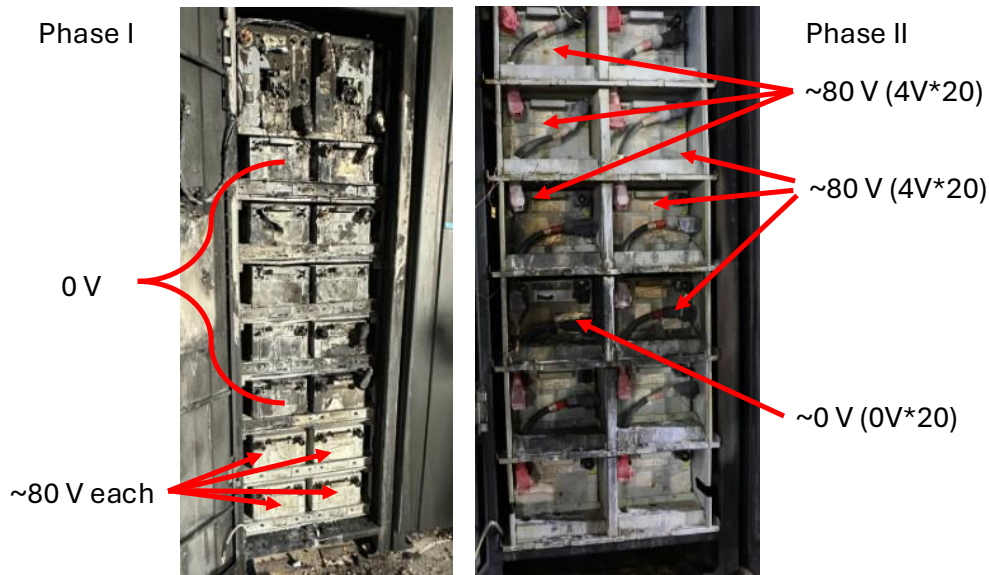
Post-test inspection showed that the unit of origin sustained significant thermal damage in the Phase I test (see Figure 3-7). The front surfaces of Modules 23 and 24, along with those positioned above them, showed visible thermal damage. Internal components, such as plastic caps, demonstrated signs of charring and heat-induced damage. Close examination of Modules 15 to 24 showed that most of their cells had undergone venting, as evidenced by open vent ports. However, the bottom four modules maintained a measured voltage of 80 V, confirming that TR did not propagate to them.

Figure 3-7: Images of the unit of origin and measured voltages after tests, left: Phase I test, right: Phase II test.

In contrast, the Phase II test resulted in damage confined solely to the initiating Module 23, with a measured voltage of 0 V post-test. All other full modules maintained a voltage of 80 V, demonstrating no TR propagation. In addition, plastic caps and cables located in front of all modules (except Module 23) showed only minor discoloration, suggesting minimal thermal exposure.

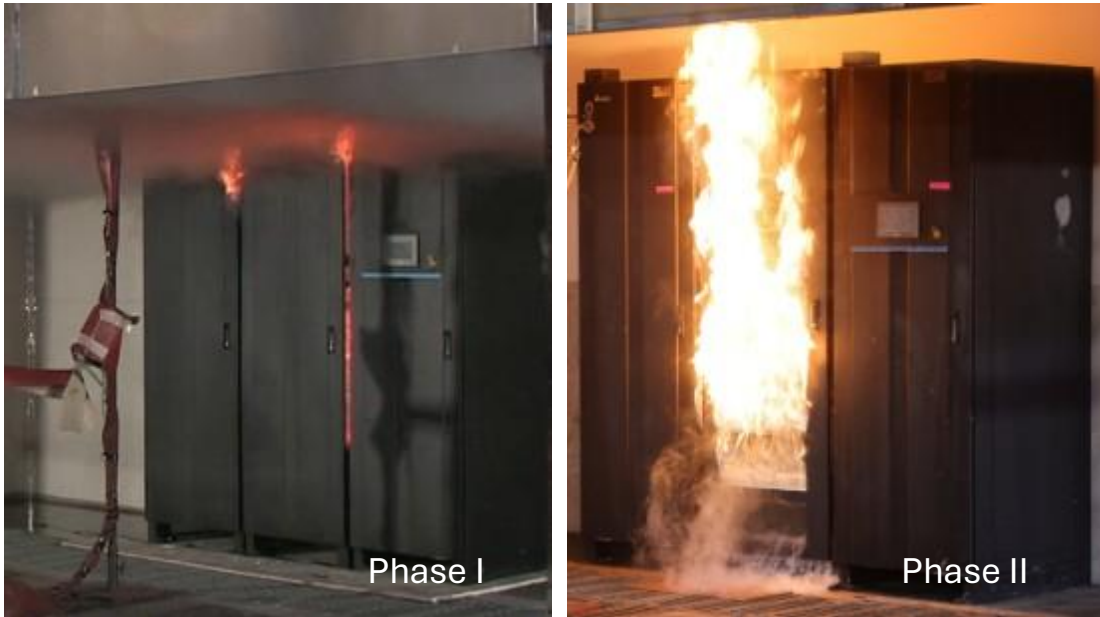
Figure 3-10 shows images captured during the Phase I and Phase II tests. In the Phase I test image, the flame is largely obscured by the unit doors and adjacent units, while in the Phase II image, a prominent flame is clearly visible in front of the perforated unit door. At the time of imaging, the HRR measurements were approximately 300 kW for the Phase I test and 200 kW for the Phase II test. The limited flame visibility in Phase I is attributed to the cavity fires occurring within the enclosure, which were concealed by the closed doors. Conversely, in Phase II, despite the lower HRR, the flame was external and unobstructed, resulting in a greater visual prominence.

Figure 3-10: Images of the test at ~17 minutes in Phase I and ~12 minutes in Phase II tests.

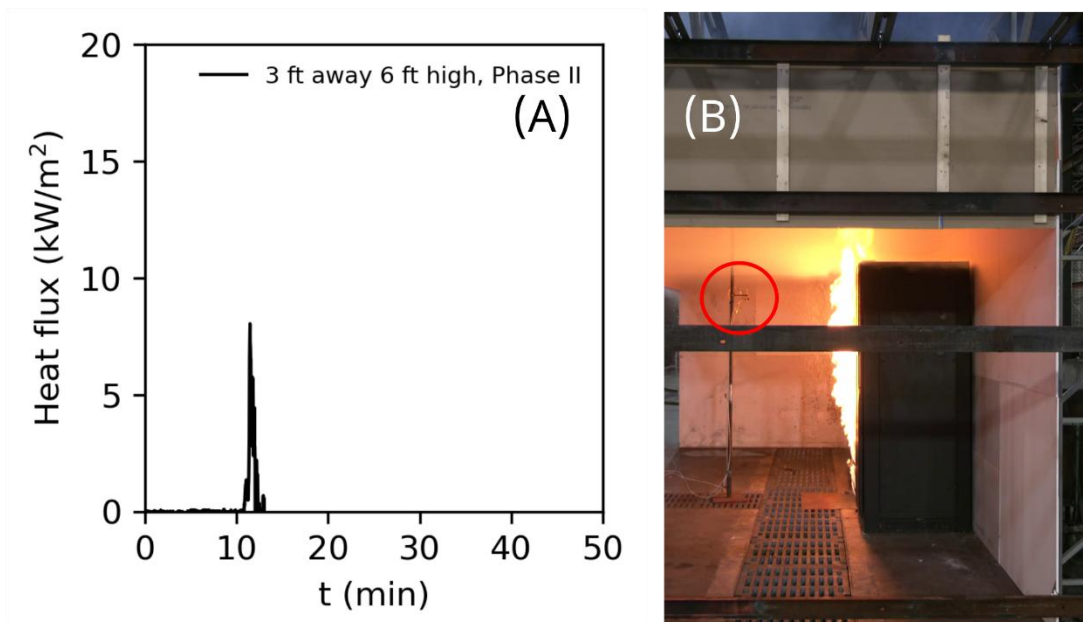
Figure 3-12: Heat flux measurement results in the Phase II test, (A) heat flux history, and (B) image taken at the time of sprinkler activation, with the red circle indicating the location of the heat flux gauge.

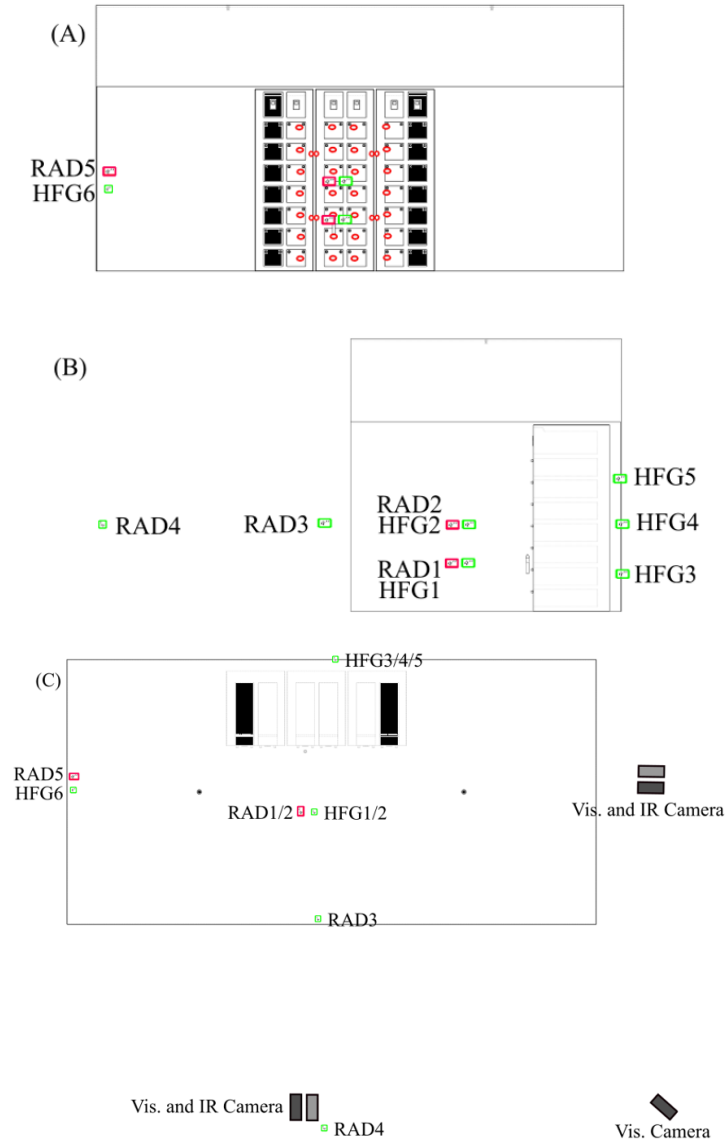
Figure C-1 shows the instrumentation utilized in the Phase I large-scale fire test. These instruments are designed to assess the status of fire propagation within the unit of origin and the thermal exposure of the fire to surrounding areas, including adjacent units and compartment walls. Figure C-1(A) presents a front-view schematic depicting the installation of thermocouples on the unit of origin for Phase I.

Figure C-1: Schematic of the large-scale test instrumentation layout in Phase I test: (A) front view schematic, the red circles represent thermocouples, (B) side view schematic, (C) plan view of the rack of origin and adjacent racks.

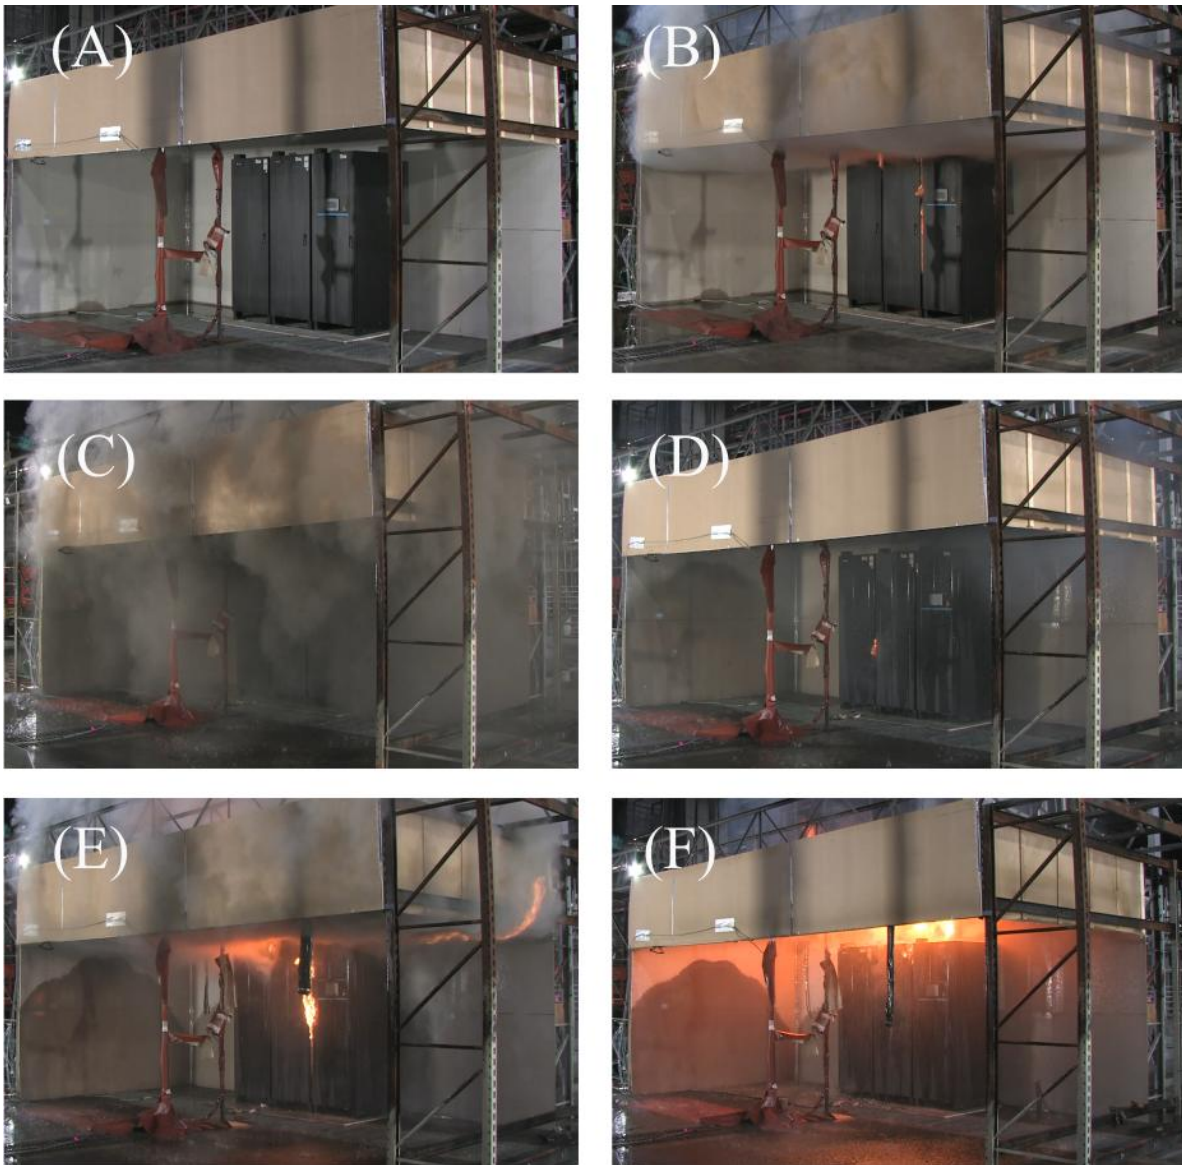
Figure D-1: Representative images of the Phase I fire test: (A) pretest, (B) at approximately 17 minutes flames emerge from the top surface and door seams of the initiating unit, (C) sprinkler activation at around 24 minutes, (D) ~29 minutes, reignition is observed with flames emerging from the initiating unit, (E) ~40 minutes, fire size increases and flames emerge from the partially open side walls, (F) ~42 minutes, fire heating damaged the ceiling structure, causing partial ceiling collapse, and flames emerge from the top of the room.
