INSPECTION AND MAINTENANCE OF ROOF ASSEMBLIES

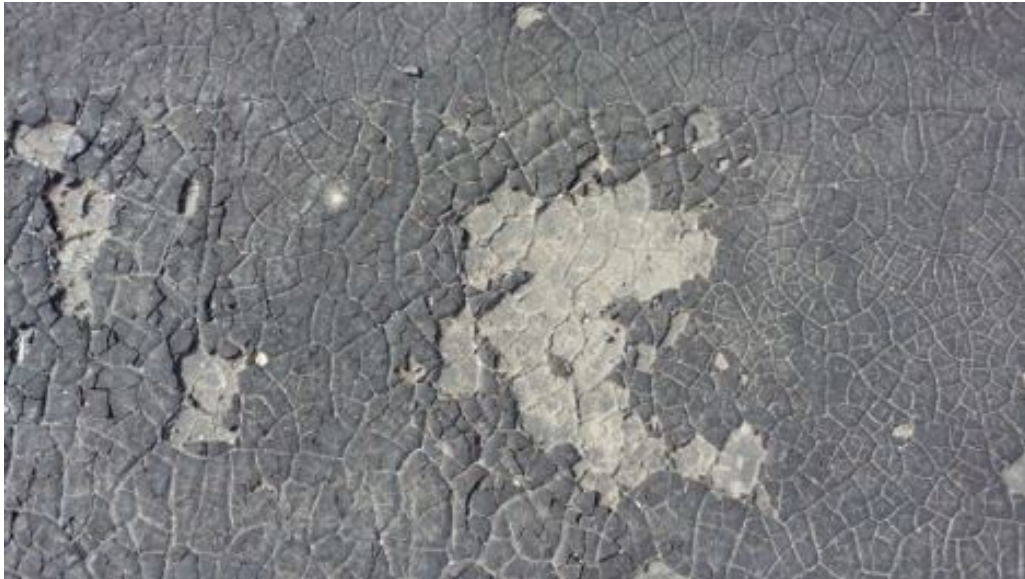
Figure 1.1-1 shows damage to a more than 20-year-old four-ply built-up roof from only 1 in. (25 mm) diameter hail, which has "chipped" parts of the asphalt flood coat that has "alligatored" as a result of age and loss of solvents (resulting in brittleness and loss of adhesion to the fiberglass felts). The alligatored appearance is a clear indication that the roof has aged and is vulnerable to damage from small hail.

Fig. 1.1-1 Hail damage to 20-year-old "alligatored" built-up roof

- J. Multi-ply roof covers (built-up or modified bitumen): Punctures, cracks, open roof seams, blisters (see Figure 3.1-8), wrinkles, ridges, missing granules, fastener back-out, unadhered areas, continuous distribution of aggregate (if present), and continuous and nondeteriorated surface coatings (if present). Also deteriorating felts (e.g., scrim is showing as in Figure 3.1-10), and alligatored surfaces (see Figure 1.1-1).

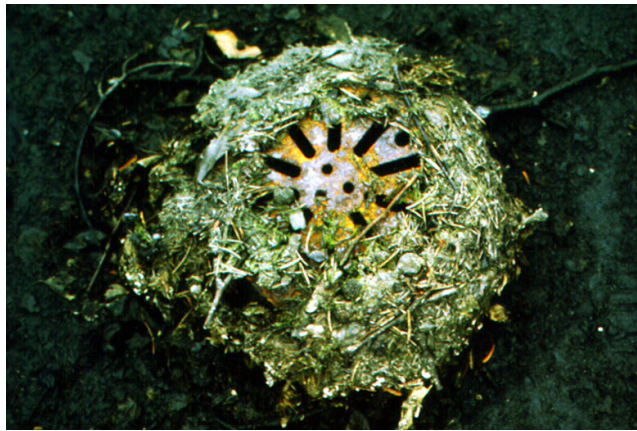
Fig. 3.1-1. Debris blocking roof drain

- E. Debris blocking or restricting roof drains (see Figures 3.1-1 and 3.1-2), scuppers, gutters and downspouts. Check for missing debris covers over interior roof drains.

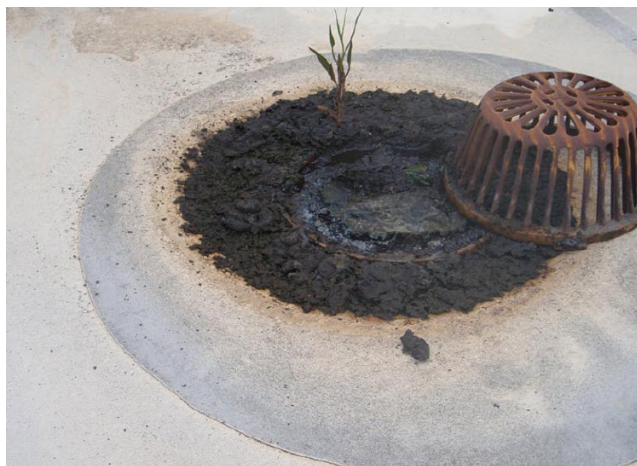
Fig. 3.1-2. Clogged roof drain

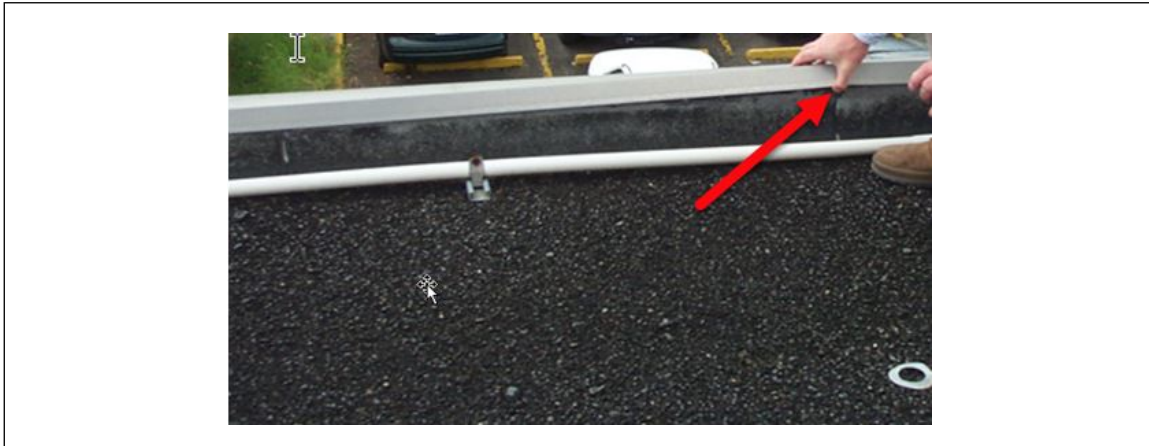
Fig. 3.1-3. Flashing easily lifted (follow appropriate safety procedures when near the roof edge)

- B. Flashing that has loose or missing fasteners, is loose (see Figure 3.1-3), bent, or missing; missing joint covers; holes or corrosion; and cracked or weathered sealants. Also loose, open, or deteriorated stripping material sealing the roof to the flashing.

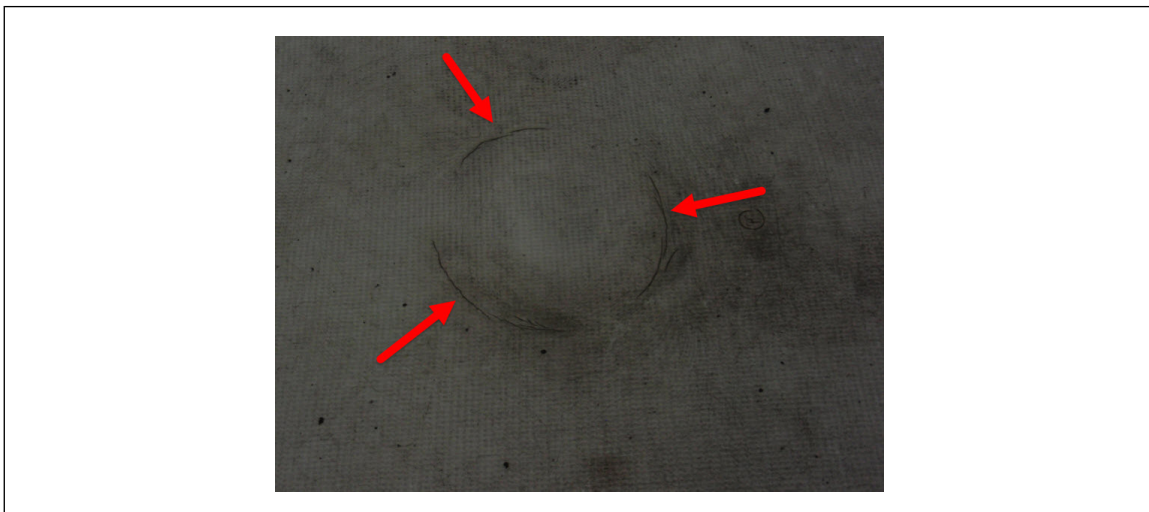
Fig. 3.1-4. Cuts in PVC cover at the edge of a stress plate

- I. Single-ply membranes for holes, cuts (inspect closely at stress plates where the membrane can be cut, including by hail; see Figure 3.1-4), ridges, open seams, crazing, erosion, deterioration or the scrim (reinforcement) showing, screws pulling out of the deck, unsupported areas of the membrane (caused by warping, bowing, or shrinkage of insulation boards), unbonded membranes in adhered roofing systems (billowing when windy), improper ballast distribution and coverage of the membrane, peeling or flaking of coatings (see Figure 3.1-6), or non-fleece-backed PVC roof covers installed directly (i.e., without a separating layer) over asphalt or polystyrene insulation.

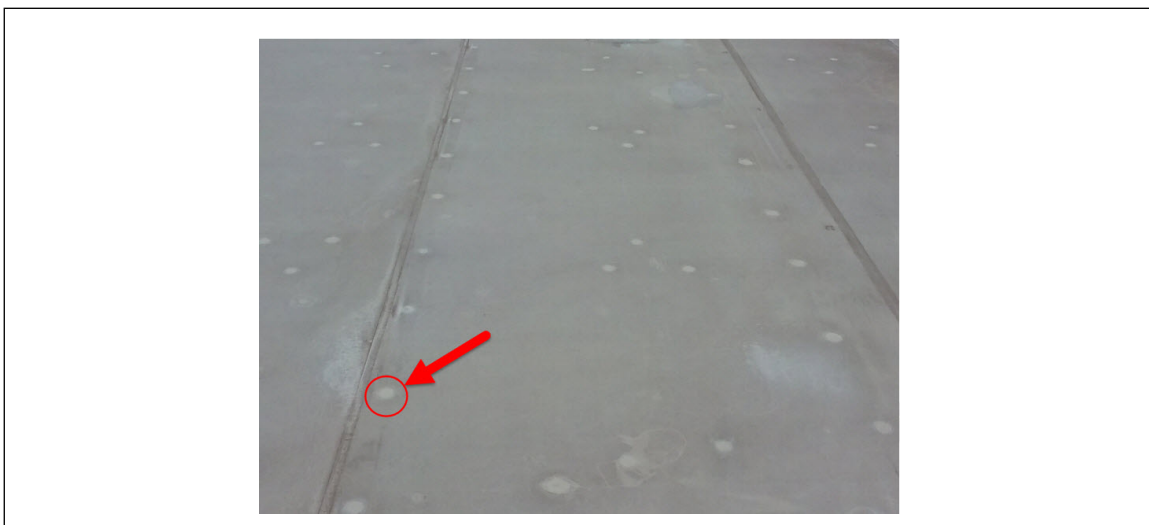
Fig. 3.1-5. Mechanically attached PVC cover with lighter areas over plastic stress plates that may indicate plasticizer loss and increase in brittleness

- 2. Darkening of the membrane, with originally white membranes turning yellow or brown, or areas over plastic stress plates becoming lighter (see Figure 3.1-5). Plastic stress plates can cause increased plasticizer migration in PVC roofs.

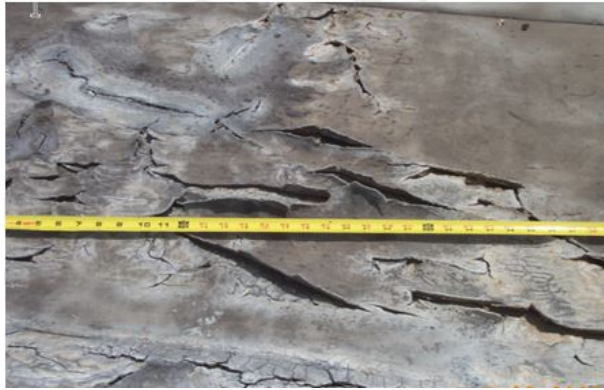
Fig. 3.1-6. Shrinkage and embrittlement of a thermoplastic single-ply roof with flaking of an incompatible asphaltic coating

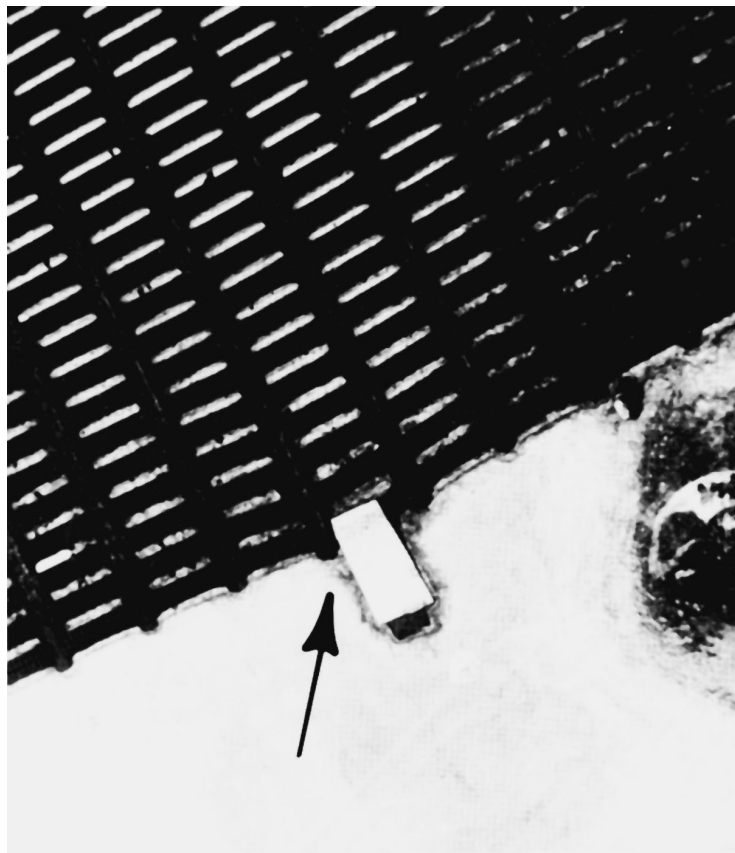
Fig. 3.1-7. Rubber walkway pad secured to the PVC membrane with heat-welded tabs

- 1. Stretching or tightening of the membrane. Usually noticeable at the edges and seams, flashings, roof penetrations or walkway pads (see Figure 3.1-7).

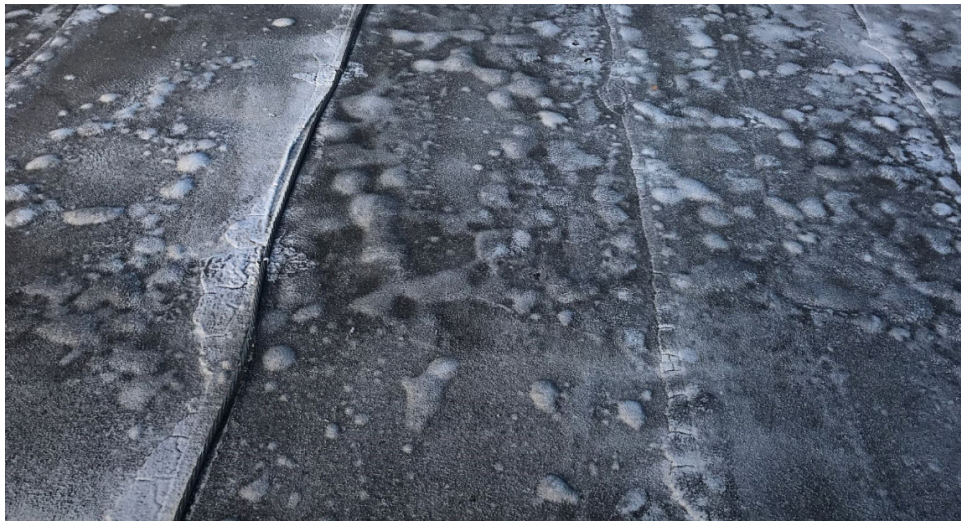
Fig. 3.1-8. Severe blistering of a built-up roof

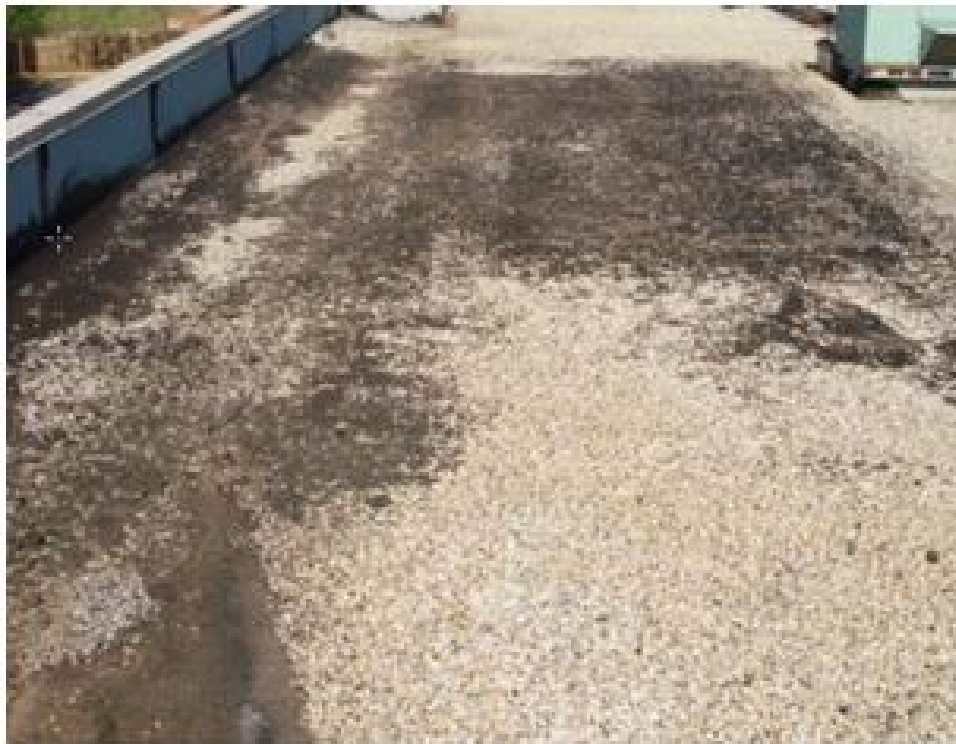
Fig. 3.1-9. Built-up roof with discolored area where water ponds (note exposed roof areas missing gravel)

- F. Improper roof drainage, including ponding (see Fig. 3.1-9).
- G. HVAC condensate or other liquids discharging onto roof surfaces.
- H. Unsecured roof access points.

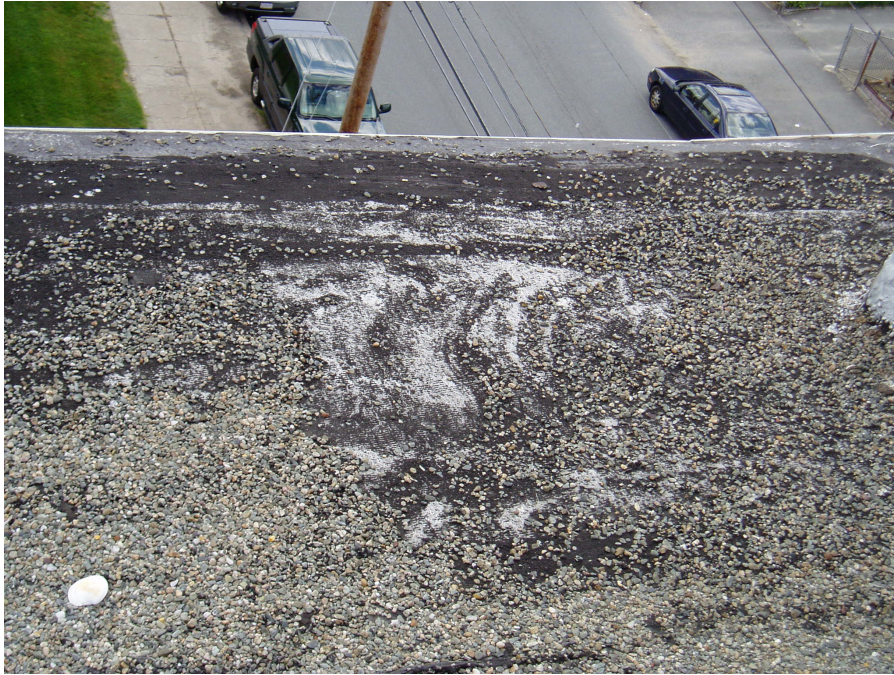
Fig. 3.1-10. Scrim showing where gravel is missing

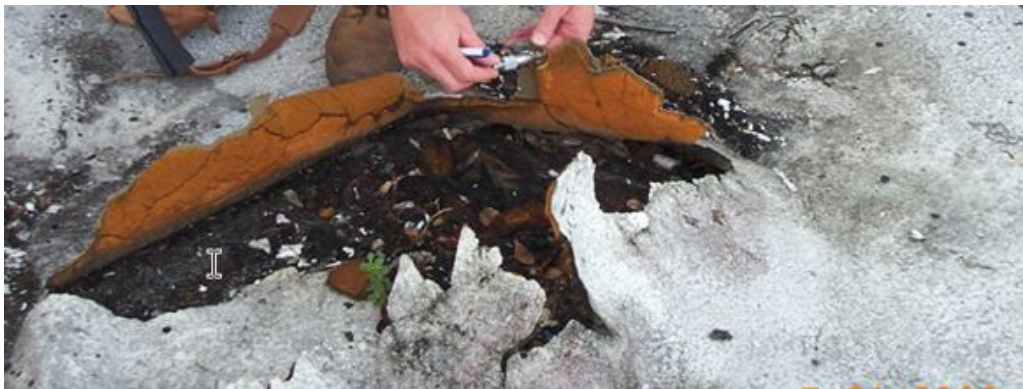
Fig. 3.1-11. Spray polyurethane foam flaking and delaminating

- K. Spray polyurethane foam roofs for pinholes, cracks, splits, blisters, or erosion, peeling or deterioration of the coating or polyurethane foam (Fig. 3.1-11). It is critical that the elastomeric top coat over the foam is in good condition or the foam will deteriorate.

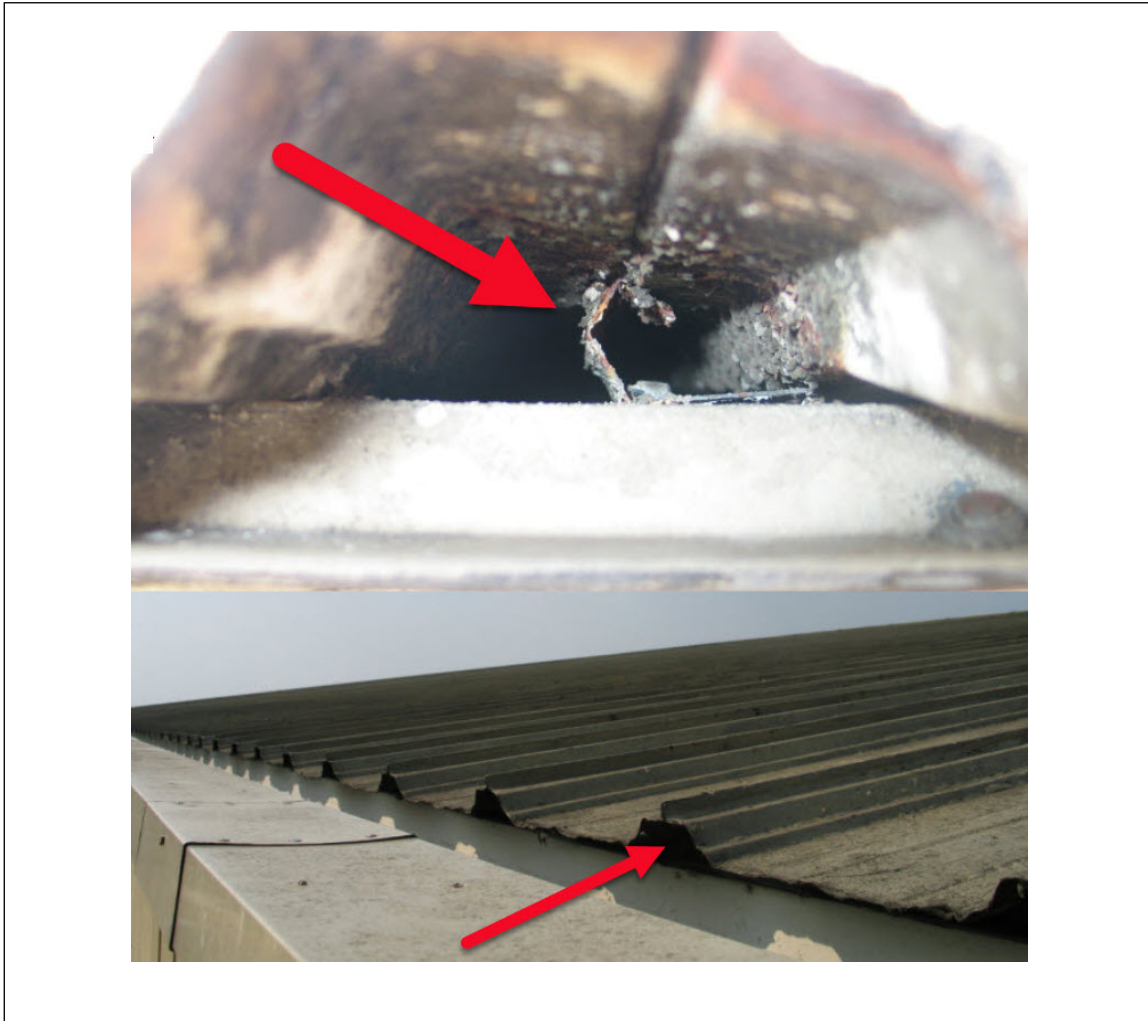
Fig. 3.1-12. Corroded and deformed roof clip on standing seam roof in coastal area

- M. Metal roof systems: Missing or loose fasteners; fasteners with missing or deteriorated flexible gaskets; panels that have holes, cracks, severe deformation or severe corrosion; panel clips with severe corrosion (see Figure 3.1-12) or damage to seams that can leak water.
