RESEARCH TECHNICAL REPORT
*Fire Protection Requirements
of Empty Intermediate
Bulk Containers (IBCs)*

Fire Protection Requirements of Empty Intermediate Bulk Containers (IBCs)

FM Global Research Division
1151 Boston-Providence Turnpike
Norwood, MA 02062

July 2012

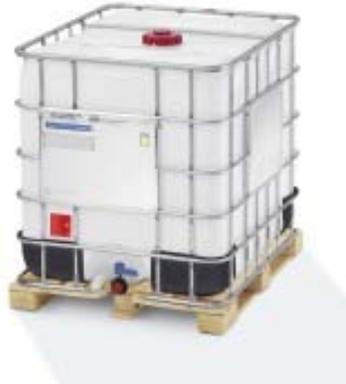
An opening (DN 150 with screw tap) is provided at the top for filling and an outlet (DN 50 butterfly valve) is provided at the bottom for dispensing. The outlet of the IBC is located at an indent in the bottle so the wire cage can provide protection from damage. This area is commonly referred to as the dog-house of the IBC, located on the 102 cm (40 in.) side of the IBC. A photo of an IBC with a wood pallet is provided in Figure 2-2.

Figure 2-2: Photo of IBC on wood pallet (internet image [2])

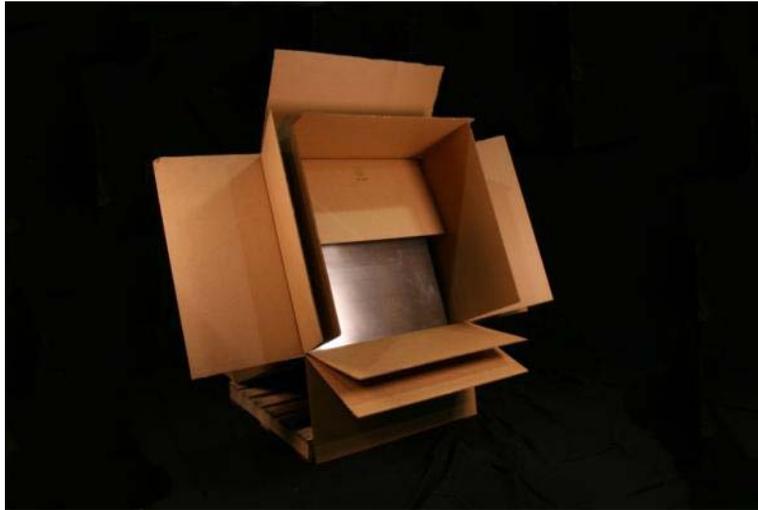
In addition to the IBCs, Class 2 commodity was used during the test program as ‘targets’ to assess fire spread. The FM Global standard Class 2 test commodity consists of three double-wall corrugated paper cartons. The dimensions for the inner, middle, and outer box are 1.02 m x 1.02 m x 0.96 m (40.3 in. x 40.3 in. x 37.8 in.), 1.04 m x 1.04 m x 0.99 m (41.0 in. x 41.0 in. x 39.1 in.), and 1.06 m x 1.06 m x 1.05 m (41.8 in. x 41.8 in. x 41.5 in.), respectively. Inside the cartons is a five-sided sheet metal liner, representing a non-combustible content. The cartoned liner is supported on an ordinary, two-way, slatted deck, hardwood pallet, measuring 1.07 m x 1.07 m x 13 cm (42 in. x 42 in. x 5 in.). A photo of the Class II commodity is provided in Figure 2-3.

Figure 2-3: Photo of Class 2 Commodity

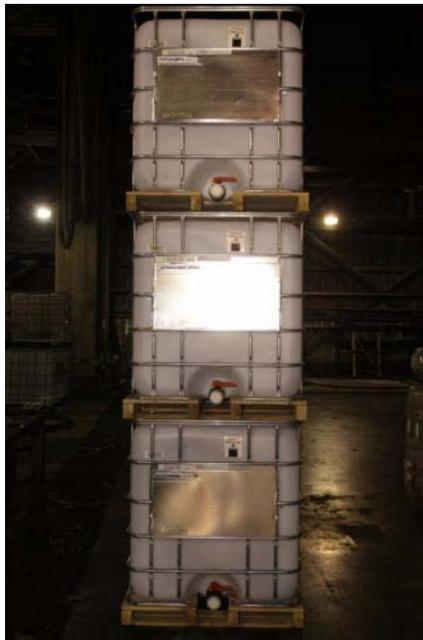
Stacking of the intermediate bulk containers is a common method of storage where the IBCs are set directly on top of each other. Often, the pallets of the IBCs and the wire cages are designed so they align during stacking to improve stability. By stacking the IBCs, floor space can be saved by storing the product vertically, but without the use of racks. Typically, IBCs can be stacked 3-high, though higher storage is possible depending on the product in the IBCs. For this program, IBCs stacked 3-high were utilized for all tests. The nominal height of a 3-high stacked array was 3.5 m (11.5 ft). A photo of a single stack of the IBCs is provided in Figure 2-4.

Figure 2-4: Photo of a Single Stack of IBCs

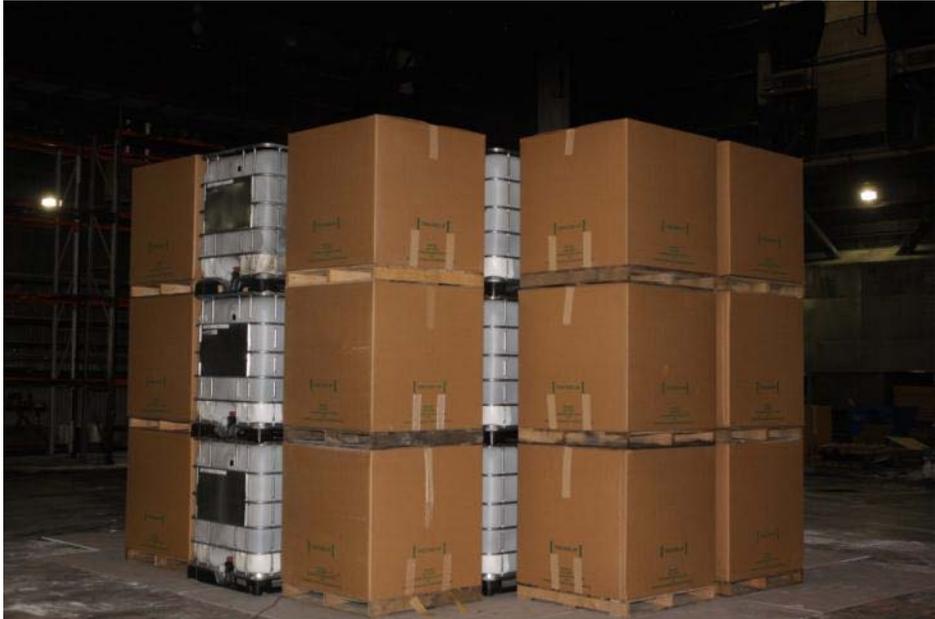
Figure 2-6: Photo of IBC Array

A schematic plan view of the test array is provided in Figure 2-5. The main array was comprised of the core IBCs (2 x 3) in the schematic. The stacks around the edge of the array were the targets during the tests. Photos of the actual IBC array are provided in Figure 2-6 and Figure 2-7.

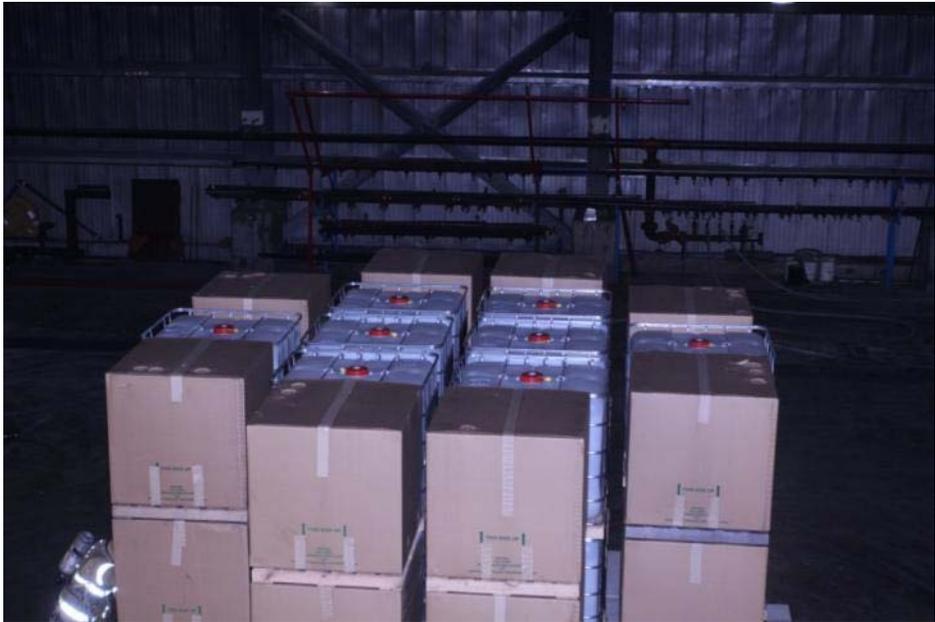
Figure 2-7: Photo of IBC Array (from elevation)

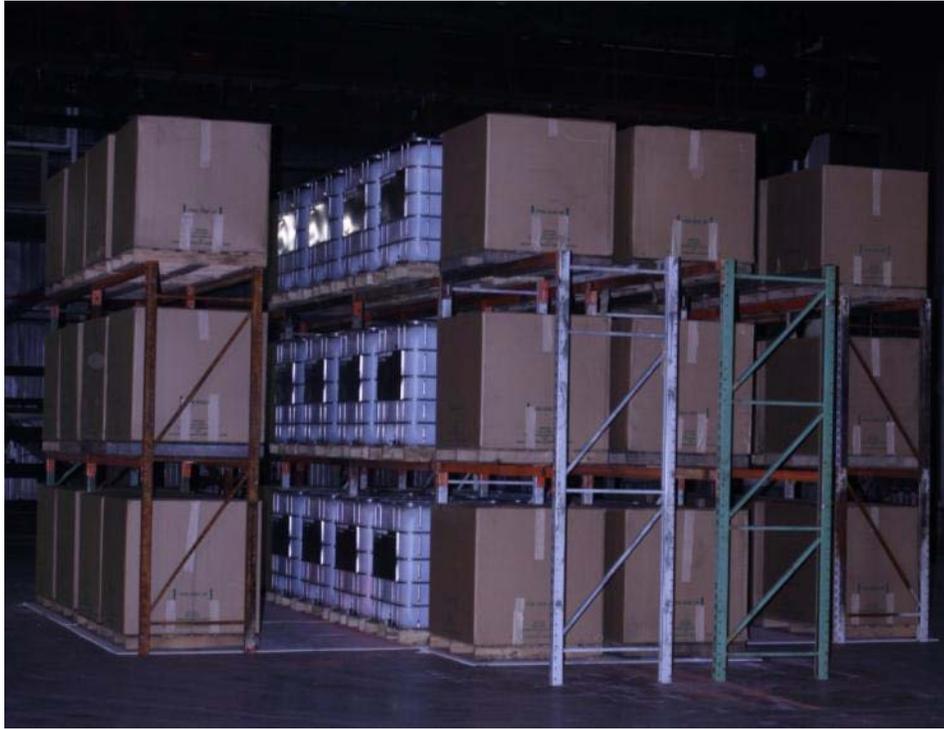
Figure 2-9: Photo of Rack Storage IBC Array

The main array was comprised of both empty composite IBCs and Class 2 commodity. In each row of the main array, the inner four pallet loads were the empty composite IBCs. Capping the ends of the double row rack was Class 2 commodity to assess fire propagation during the test. Additionally, Class 2 commodity was used for both target arrays. A plan view schematic of the rack storage test array is provided in Figure 2-8. A photo of the rack storage test array is provided in Figure 2-9.

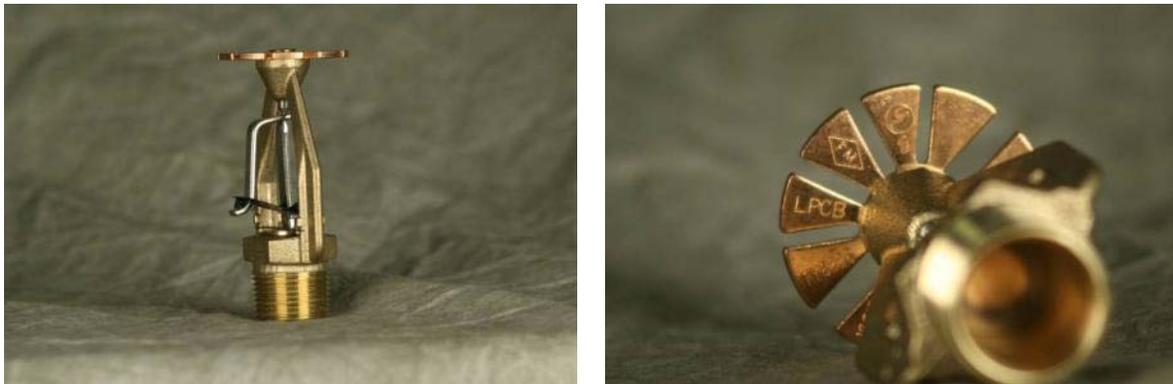
For the majority of the tests (5 of 6), ceiling sprinkler protection was provided by K-factor 202 lpm/bar^{1/2} (14.0 gpm/psi^{1/2}), quick response, pendent sprinklers, with a 74 °C (165 °F) link. Photos of the sprinkler are provided in Figure 2-10.

Figure 2-10: Photos of K-factor 202 QR Sprinkler

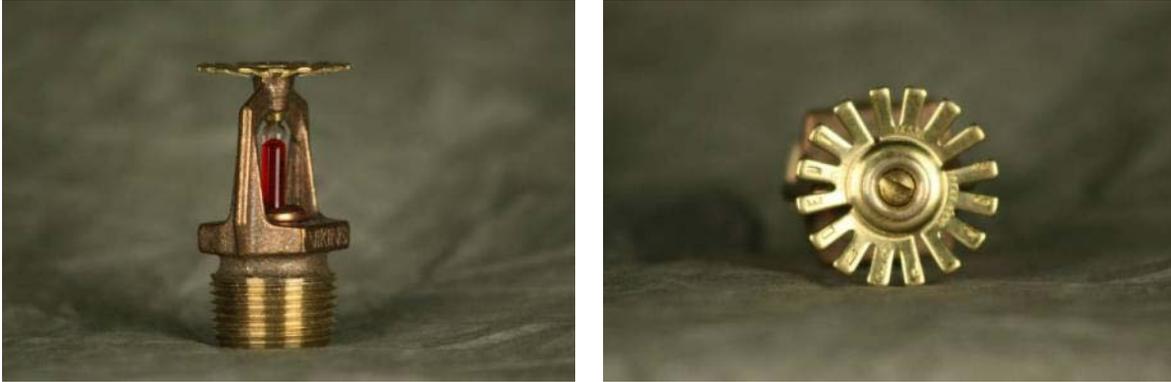
For one test, ceiling sprinkler protection was provided by K-factor 161 lpm/bar^{1/2} (11.2 gpm/psi^{1/2}), standard response, pendent sprinklers, with a 68 °C (155 °F) bulb. Photos of the sprinkler are provided in Figure 2-11.

Figure 2-11: Photos of K-factor 161 SR Sprinkler

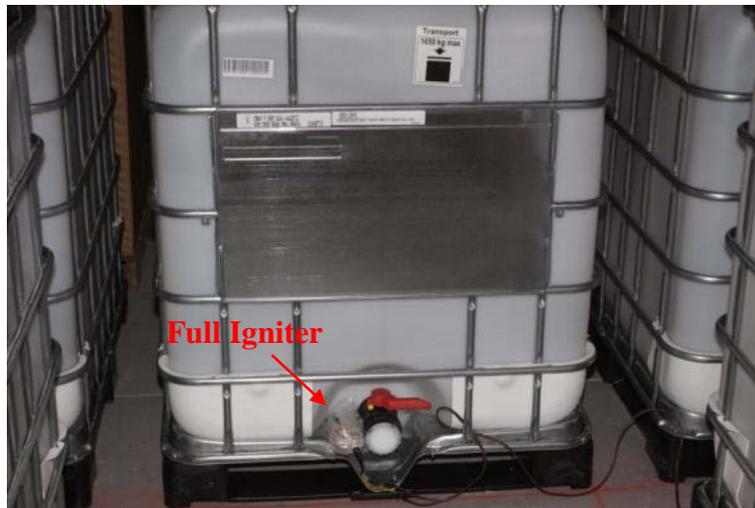
For the stacked IBC tests, ignition was achieved with an FM Global standard full igniter. The igniter is a 76 mm x 152 mm (3 in. x 6 in.) cylinder of rolled cellucotton. The igniter is soaked in 237 ml (8 oz.) of gasoline and sealed in a plastic bag. It was placed in the doghouse of the intermediate bulk container located at floor level and facing the longitudinal flue, as indicated in Figure 2-12. A photo of the igniter placed in the doghouse of the IBC is provided in Figure 2-14. The igniters were lit with an electric match at the start of the test and the fire was allowed to develop naturally.

Figure 2-14: Photo of Igniter Placement for Stacked IBC Tests

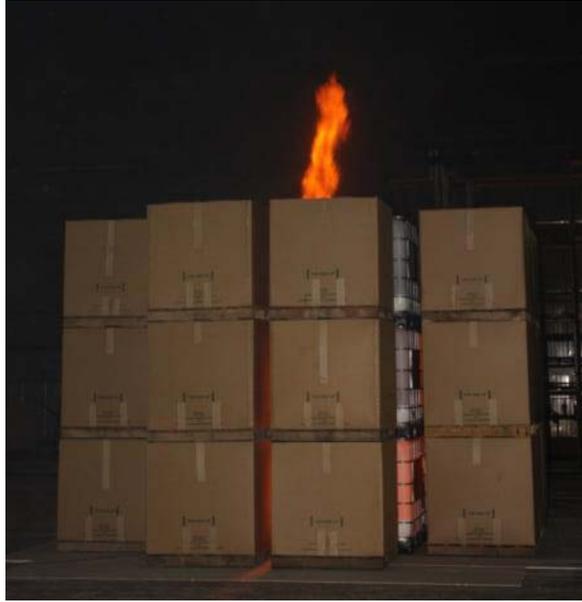
The fire was initiated with an igniter placed in the doghouse of the 1st tier⁹ IBC in the western row¹⁰. The fire developed slowly and flames reached the top of the 1st tier IBC at 1 min 34 s. As the IBC became more involved, the fire intensity increased and flames were burning beneath the 2nd tier IBC at 2 min 35 s. Plastic was observed dripping into the center longitudinal flue creating a small plastic pool fire in the flue. At 4 min 33 s, the pool had spread across the flue and the flames were impinging on the eastern row of IBCs across from ignition. At 5 min 16 s, the IBC at the base of the eastern row became involved. The fire intensity increased in the longitudinal flue and flames reached the top of the 1st tier within the flue. At 8 min 54 s, the flames reached the top of the array and at 9 min 13 s, flames were 1.2 m (4 ft) above the array, as shown in Figure 3-1.

Figure 3-1: Photo of Array at ~9 min 13 s (Test 1)

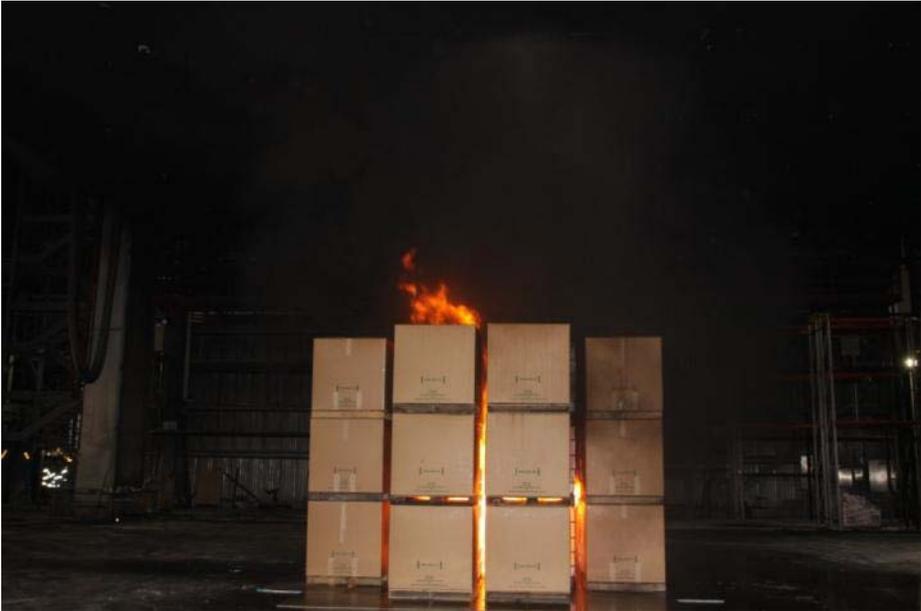
Figure 3-8: Photo of Array at 1st Sprinkler Operation (Test 2)

During the test, a single sprinkler operated and quickly controlled the fire. The sprinkler operation pattern is provided in Figure 3-7. A photo of the test array at 1st sprinkler operation is provided in Figure 3-8. The sprinkler was able to prevent fire spread to the target commodity surrounding the main array and most observed damage was prior to the 1st sprinkler operation¹². A photo of the post-test damage is provided in Figure 3-9 and the extent of damage is provided in Figure 3-10 through Figure 3-12.

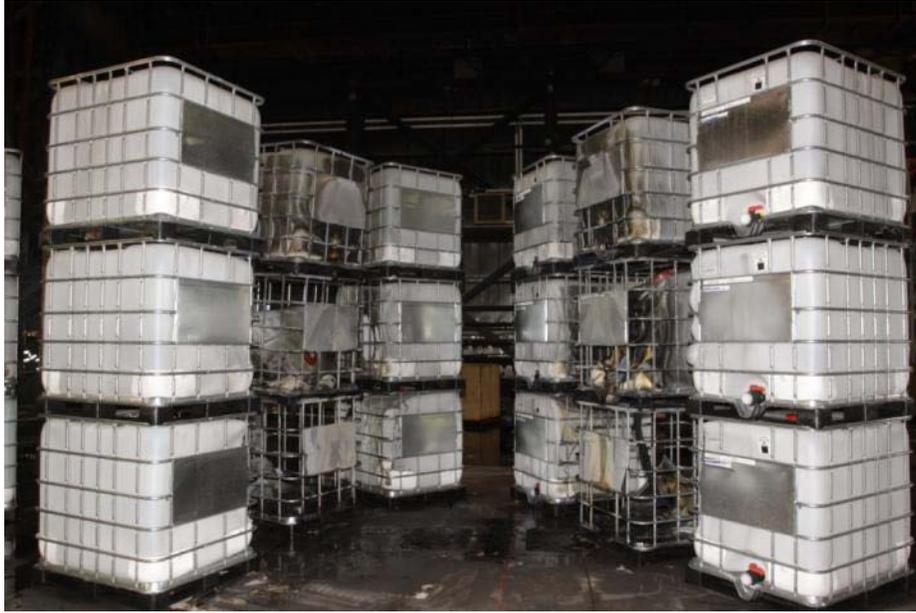
Figure 3-9: Test 2 - Post-Test Photo of Array (Opened for Photo)

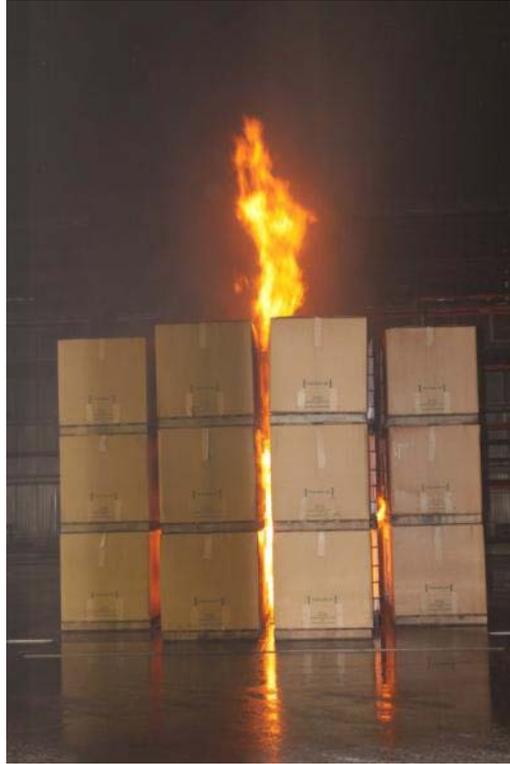
Figure 3-14: Photo of Array after 1st Sprinkler Operation ~9 min 40 s (Test 3)

During the test, six sprinklers operated but were not able to prevent fire spread through the array. The sprinkler operation pattern is provided in Figure 3-13. A photo of the test array after the 1st sprinkler operation is provided in Figure 3-14. A photo of the array prior to the 2nd sprinkler operation showing the fire spread into the target IBCs is provided in Figure 3-15. A photo of the post-test damage is provided in Figure 3-16 and the extent of damage is provided in Figure 3-17 through Figure 3-19.

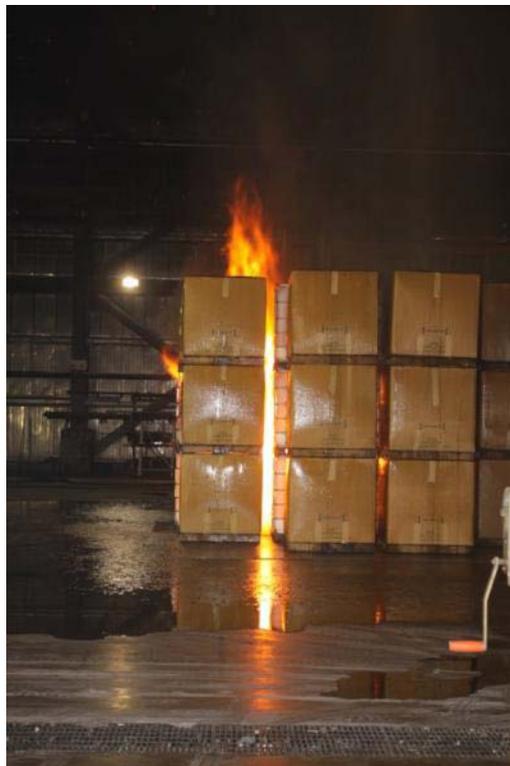
Figure 3-15: Photo of Array at ~16 min 38 s (Test 3)

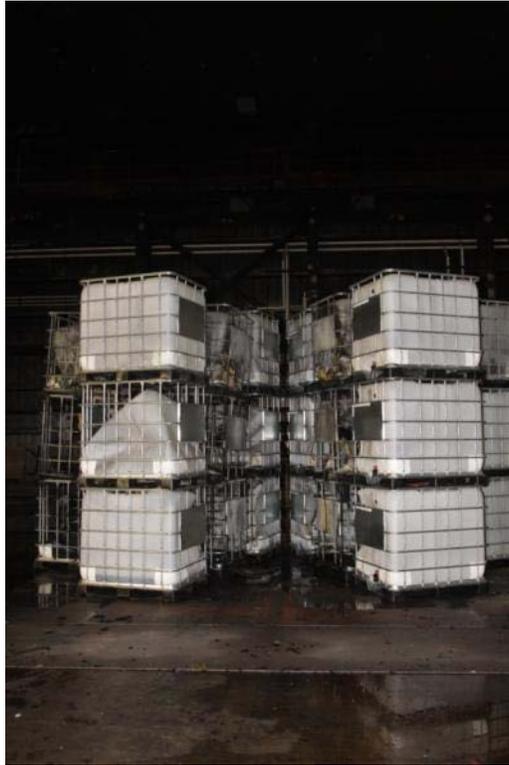
Figure 3-16: Test 3 - Post-Test Photo of Array (Opened for Photo)

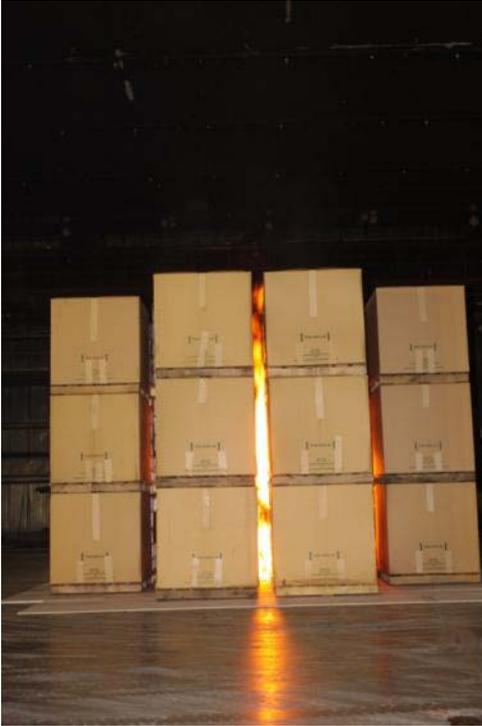
Figure 3-21: Photo of Test Array just Prior to 1st Sprinkler Operation (Test 4)

The 1st sprinkler operation was at 8 min 24 s. The fire was quickly knocked down with some flames remaining below the 2nd tier pallets in the longitudinal flues. At 12 min, only small flames were observed beneath pallets where the fire was shielded from the sprinkler spray. The test was terminated at 20 min.

During the test, a single sprinkler operated and quickly controlled the fire. The sprinkler operation pattern is provided in Figure 3-20. Only localized burning in shielded areas remained for the duration of the test and the fire was contained to the main array. A photo of the test array at 1st sprinkler operation is provided in Figure 3-21. A photo of the post-test damage is provided in Figure 3-22 and the extent of damage is provided in Figure 3-23 through Figure 3-25.

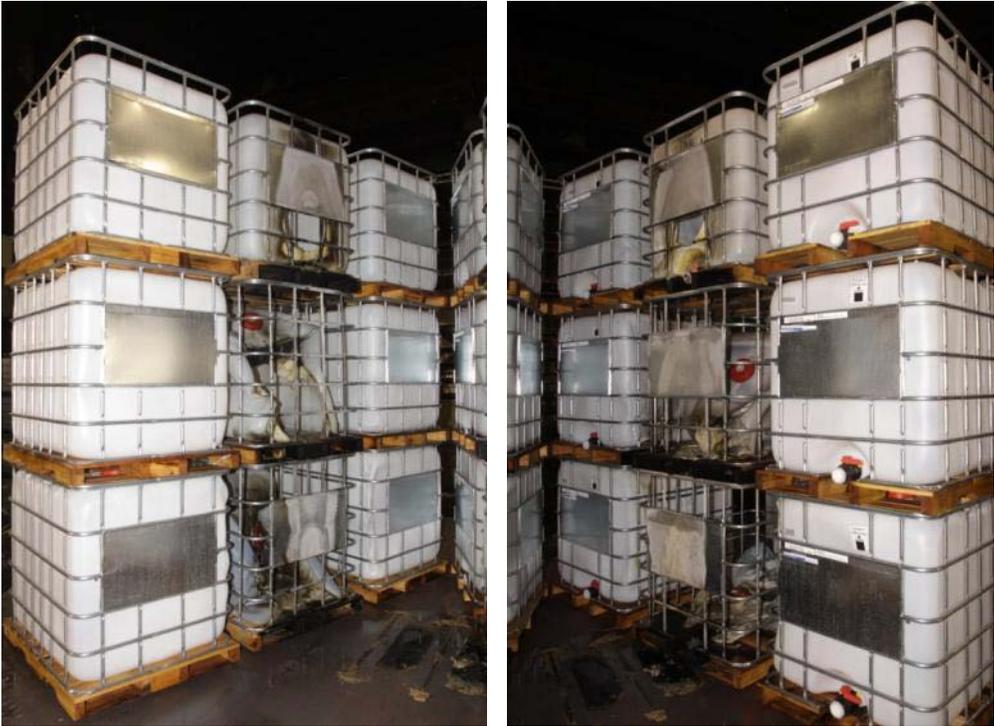
Figure 3-22: Test 4 - Post-Test Photo of Array (Opened for Photo)

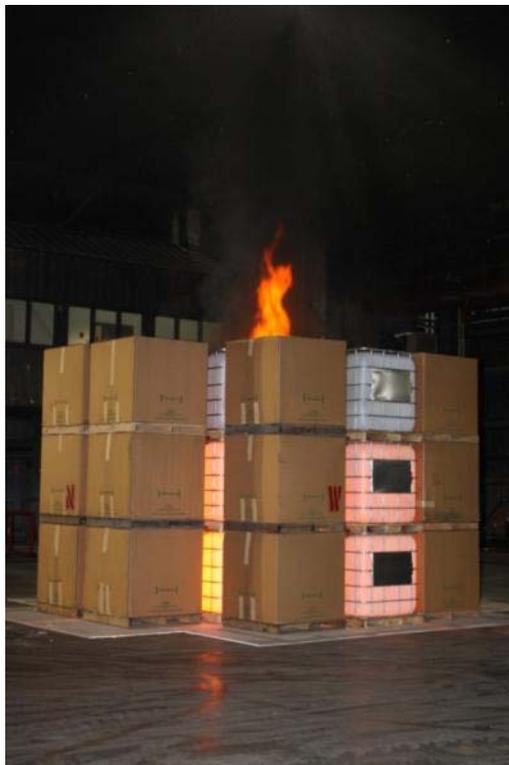
Figure 3-27: Photo of Array Prior at 1st Sprinkler Operation ~9 min 30 s (Test 10)

At 9 min 30 s, the 1st sprinkler operated. At 9 min 45 s, flames from the center longitudinal flue were 3.0 m (10 ft) above the array and flames in the west and east longitudinal flue were above the array. At 9 min 56 s, flames were reaching ceiling level and at 10 min 4 s, all 18 IBCs in the main array were involved. Ignition of the east and west targets was observed at 10 min 13 s.

During the test, 17 sprinklers operated but were not able to prevent fire spread through the array. The sprinkler operation pattern is provided in Figure 3-26. A photo of the test array at 1st sprinkler operation is provided in Figure 3-27. A photo of the array prior to the 2nd sprinkler operation showing the fire spread into the target IBCs and flames at ceiling level is provided in Figure 3-28. The extent of damage is provided in Figure 3-29 through Figure 3-31.

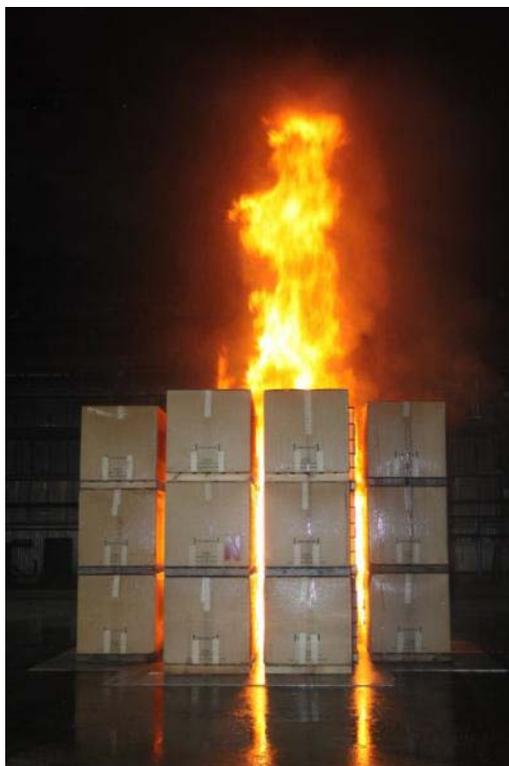
Figure 3-28: Photo of Array Prior to 2nd Sprinkler Operation ~10 min 12 s (Test 10)

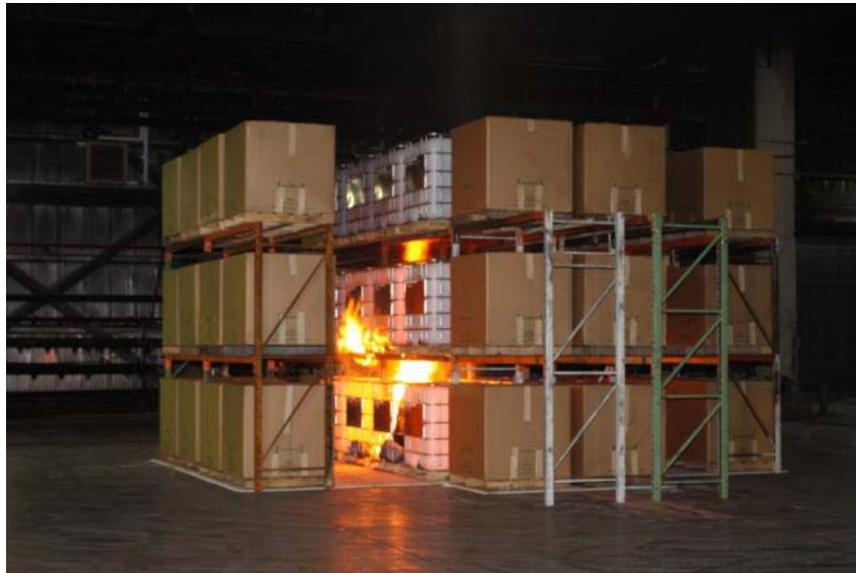
Figure 3-33: Photo of Array Prior at 1st Sprinkler Operation ~7 min 28 s (Test 11)

The 1st sprinkler operation was at 7 min 28 s. The sprinkler quickly impacted the fire and at 8 min 30 s, flames were no longer observed in the flue spaces of the array. Small fires still persisted beneath the 2nd tier pallets where the fire was shielded from the sprinkler spray. These fires caused melted plastic to drip into the 1st tier where small fires were formed at floor level. None of the small fires spread or increased in intensity for the remainder of the test. The test was terminated at 25 min.

During the test, a single sprinkler operated and quickly controlled the fire. The sprinkler operation pattern is provided in Figure 3-32. Only localized burning in shielded areas remained for the duration of the test and the fire was contained to the ignition flue. A photo of the test array at 1st sprinkler operation is provided in Figure 3-33. A photo of the localized burning beneath the pallets is provided in Figure 3-34. A photo of the post-test damage is provided in Figure 3-35, and the extent of damage is provided in Figure 3-36 through Figure 3-38.

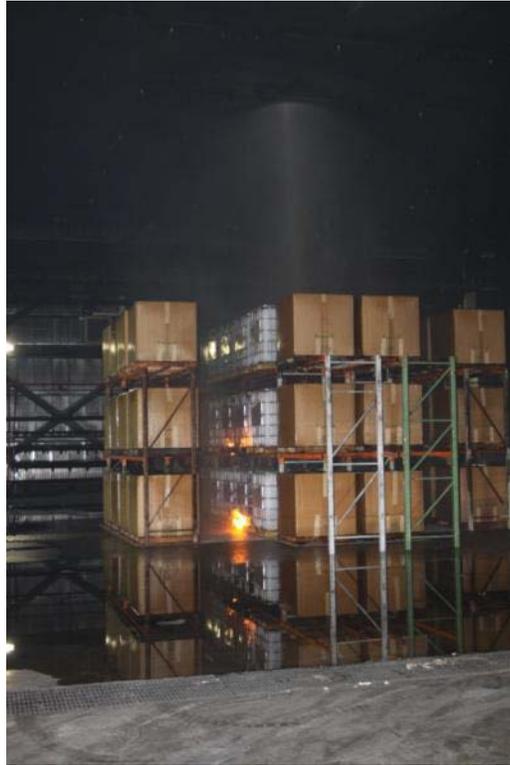
Figure 3-34: Photo of Test Array at ~ 22 min 16 s (Test 11)

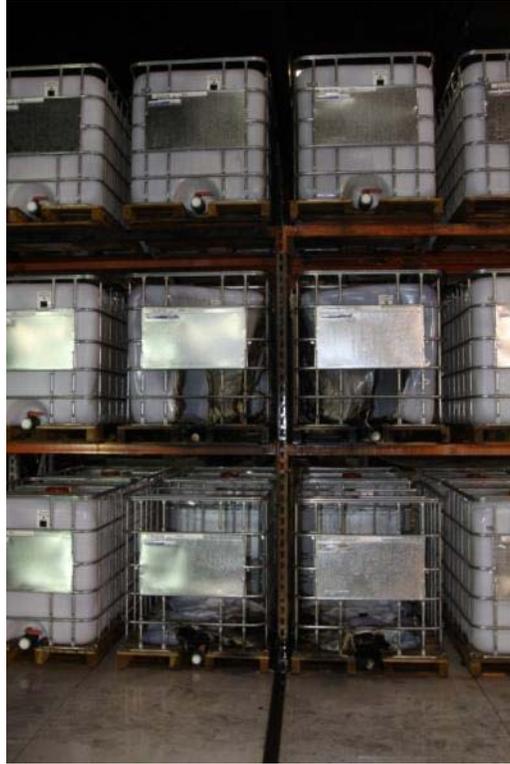
Figure 3-35: Test 11 - Post-Test Photo of Array (East Face)
