## ROOF ANCHORAGE FOR OLDER, WOOD-ROOFED BUILDINGS

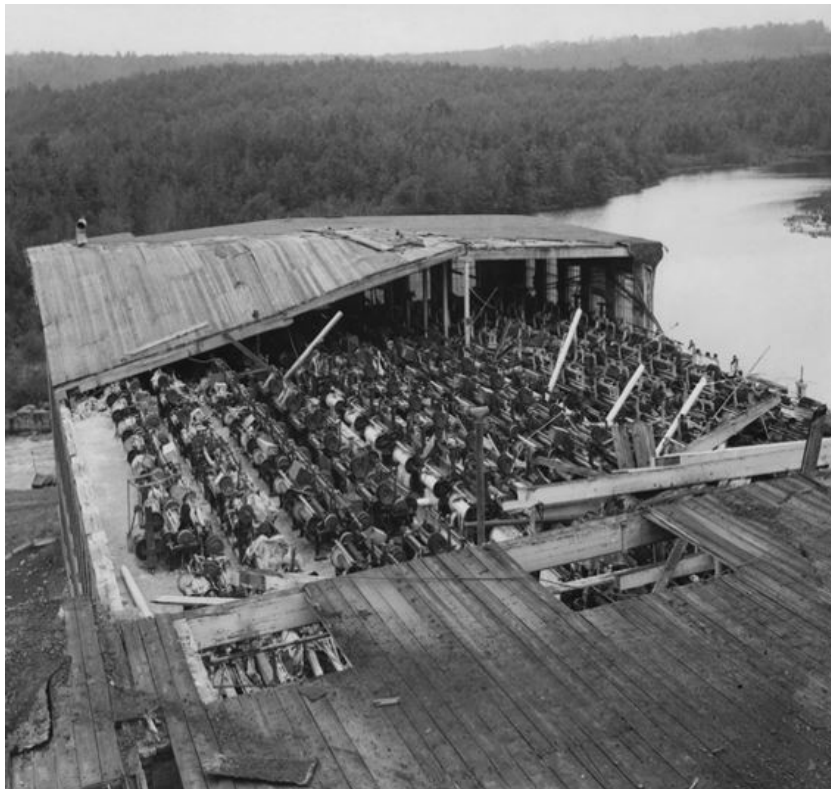
Fig. 1.1-1. Roof damaged in the 1938 New England Hurricane (after debris removal)

Insufficient anchorage of roof-support members has been the major reason for wind damage to older, wood-roofed buildings. Figure 1.1-1 shows hurricane damage to a plank-on-timber building where the roof beams rested on the interior columns without any anchorage, with wind uplift resisted only by the weight of the roof and roof-support members. Hurricane winds then lifted the roof-support members off the building columns and the walls collapsed (Figure 1.1-2).

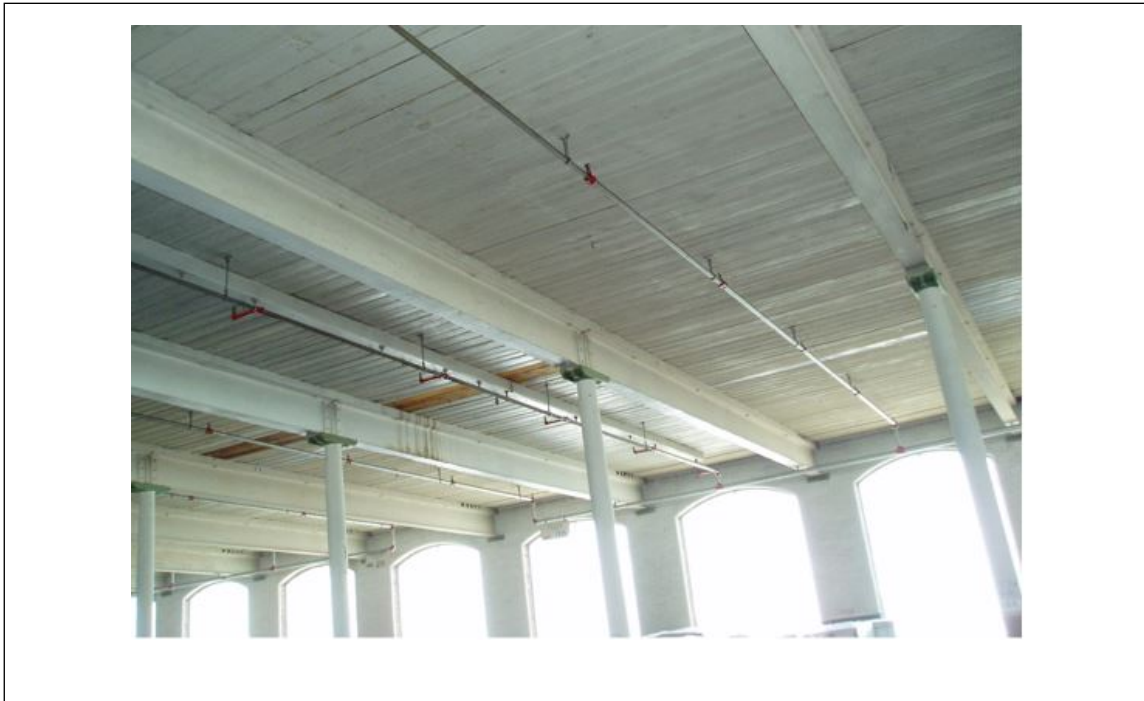
Fig. 1.1-3. Typical plank-on-steel building

Fig. 1.1-3 shows the roof interior of a typical plank-on-steel building where roof-support members rest on interior columns. See Section 3.0 for construction details.

*Fig. 3.1-3. Closeup of column cap (green) in Figure 1.1-3 (the column cap is not secured to the column)*

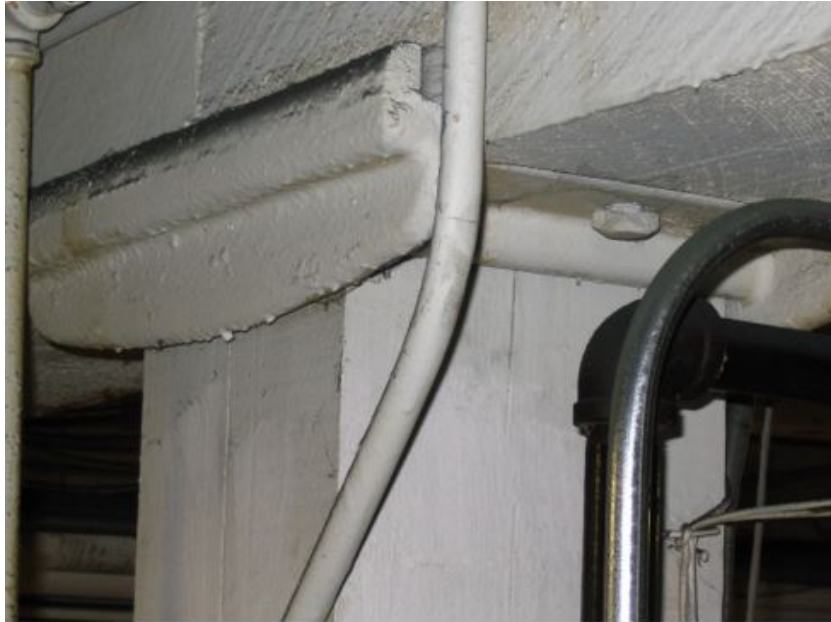
*Fig. 3.1-2. Closeup of wood roof beam resting on wood column with metal column cap*

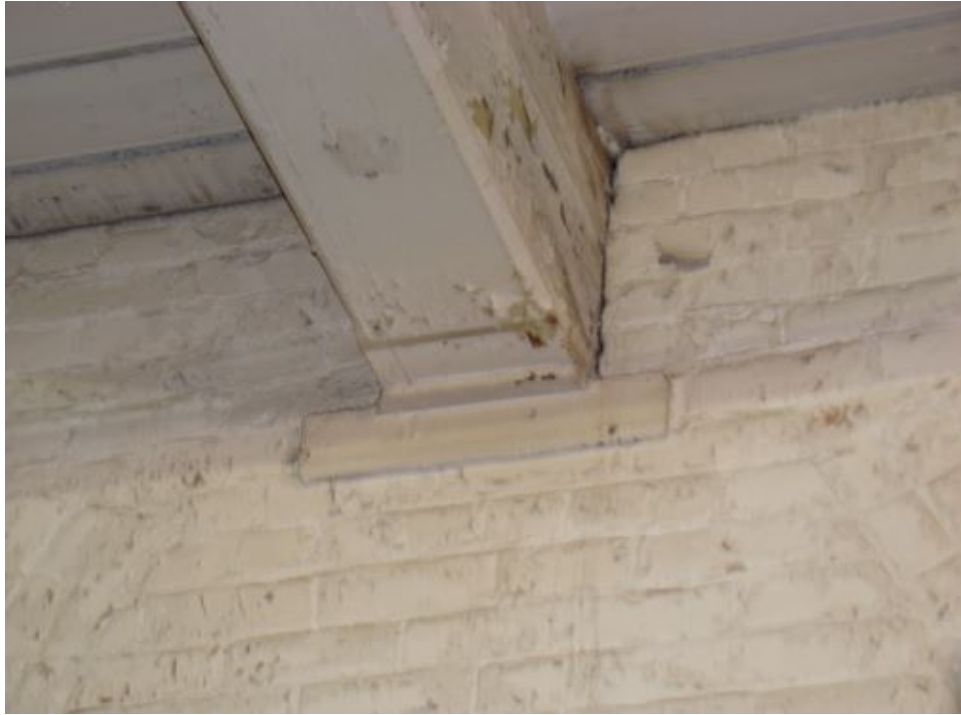
*Fig. 3.1-4. Wood roof beam rests on metal plate in brick wall*

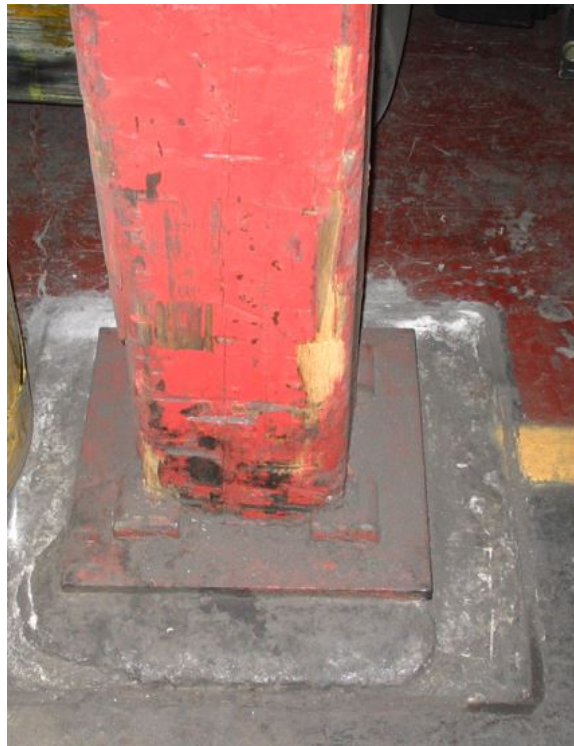
*Fig. 3.1-5. Base of unanchored building column resting on floor*

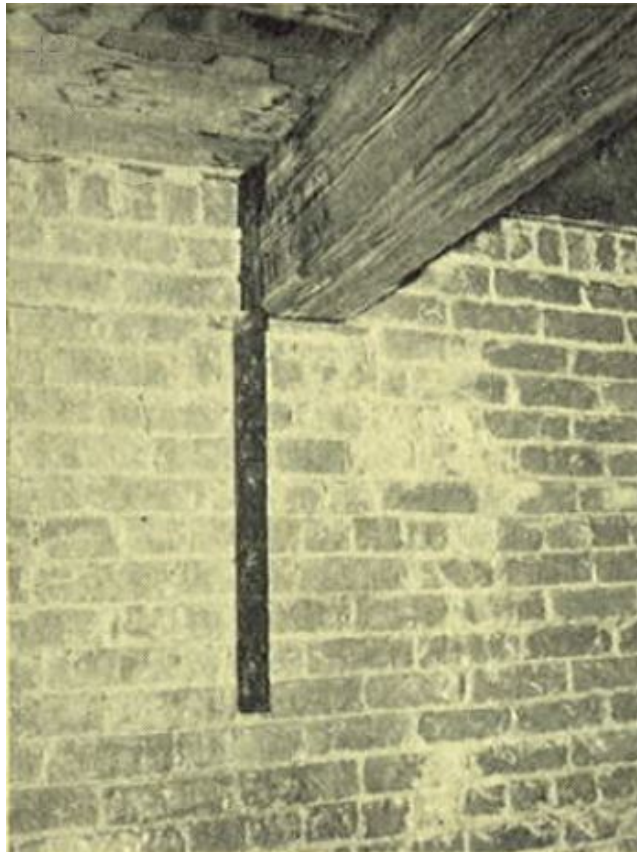
*Fig. 3.1-7. Wood roof beam anchored with short steel straps and masonry anchors*

Roof beams at the perimeter of plank-on-timber buildings may be secured to brick walls with steel straps attached to the wall as in Figures 3.1-6 and 3.1-7. Elsewhere, the designers may have relied on the dead load of the thick wood or steel beams, wood planking and built-up tar and gravel roofing to hold the roof members down.

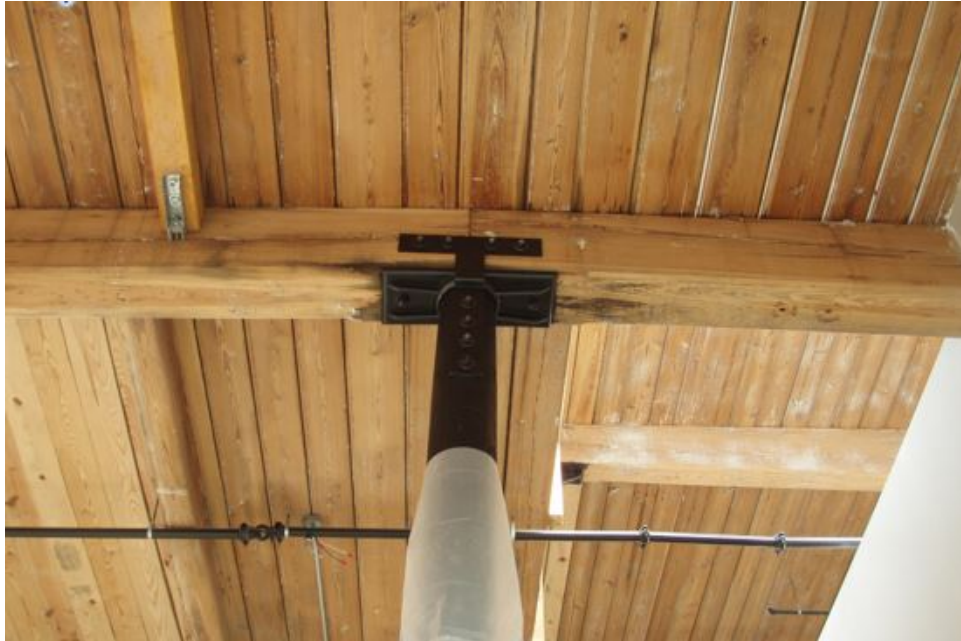
*Fig. 3.1-8. Metal bracket added during renovation to anchor roof beam to the top of the building column (courtesy WinnResidential LP)*

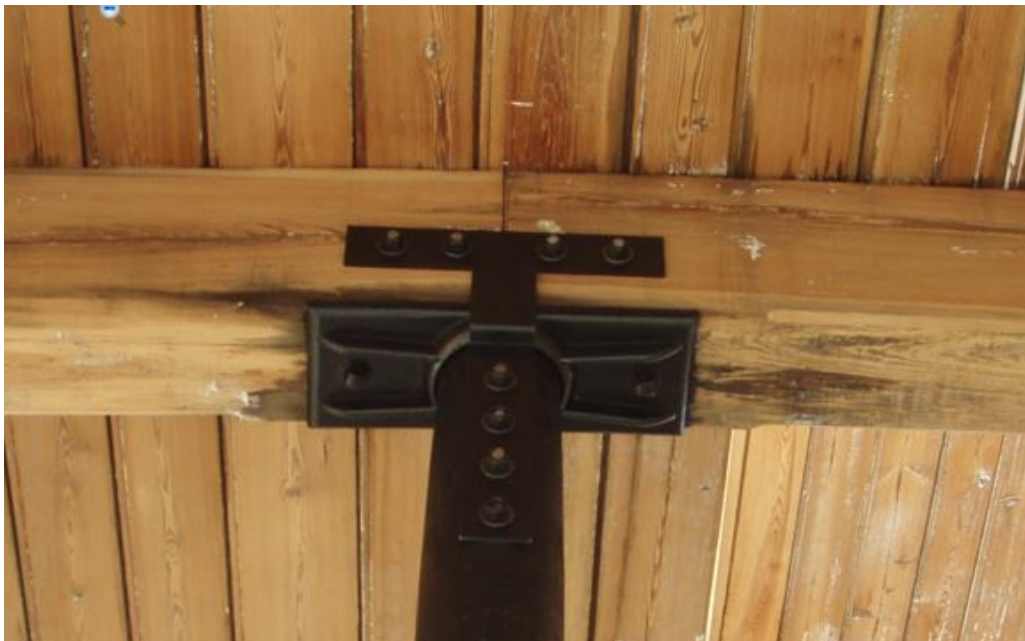
*Fig. 3.1-9. Closeup of metal bracket in Figure 3.1-8 (courtesy WinnResidential LP)*

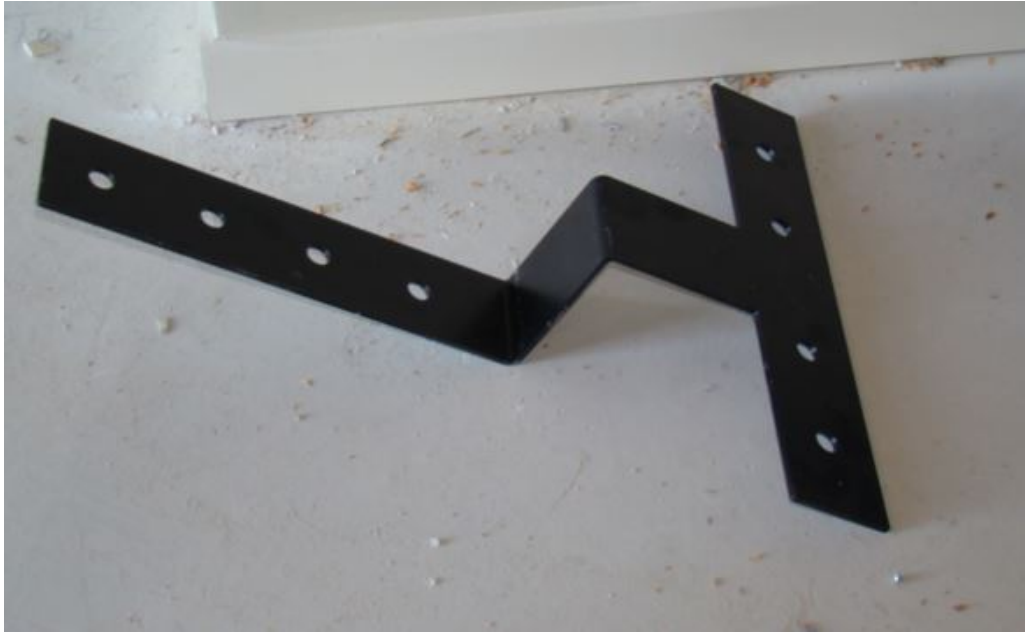
*Fig. 3.1-10. Metal bracket in Figures 3.1-8 and 3.1-9 (courtesy WinnResidential LP)*

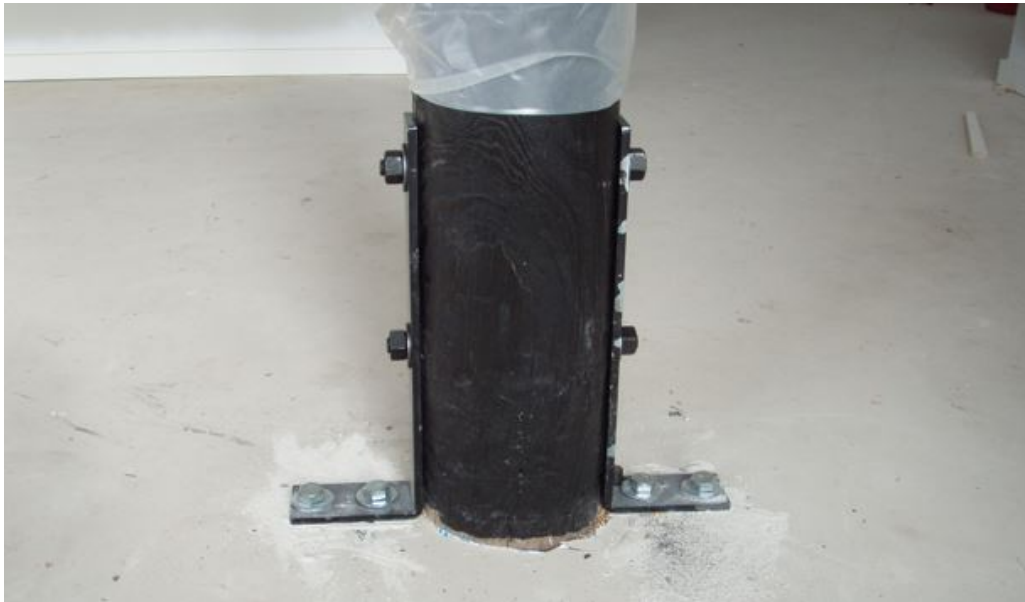
*Fig. 3.1-11. Base of wood column secured to new concrete floor poured over the original wood plank floor (courtesy WinnResidential LP)*

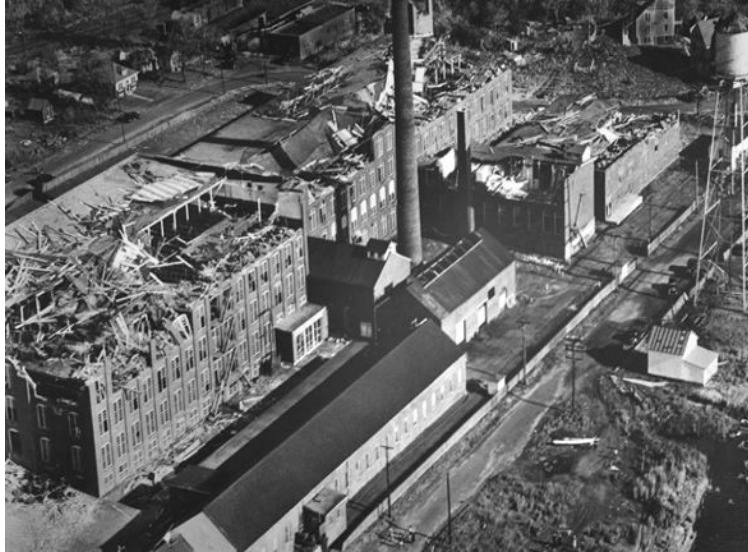
*Fig. 3.2-1. Plank-on-timber textile mill in Pawcatuck, CT damaged by the 1938 hurricane*

The largest wind event damaging plank-on-timber, plank-on-steel, and boards-on-joist buildings was the 1938 “Great New England Hurricane,” also known as the “Long Island Express,” that struck the New England region of the United States on September 21, 1938. Figures 3.2-1 and 3.2-2 show damage to plank-on-timber buildings from this hurricane.

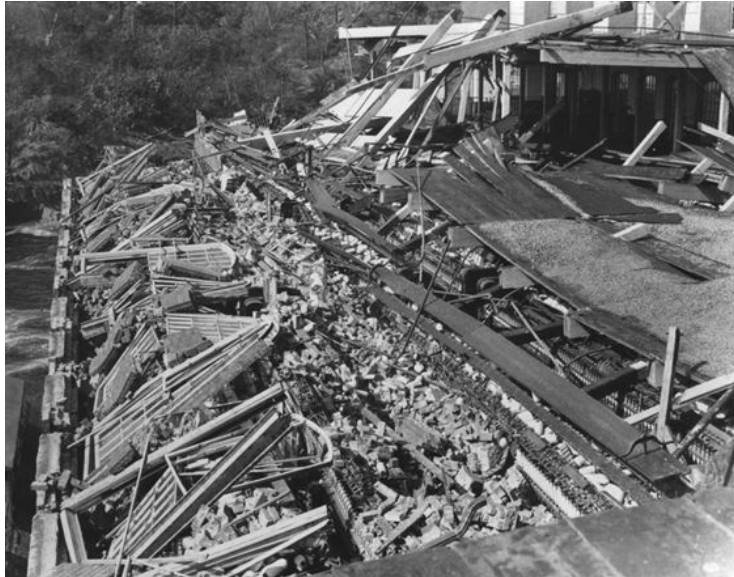
*Fig. 3.2-2. Plank-on-timber textile mill damaged by the 1938 hurricane*
