METAL TREATMENT PROCESSES

FM Property Loss Prevention Data Sheets

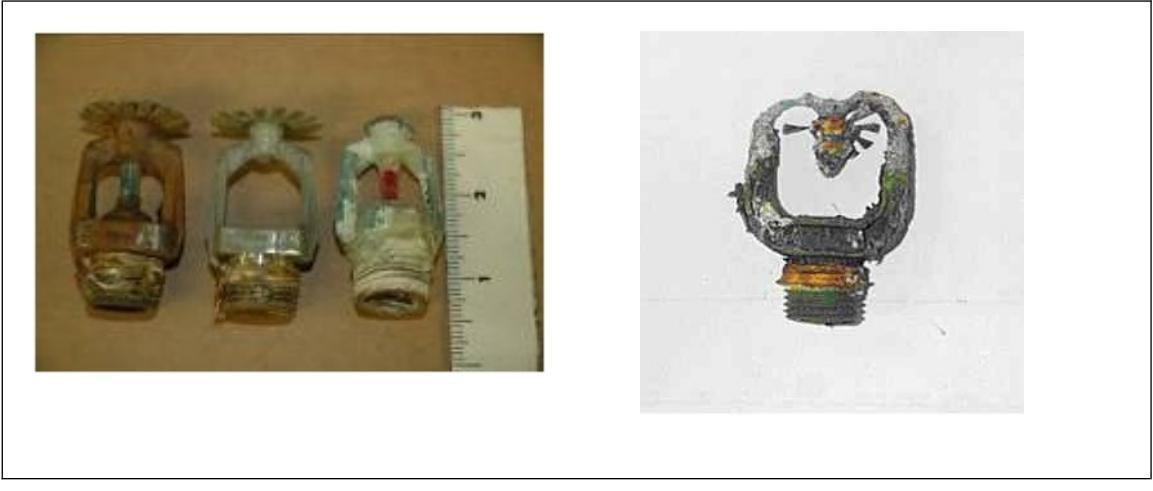
Fig. 1. Corrosion-damaged fire protection components

2.4.1 Conduct quarterly visual inspections of the fire protection system (sprinklers, valves, pipe work, and detectors) for signs of corrosion. Replace components as needed. (Figure 1 shows examples of corrosion-damaged fire protection components.)
