## CABLES AND BUS BARS

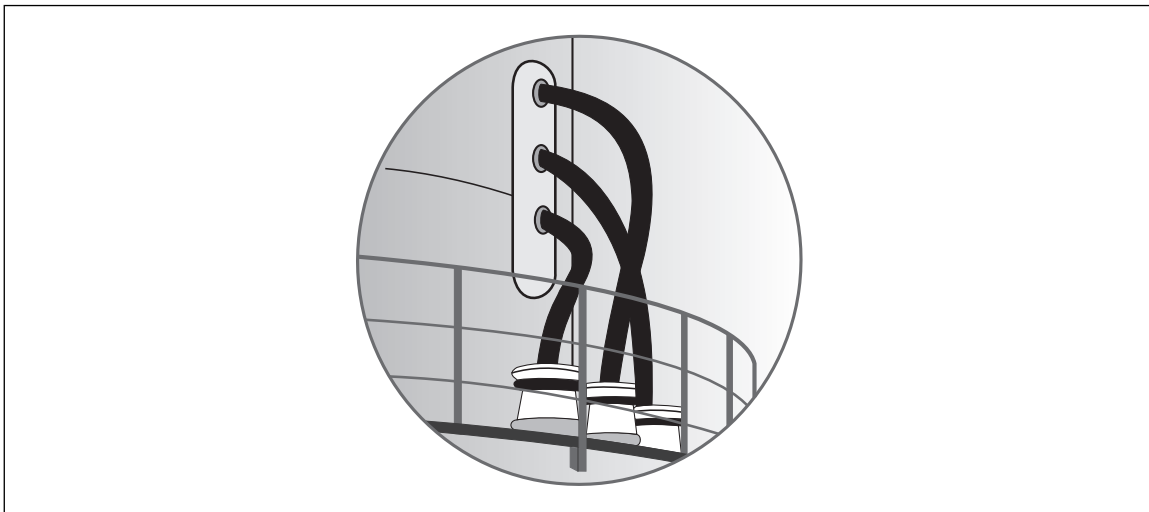
Fig. C.3.2. Accessory armor hang-off

An armor hang-off device is used to lock a cable on top of a J-tube at off-shore platforms.
